FINAL TECHNICAL REPORT

ACRONYM : TEAM

TITLE : Testing and Assessment of Marble and Limestone

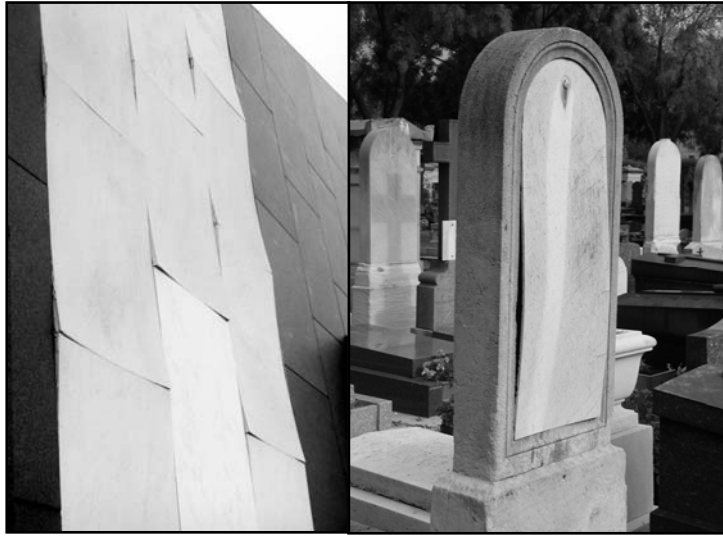
Figure B: Bowing of marble on the Finlandia Hall, Helsinki, Finland (left) and on a gravestone in the Montmartre cemetery, Paris, France (right).

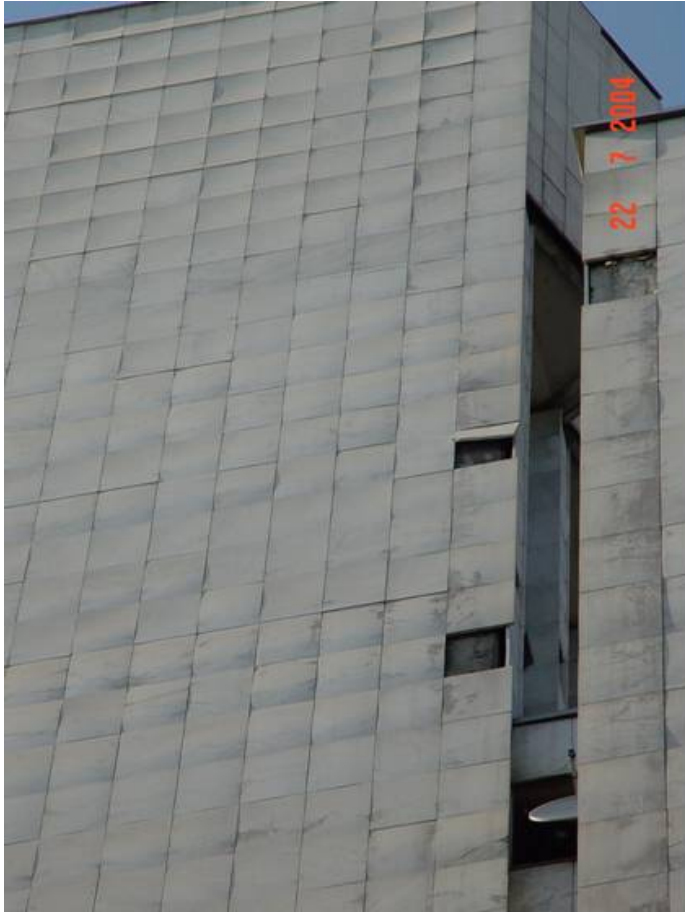
Figure 1.2. A building in Zagreb, Croatia have concave bowing at higher levels of the building and convex at lower levels at same facade elevations.

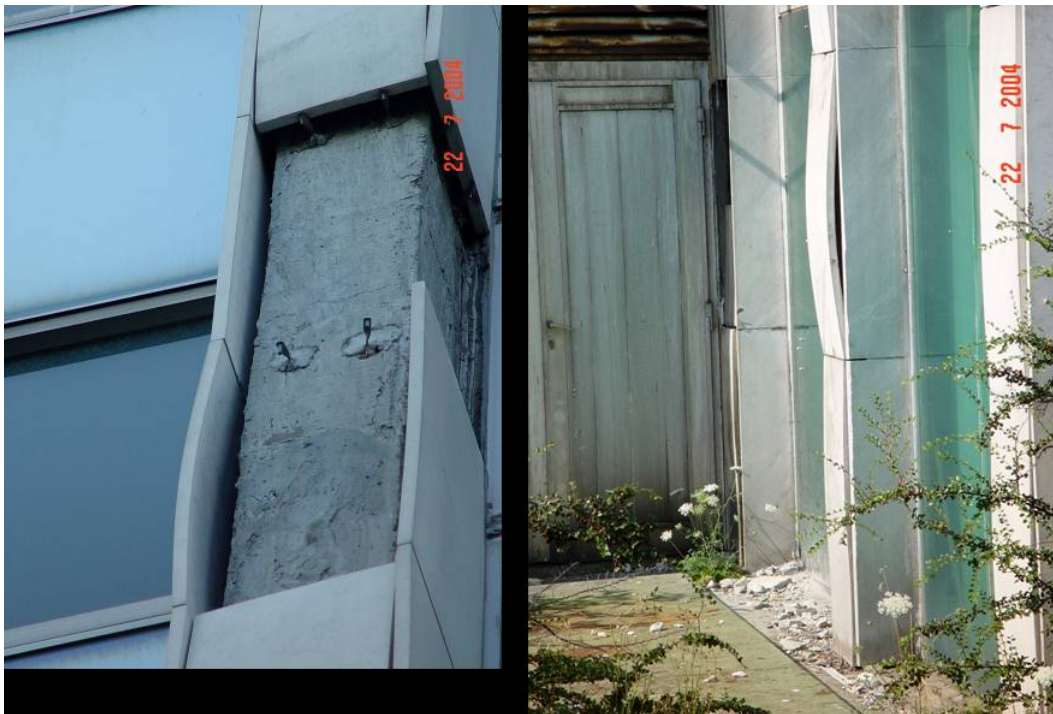
- There is a clear correlation between bowing behaviour and deterioration leading to loss of strength (figure 1.3).
- It cannot be stated that non-bowing stone slabs are not deteriorating and losing strength (e.g. mortised facade slabs seem to be hindered from bowing but might still deteriorate)
- There are quite a few different types of marble (with different origin related to quarry areas) that demonstrate the bowing behaviour.
- Marble types or selections from same quarry area or even same quarry can demonstrate bowing as well as non-bowing behaviour.
- Damages and problems of other kind than bowing and deterioration have been registered and noted but not further discussed within the TEAM programme.
- Marble types with known or measured bowing problems and marked strength loss should be avoided in thin building claddings.

Figure 1.3. Severe strength loss associated with bowing.

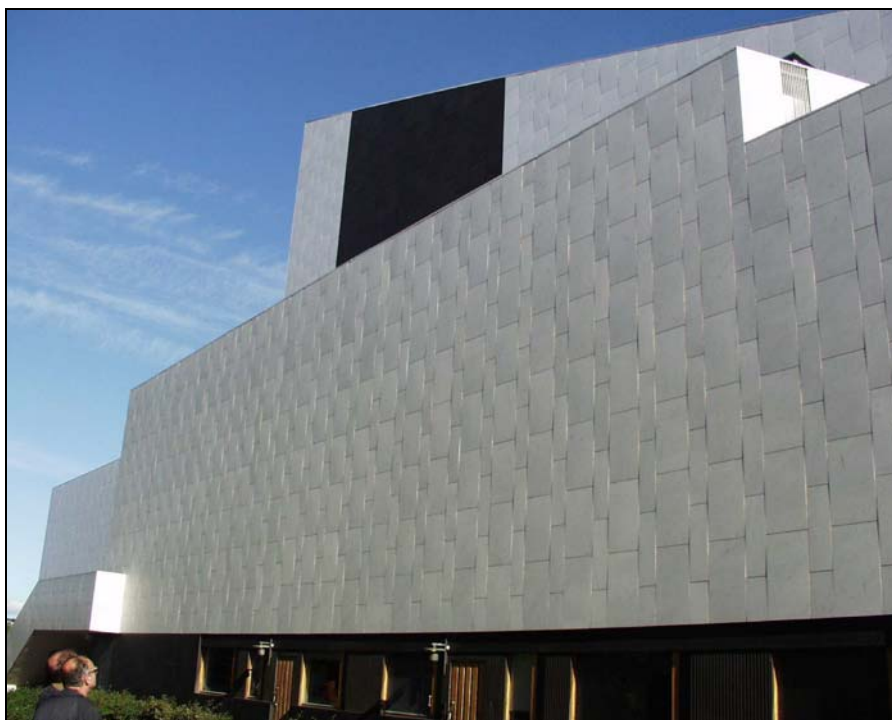
Since it is nearly impossible to restrict the temperature and moisture variations for claddings, the proper choice of marble type becomes very important. In this respect it appears to be highly desirable to develop a reliable and conclusive laboratory test method for investigation of bowing and strength loss sensitivity of carbonate rocks. The need for a reliable test method can best be illustrated by the fact, that the new marble cladding on Finlandia City Hall started to bow significantly (figure 1.5) less than one year after replacement in 1999.

Figure 1.5. Finlandia City Hall, Helsinki. The new marble cladding clearly bowed in less than 1 year after the old marble cladding had been replaced. The photo was taken in spring 2001. NB: Almost all of the old panels were bowing concave, however the new panels bow convex! In both cases the marble type was a Carrara marble (Bianco Carrara).

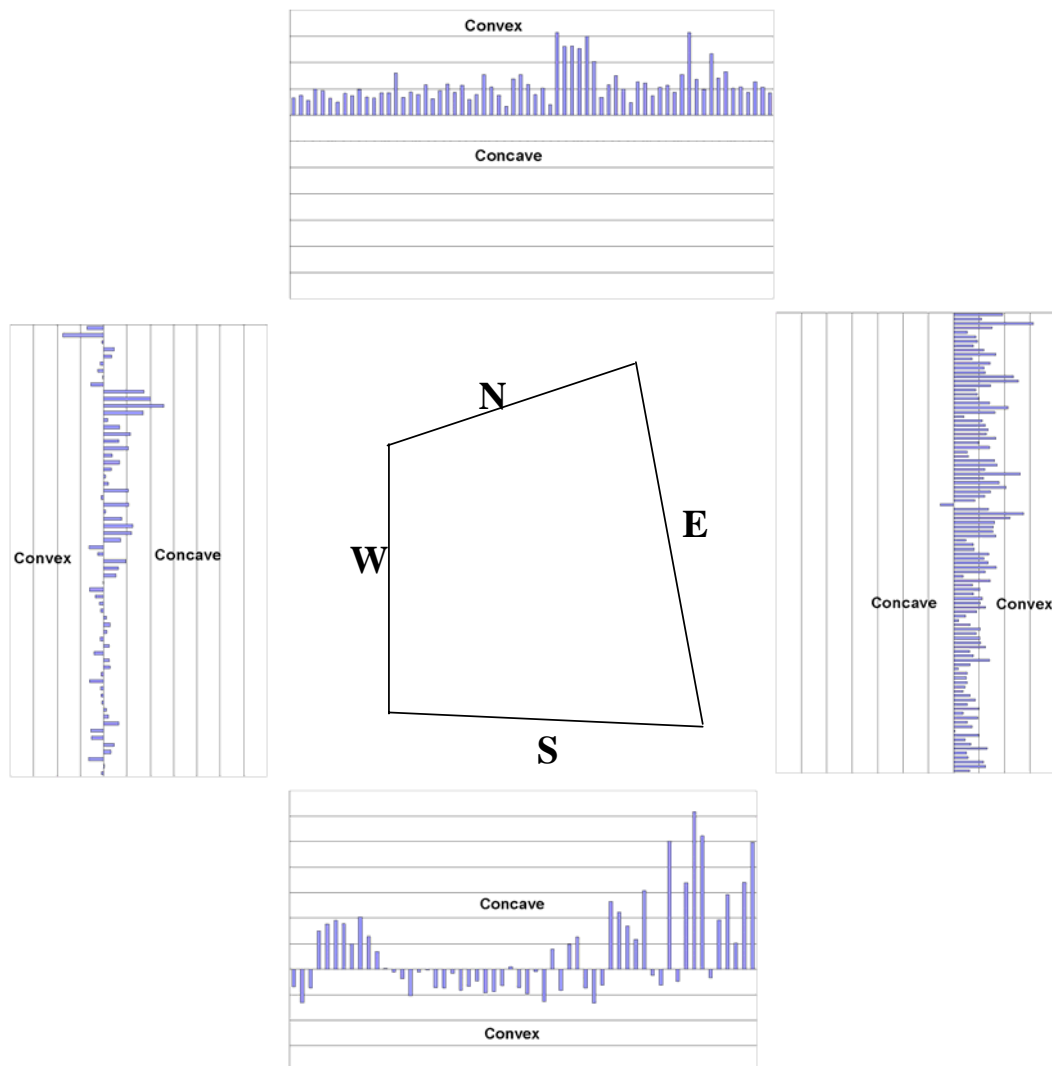
For several buildings or part of these more pronounced bowing was observed on the east or west facades than on the south facades. A reason for that could be that a low sun angle might cause larger temperature variations during a day than a high continuous sun angle. That might have influence on the bowing behaviour between different facade orientations on a certain building. Besides this, it is a fact that the sun angle varies from north / south to the equatorial zone, and that might give some explanation why bowing behaviour differs between different zones.

Figure 2.3. Bow measurements at Danish National Bank in 2001, 2nd row from the ground. Scale for bowing is in steps of 1 mm/m.

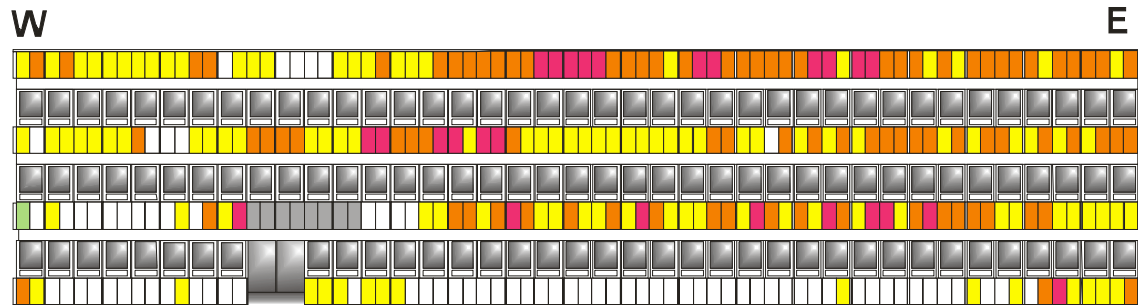
For the buildings in Göttingen (see figure 2.4) and the building in Nyköping it is observed that the bowing phenomenon increases with the height above ground. This may be explained as the exposure and the variation of the climate (wind, humidity, temperature) increases with the height above ground.

Figure 2.4. Building map of the southern facade of the Theologicum Building (true to scale). Different colours represent panels with different bowing amplitudes (colour code see figure 2.5)

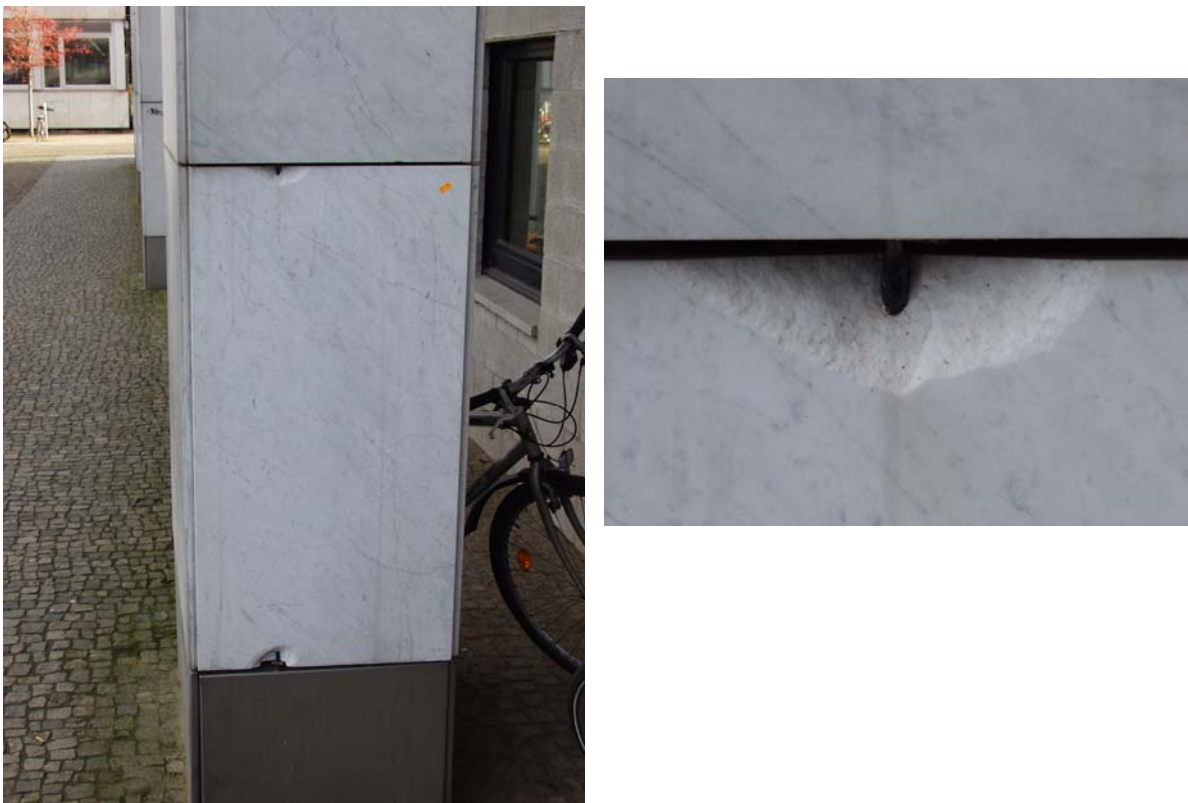
Cracks and stone damages are observed near the supporting dowel anchors or kerfs. An increase in bowing is correlated with an increase in the relative frequency of damages e.g. cracks and breakouts (figures 2.6, 2.7 and 2.8).

Figure 2.6. Typical crack out of fixing pins at Göttingen university library.

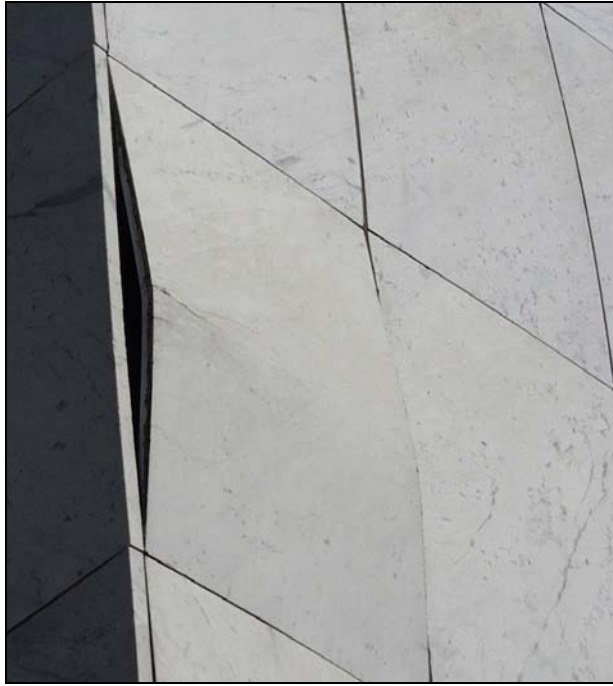
Figure 2.7. Panel fixed by fixing pins at top and bottom, cracked by bowing.

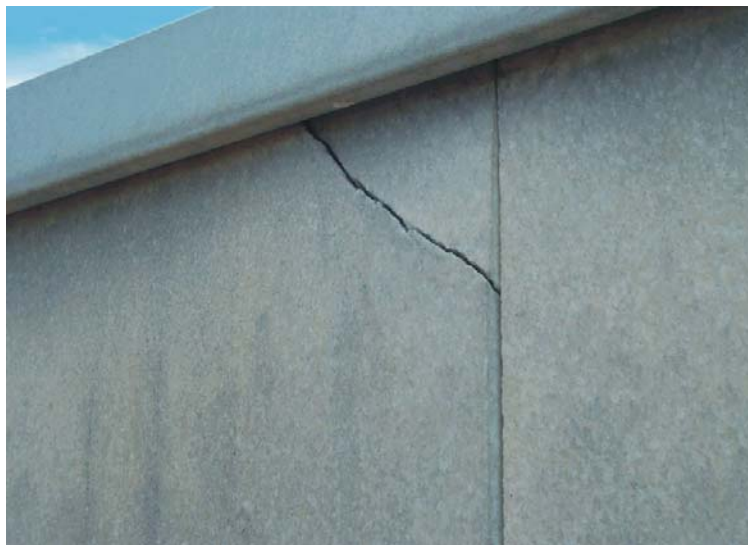
Figure 2.8. Cracking at corner, typical for panel anchored by rail at Theologicum.

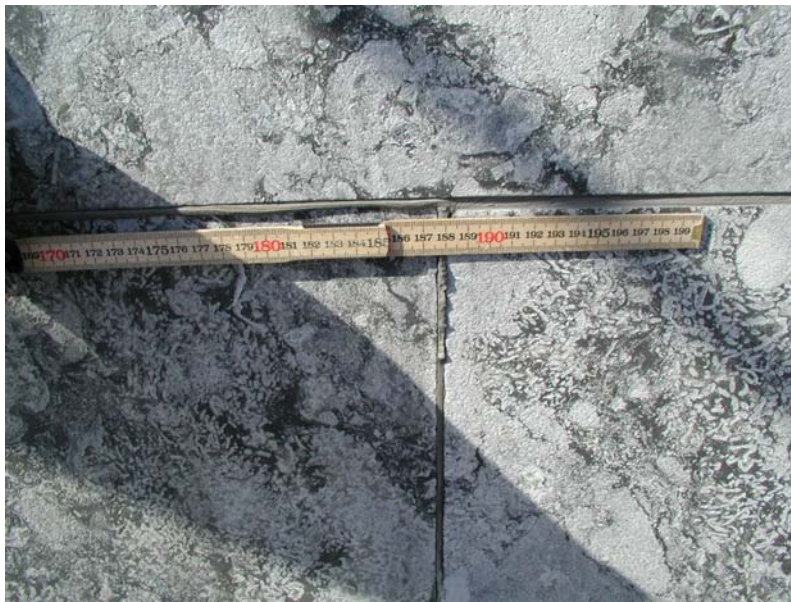
Figure 2.9. Elastic joint between expanded panels. Notice the squeezed out elastic sealant.

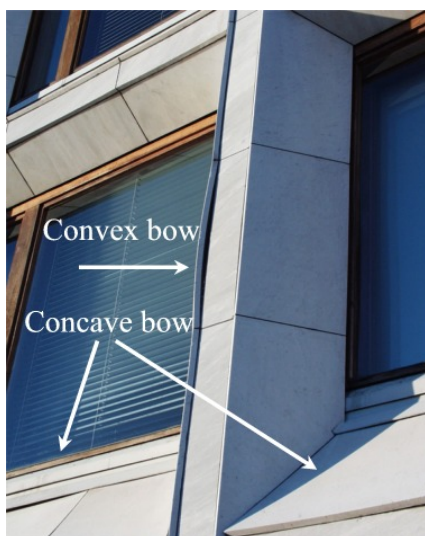
Figure 7.1. The same marble can display different bowing patterns on the same building.

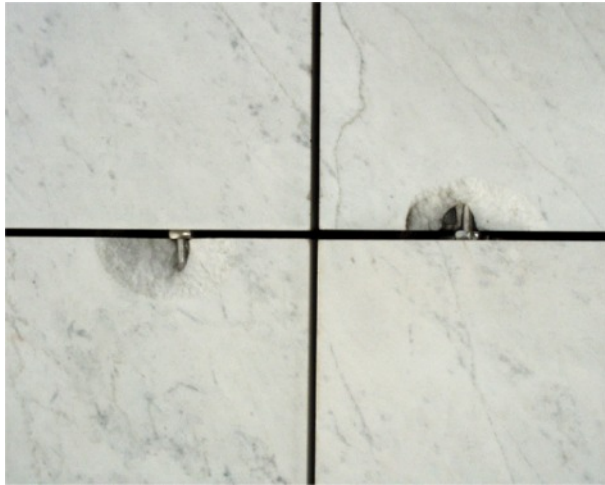
Figure 7.3. Cracking at anchoring points due to excessive expansion in relation to the dimensions of ‘dilatation’ joints.
