# VTT BUILDING AND TRANSPORT

### Developing long term durability of marble facades

#### Subproject "Test wall"

Espoo, April 20, 2001

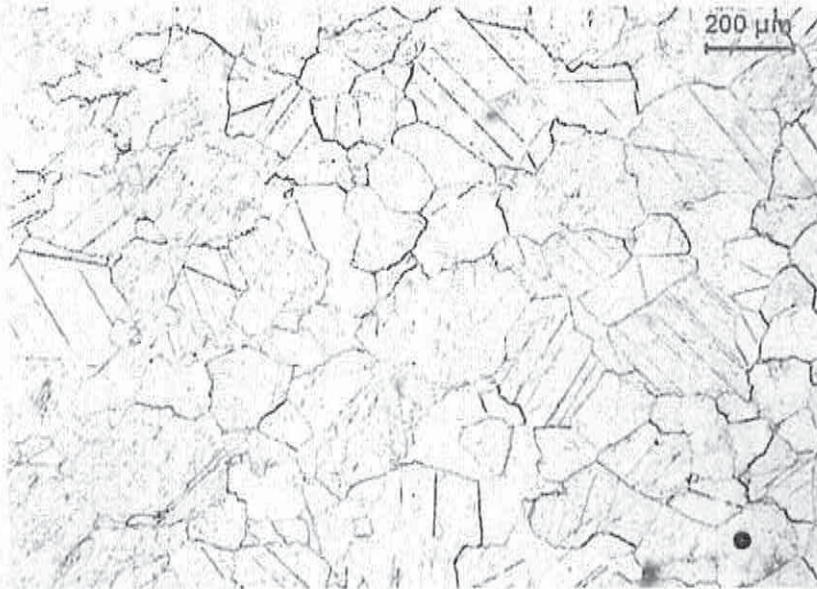
- groundmass fine-grained, fairly even-grained, not oriented, massive
- average grain size 200-300 μm
- slightly porphyroblastic, some larger porphyroblasts (max Ø 6 mm) in the groundmass
- nearly pure carbonate rock, contains only very little opaque minerals
- alteration of the grains insignificant
- no changes observable after 1 year on the test wall

**Figure 23.** Microstructure of marble A. 1 year on the test wall. Plane-polarized light.

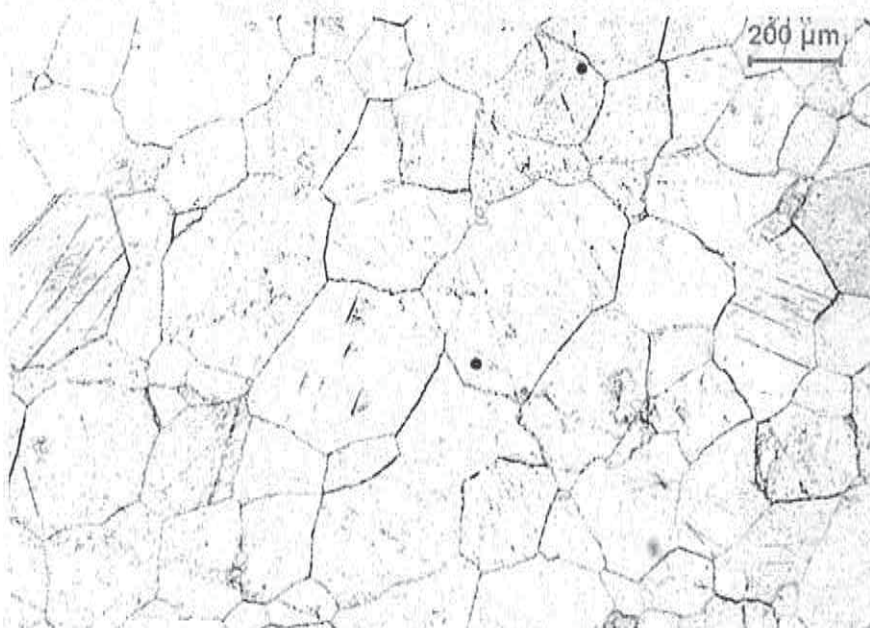
- fine-grained, fairly even-grained, not oriented, massive
- average grain size 200-300 μm
- nearly pure carbonate rock, contains very little mica type minerals
- some alteration of the grains
- no changes observable after 1 year on the test wall

**Figure 26.** Microstructure of marble D. 1 year on the test wall. Plane-polarized light.

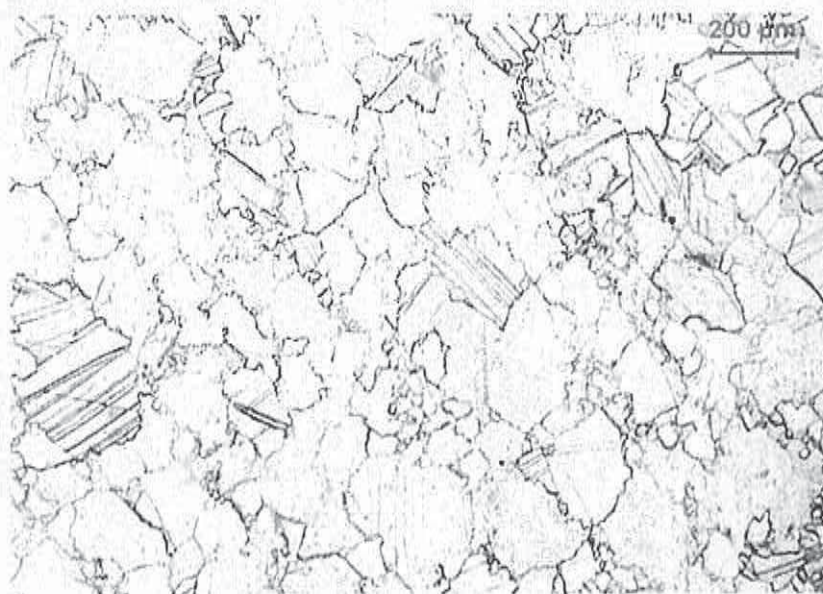
- very fine-grained (cryptocrystalline) lenses among the groundmass, the lenses pass gradually into groundmass
- nearly pure carbonate rock, contains some opaque and mica type minerals
- some alteration of the grains
- no changes observable after 1 year on the test wall

**Figure 29.** Microstructure of marble E. 1 year on the test wall. Plane-polarized light.

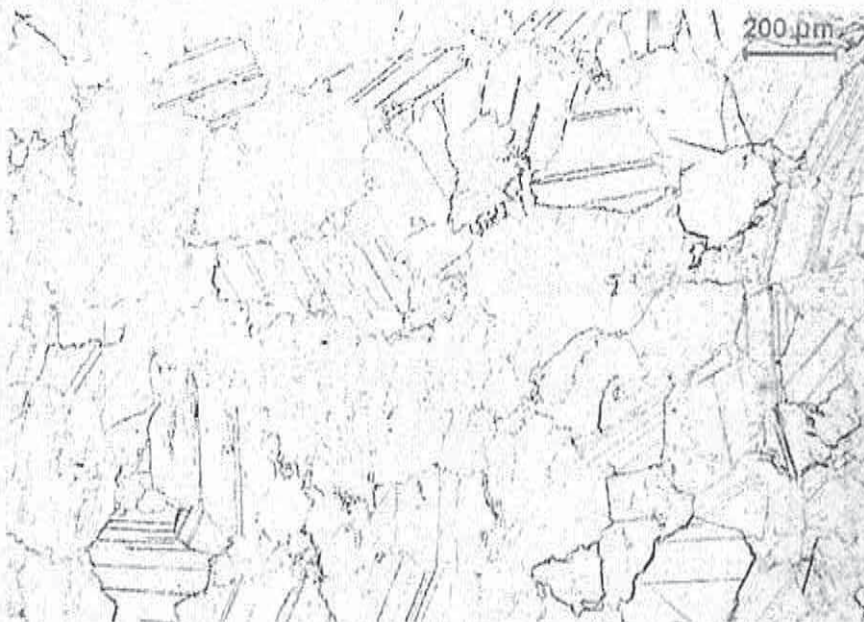
- fine-grained, not oriented
- average grain size about 200  $\mu\text{m}$
- very fine-grained (cryptocrystalline) lenses and veins among the groundmass, the lense boundaries are usually distinguished from the groundmass
- nearly pure carbonate rock, contains some opaque minerals
- little alteration of the grains
- no changes observable after 1 year on the test wall

**Figure 32.** Microstructure of marble K. 1 year on the test wall. Plane-polarized light.

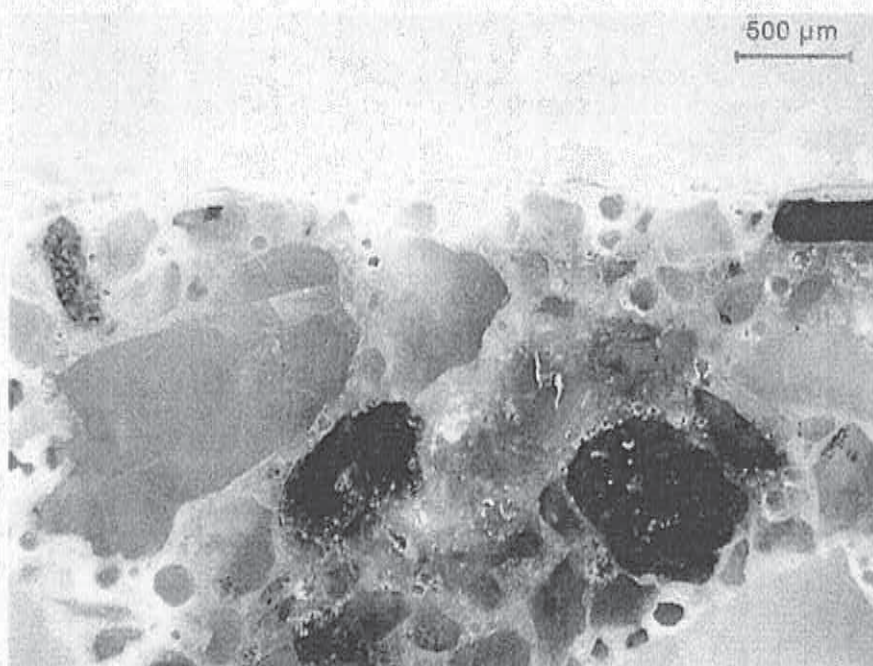
- contact between marble and concrete tight and cohesive
- a thin layer of third material, probably primer, between marble and concrete
- material (primer) layer rather continuous, though pores are common; thickness of the layer generally 20-30  $\mu\text{m}$ , in places even 60  $\mu\text{m}$
- in the unused element only a few very tiny cracks along the marble/concrete contact zone
- in the element stressed for 1.5 years on the test wall some slight and narrow cracking at the marble/concrete contact zone

**Figure 80.** Microstructure of marble clad element F. 1.5 years on the test wall. Objective 2.5x, oblique illumination.

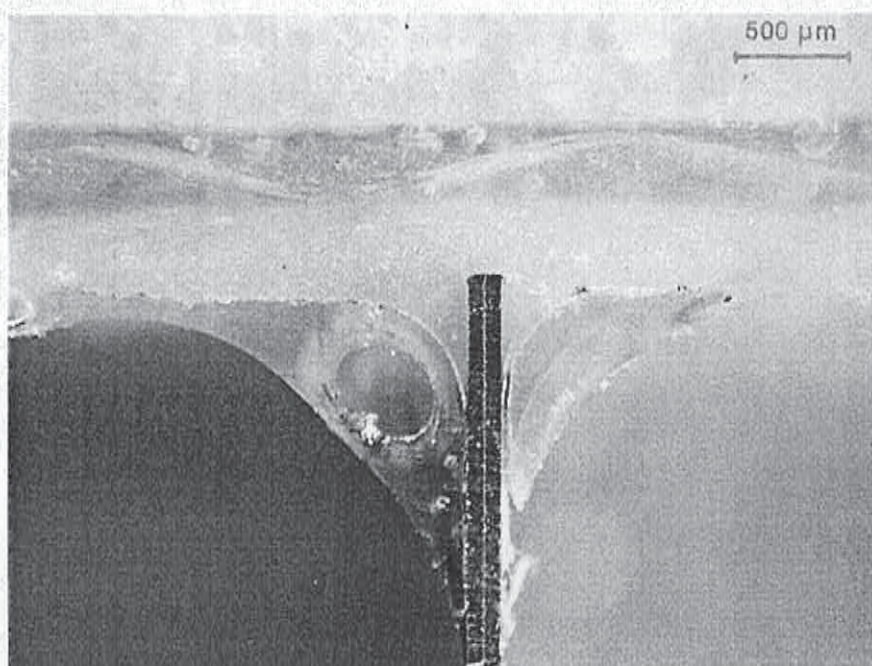
- a layer of glue between marble and metal structure, thickness of the layer approximately 1 mm
- structure of the unused element partly cracked along the contact zone marble/glue
- in the unused element the upper half of the glue layer tinted yellowish
- in the element stressed for 1.5 years on the test wall the upper half of the glue layer tinted brownish
- in the element stressed for 1.5 years on the test wall open crack on about 60% of the contact zone marble/glue

**Figure 84.** Microstructure of marble clad element H. 1.5 years on the test wall. Objective 2.5x, oblique illumination.

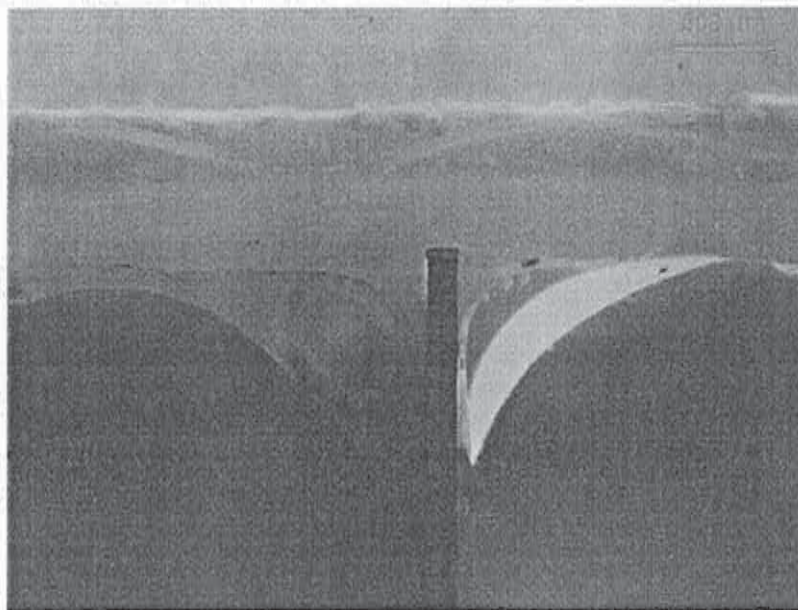
**Figure 85.** Microstructure of marble clad element H. 1.5 years on the test wall. Objective 2.5x, fluorescent light.

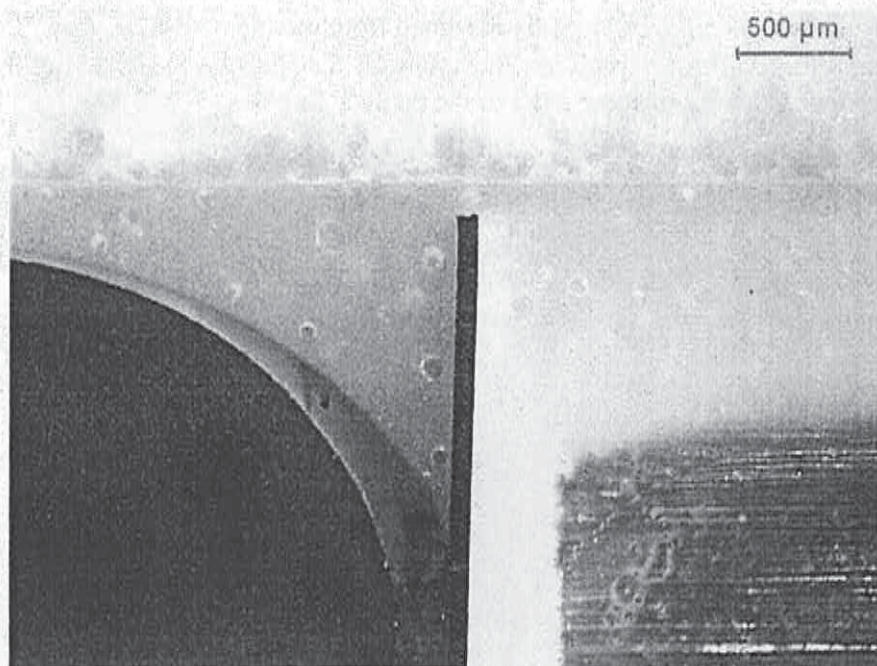
- a layer of glue between marble and metal structure, thickness of the layer approximately 0.5 mm
- the glue contains a lot of porosity
- in the unused element the glue layer partly detached from marble
- in the element stressed for 1.5 years on the test wall the glue layer rather tightly attached to marble, only minor cracking in some parts of the contact zone

**Figure 88.** Microstructure of marble clad element L. 1.5 years on the test wall. Objective 2.5x, oblique illumination.

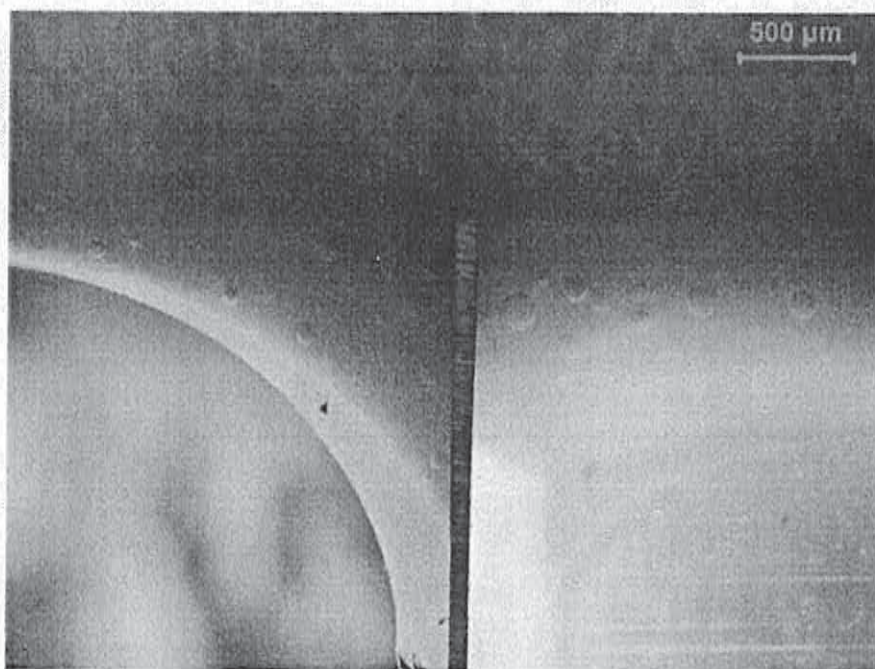
**Figure 89.** Microstructure of marble clad element L. 1.5 years on the test wall. Objective 2.5x, fluorescent light.

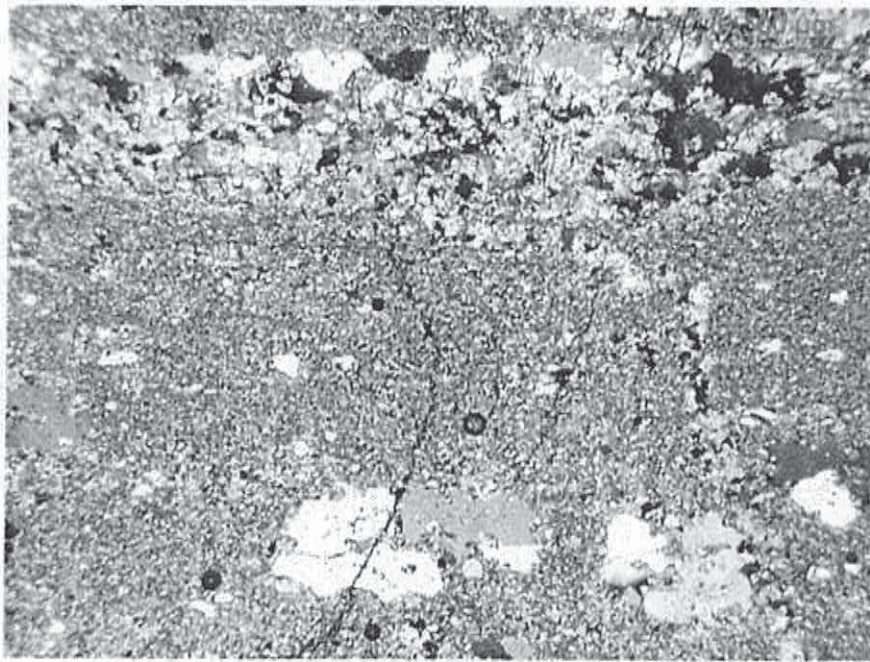
- ground mass very fine-grained, microcrystalline, dense
- clearly oriented, layered
- in places more coarse-grained veinlets with a thickness of about 1 mm, mostly oriented parallel to layering, a few also cross the layering
- some separate fine- to medium-grained quartz grains in rows, parallel to layering
- mainly carbonate rock, moderate content of quartz, other minerals include feldspar (probably plagioclase), mica (probably muscovite) and opaque minerals
- in places mica forms veinlets, partly with opaque minerals

**Figure 118.** Microstructure of dolomite from case 3. Cross-polarized light.

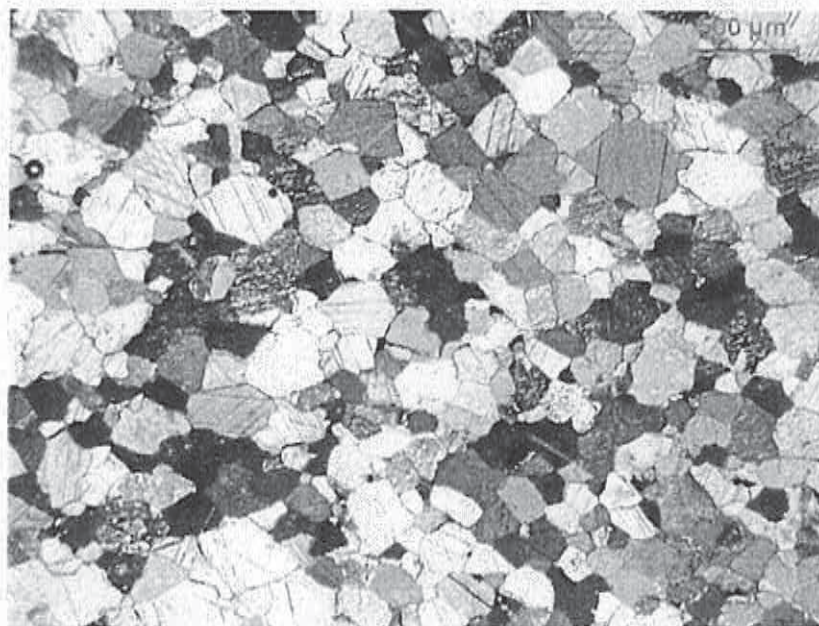
**Figure 119.** Microstructure of marble from Finlandia Hall. Cross-polarized light.

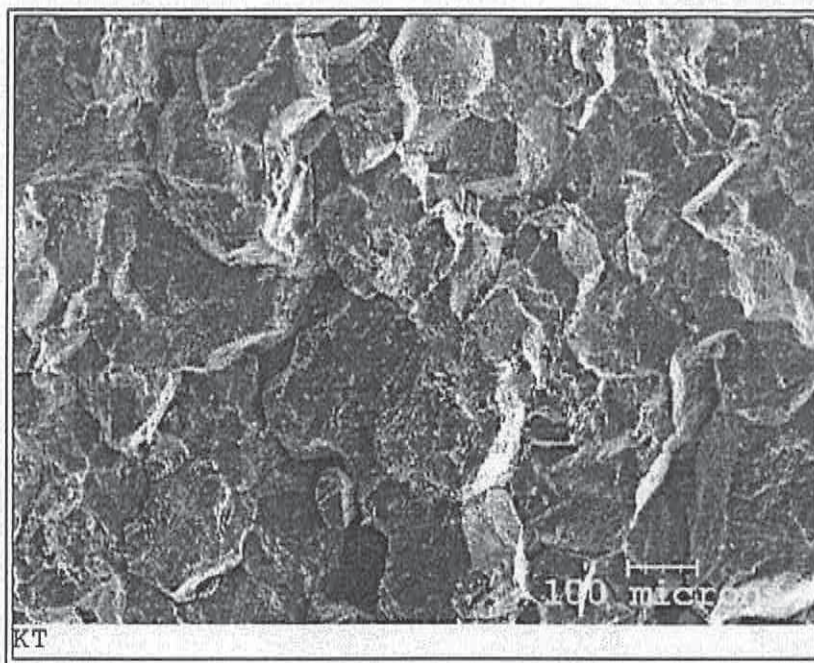
**Figure 120.** Marble from case 1. SE-image of fractured surface, 100x.

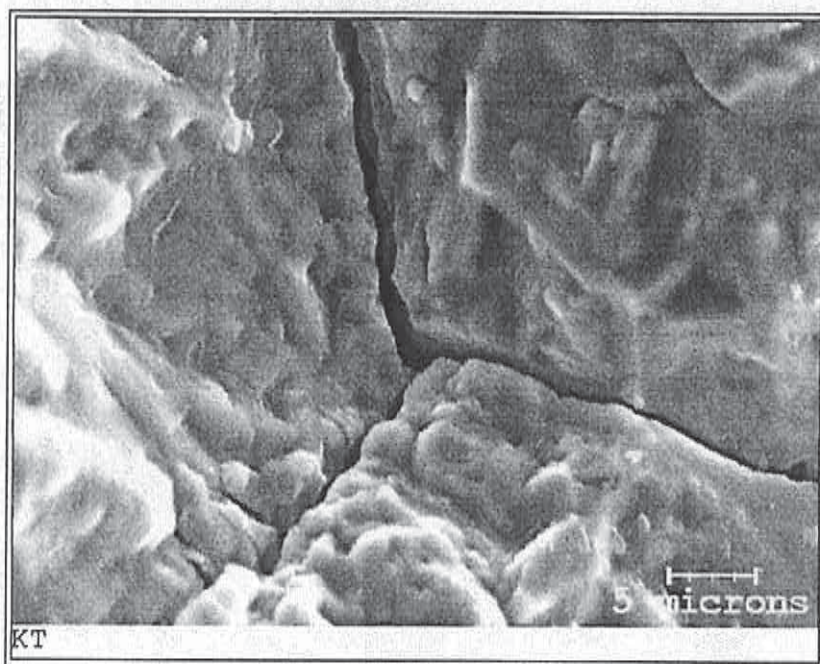
**Figure 121.** Marble from case 1. SE-image of fractured surface, 2500x.

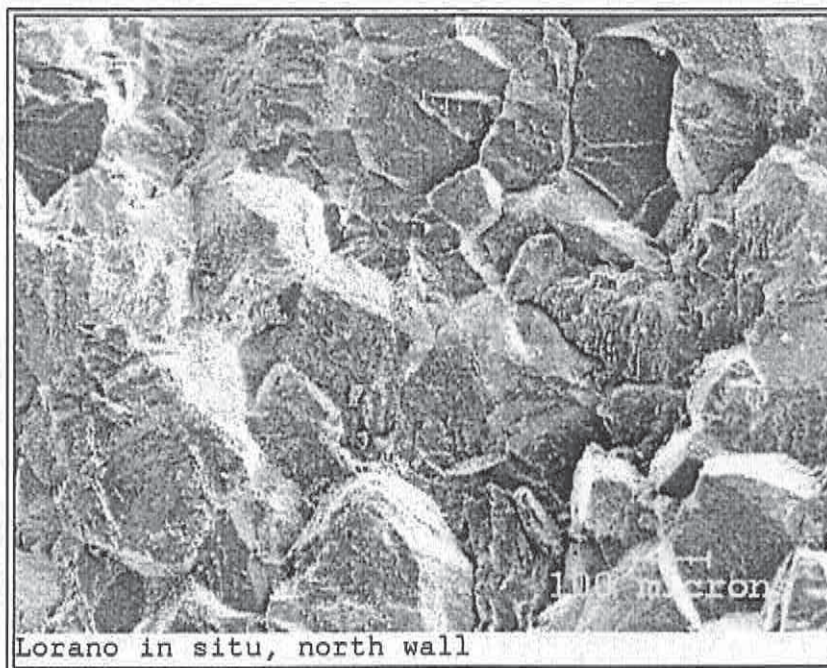
**Figure 126.** Marble from Finlandia Hall, north wall. SE-image of fractured surface, 100x.

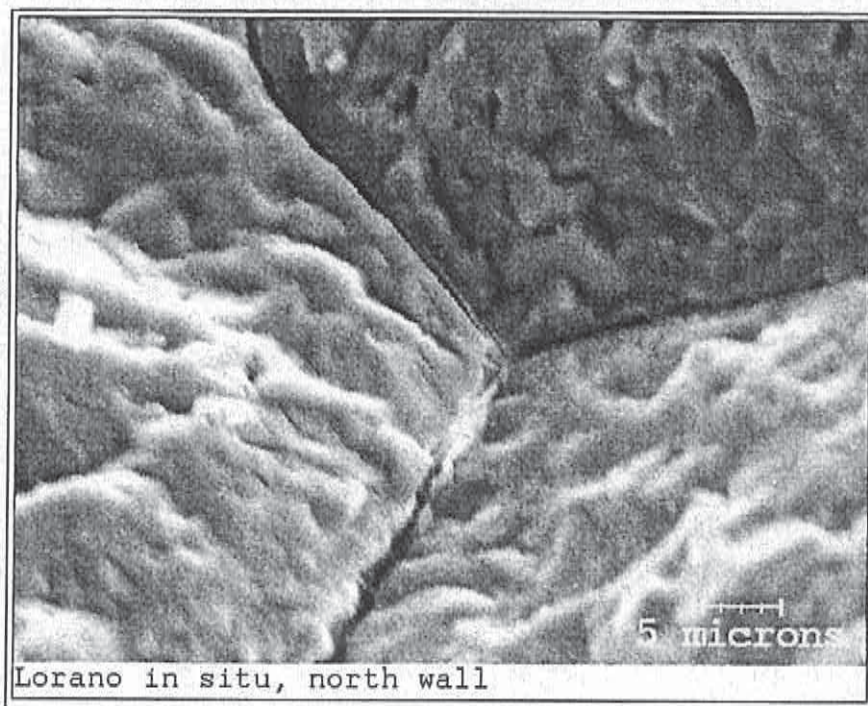
Figure 127. Marble from Finlandia Hall, north wall. SE-image of fractured surface, 2500x.
