# Rock displacement and thermal expansion study at historic heritage sites in Slovakia

Jan Vlcko · Vladimir Greif · Vladimir Grof ·  
Michal Jezny · Lubomir Petro · Martin Brcek

**Abstract** The paper discusses the results of the research devoted to the preservation of cultural heritage carried out within last two decades in Slovakia. The aim of the study depended on monitoring of selected castle rocks showing instability problems due to extremely slow displacements of creep character. Apart from traditional methods of investigation at one test site (Spis Castle), authors implemented in their work the study of thermal expansion of the rocks as a result of seasonal periodic temperature changes having potential influence on displacements and numerical modeling in order to understand better the landslide failure mechanism. The results obtained from all study sites confirmed that even slow movements have to be implemented into preservation and stabilization works in order to safeguard the sites of great historic value.

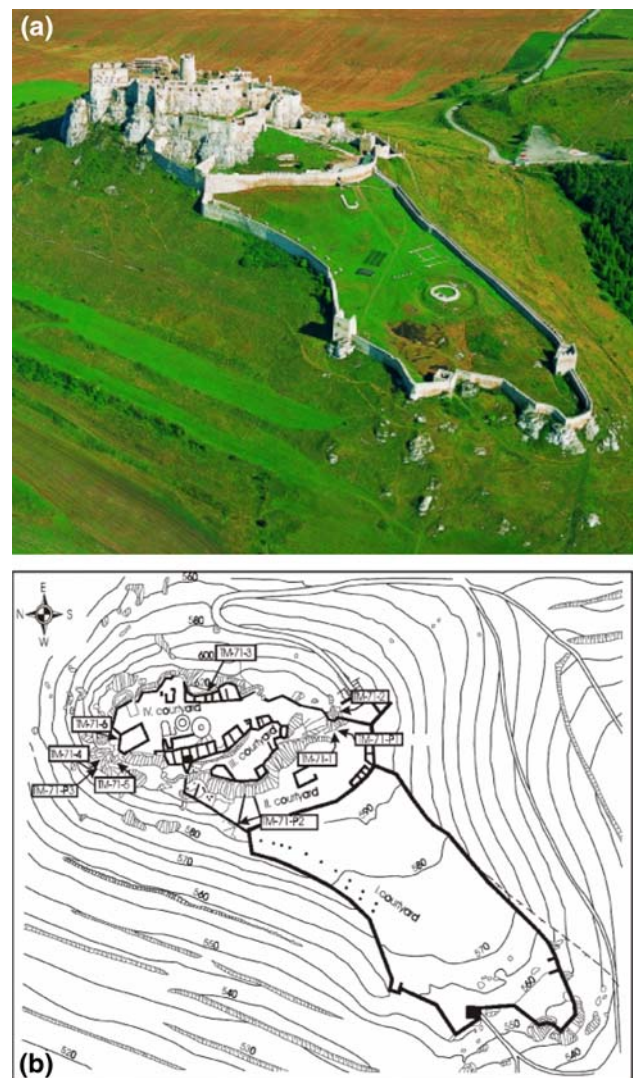
In 1980, three TM-71 type crack-gauges (TM-71-P1–P3) and in 1992 six additional were installed (TM-71-1–6). It should be noted that from a number of nine crack-gauges only four (TM-71-1, TM-71-2, TM-71-P1 and TM-71-P2) installed at the castle subgrade operate; the unexpected visitors demolished the rest (Fig. 2).

Significant displacement was observed in the southeast part of the Lower Courtyard near the castle entrance at a high travertine cliff called Perun's rock. Given past failures here, three monitoring locations were selected (Fig. 2): one (TM 71–2) in a 74-cm-wide tension crack outside the castle near the entrance to Podhradská jaskyna Cave and two (TM 71–1, TM 71-P1) on the opposite side of the cliff at Courtyard II.

**Fig. 2** Photograph (a) and the locations (b) of TM-71 crack-gauges at the Spis Castle

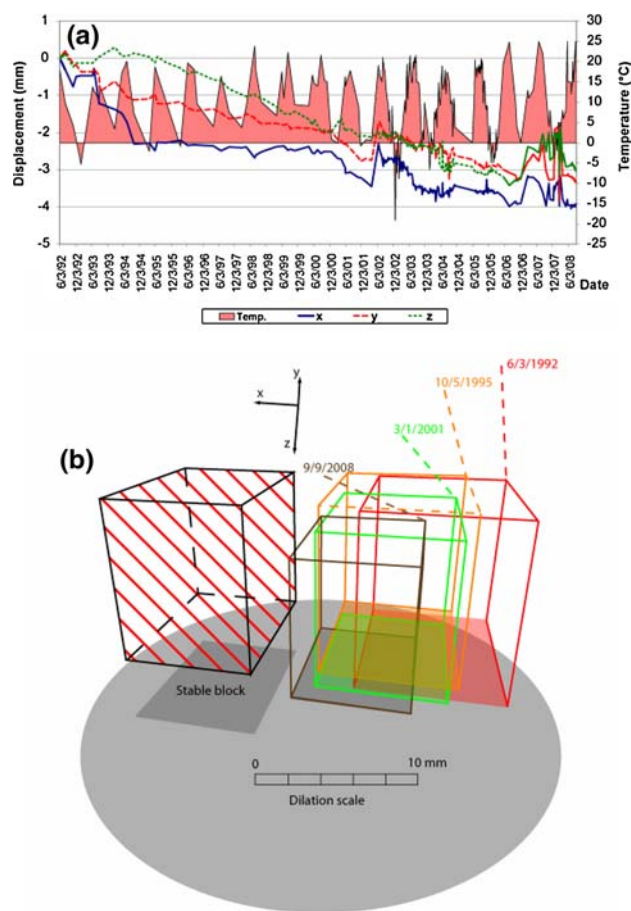
Data obtained from crack-gauge TM-71-2 indicate progressive crack closing ( $x$ -axis) of 2.3 mm for the period 1992–1994. Since then, and for the next 6 years, displacements oscillated about 2.5 mm as a function of the influence of seasonal temperature and precipitation. Since December 2000 there was a marked change in the rate of displacement. This is likely due to a large boulder which fell from the upper slope into the tension crack which is also the entrance of the Podhradská jaskyna Cave and thus formed a temporary barrier to further compression. The direct evidence for lateral pressure of Perun's rock was the progressive cracking of the boulder and the fissuring that began to occur in the repaired masonry walls. The latter effects required the eventual removal of the boulder from the open crack. Subsequent measurements confirmed an acceleration of the movements (1.0 mm) until the summer of 2006 when compression (closing of the crack) reached a maximum value of 3.98 mm for the whole monitoring period. The only exception to the trend of closing the crack occurred in spring 2002 and spring 2007 when abrupt extension (crack opening) was observed in response to “relaxation” of the opposite cliff. The recorded data confirm that boulder removal for the period of 2 years (2002–2004) accelerated the rate of displacement (approximately 1 mm per year), since that time the displacements correspond to the temperature oscillations except a short period in 2006 and 2007 (relatively rapid closing and opening with relative cumulative displacement of 0.7 mm). In  $y$ -axis the (horizontal shear) movement is relatively constant with the rate of 0.2 mm per year indicating the movement direction toward SW. In  $z$ -axis (vertical shear) the mean rate of displacement is about 0.25 mm per year and indicates the slip of the cliff. In Fig. 3a are shown the records obtained from crack-gauge TM 71-2 as well as the displacement 3D visualization of monitored block (Fig. 3b) within the period 1992–2008.

Based on monitoring records, we may estimate that the Perun's rock is tilting in the NW–SE direction. This

**Fig. 3** **a** Records from crack-gauges TM-71-2 [ $x$ -direction = opening of the crack (positive values), closing (negative values);  $y$ -direction = horizontal shearing;  $z$ -direction = vertical shearing (down slip, positive values; uplift, negative values)]. **b** Displacement's 3D visualization within the period 1992–2008

movement indicates the closing of both cracks, which are separating the cliff.

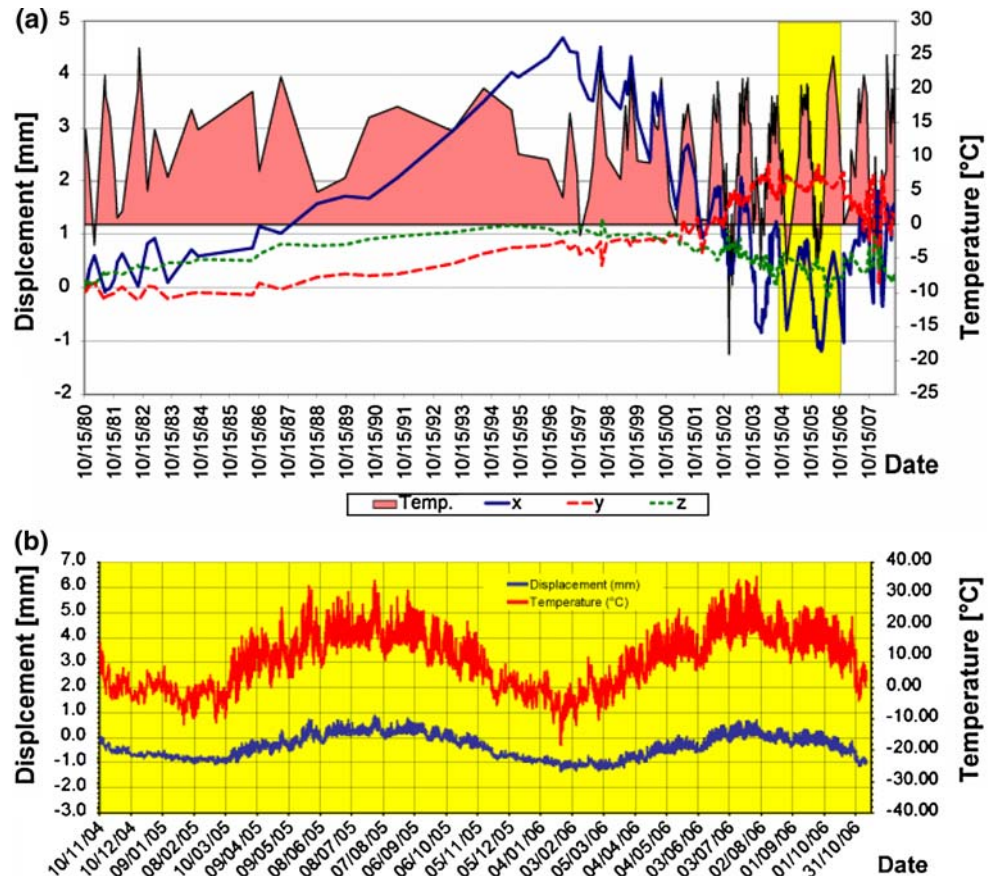
Data from the crack-gauge TM-71-P1 shown in Fig. 4 exhibit opening of the crack in the initial stage to an extent of 4.8 mm (max in 1997). Since that period, the inverse movement took place and the displacements show clear oscillation approx 0.5 mm per year with significant trend of compression (closing of the crack) in winter months and inverse displacements in summer months. The total closing of the crack since 1997 was estimated to 5.9 mm (0.59 mm per year). The trend in oscillation is since 2004 confirmed by an additional automatic crack-gauge Geocon 4.2 (crack-gauge lent with courtesy of GEOEXPERTS Ltd.)

Within  $y$ -axis until year 2001, very slow movement reaching 1.00 mm was recorded, since that period cyclic shear with forth and back movement was recorded. No significant movement in  $z$ -axis was recorded.

**Fig. 4** Records from crack-gauges TM-71-P1 [x-direction = opening of the crack (positive values), closing (negative values); y-direction = horizontal shearing; z-direction = vertical shearing (down slip, positive values; uplift, negative values)]

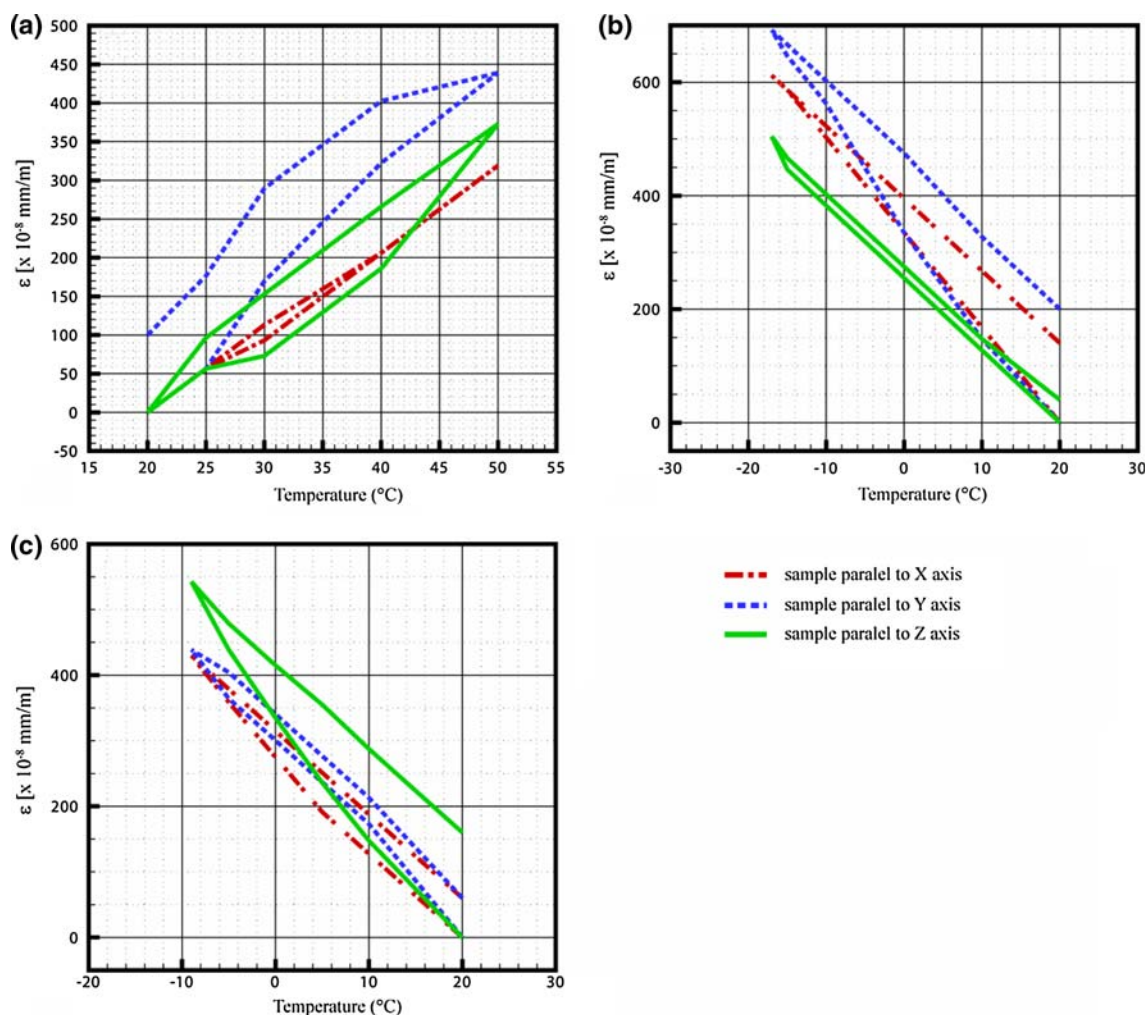
The results we gained maybe summarized as follows: the highest value of linear thermal expansion was observed on the samples corresponding to the  $y$ -axis direction with the mean  $\alpha$  value  $15.060 \times 10^{-6}^\circ\text{C}^{-1}$  and in the  $x$ -axis direction with the mean  $\alpha$  value  $13.310 \times 10^{-6}^\circ\text{C}^{-1}$ .

**Fig. 6** Temperature dilations for summer (a), winter (b) and spring/autumn (c) season temperature ranges. Red line sample prepared in the direction of  $x$ -axis (parallel to bedding), blue sample prepared in

the direction of  $y$ -axis (parallel to bedding), green sample prepared in the direction of  $z$ -axis (perpendicular to bedding)

Finally, the lowest mean  $\alpha$  value was determined on samples with  $z$ -axis direction reaching  $13.299 \times 10^{-6} \text{ } ^\circ\text{C}^{-1}$  (Fig. 6a–c).

The highest value of thermal residual strain (in some papers assigned as residual dilation) was observed in direction of  $y$ -axis with the mean value  $\Delta L_r = 3.9 \times 10^{-6}$  m, following direction in  $z$ -axis with mean value  $\Delta L_r = 1.5 \times 10^{-6}$  m and the lowest one was determined in direction of  $x$ -axis with mean value  $\Delta L_r = 1.23 \times 10^{-6}$  m (Vlcko et al. 2005). The observed differences in thermal residual strain can be explained by means of the thermal anisotropy of the calcite grains in connection with the natural preferred orientation in travertine rocks.

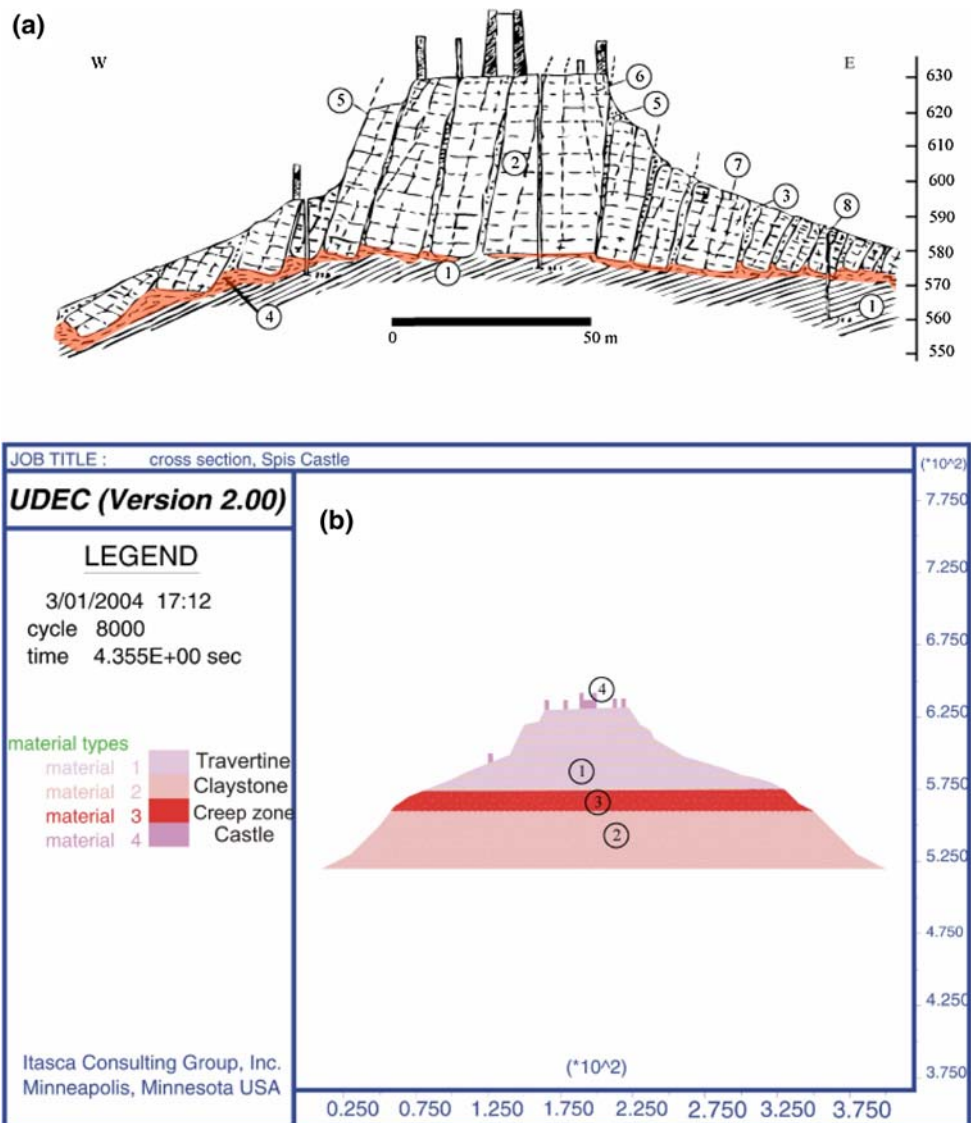
**Fig. 7** Representative geological profile (a) and its numerical representation (b). **a** 1 Claystone with sandstone (Paleogene), 2 Travertine (Mio-Pliocene, Quarternary), 3 Debris (Quarternary), 4 Creep zone, 5 Fault lines, 6 Cracks, joints, 7 Bedding planes, 8 Boreholes. **b** 1 Travertine, 2 Claystone, 3 Creep zone, 4 Castle walls

In geotechnical terms, the stratigraphical sequence can be (schematically) represented as the superposition of a rigid travertine body over claystone strata, in the upper parts highly weathered. Numerical presentation of a representative geological profile is in Fig. 7a.

UDEC model including assigned rock material properties is shown in Fig. 7b and physical and mechanical parameters as input data for modeling are summarized in Table 1.

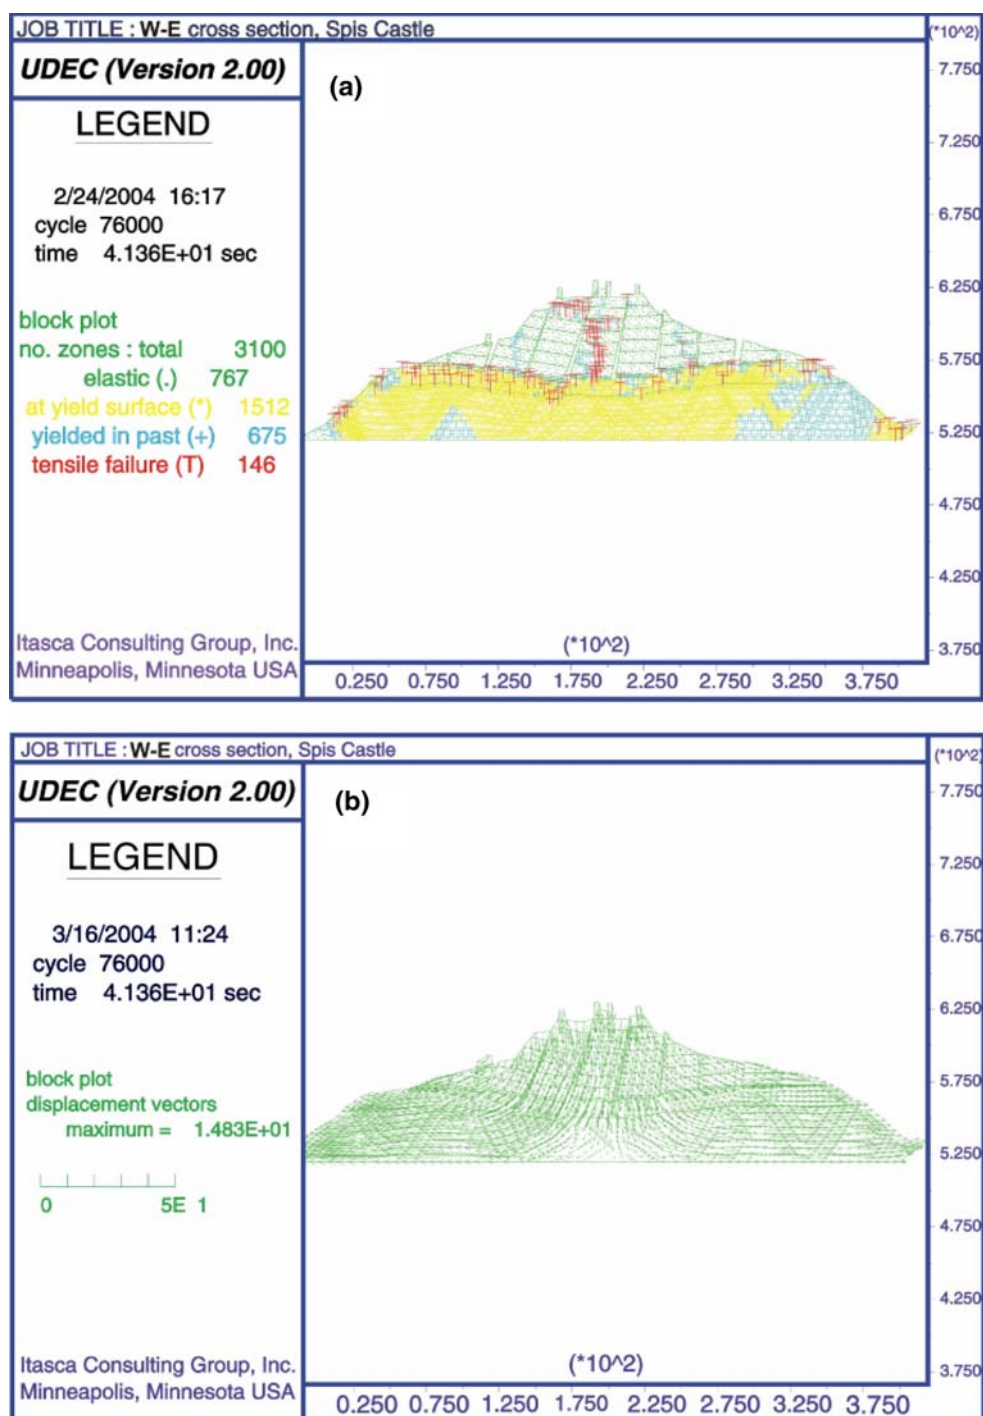
**Fig. 8** Developments of tension cracks (a) and block spreading indicated by the displacement vectors (b)

Numerical analysis confirmed that the instability of the travertine castle rock is related to significant shear strength reduction of the subgrade formation. The failure mechanism involves differential subsidence of the travertine cliffs into soft bedrock and formation of persistent tension cracks in the central part of castle rock. The development of tension cracks transmitted the strain to the castle walls and inhibited their rupture; in some places even collapse (Fig. 8a). On the marginal parts of the castle rock, the cliffs are toppled up-slope (western part), while in the eastern part these are toppled down-slope. Displacement vectors (Fig. 8b) indicate block spreading as a representative mode of failure, which is in accordance with the field study and monitoring results.

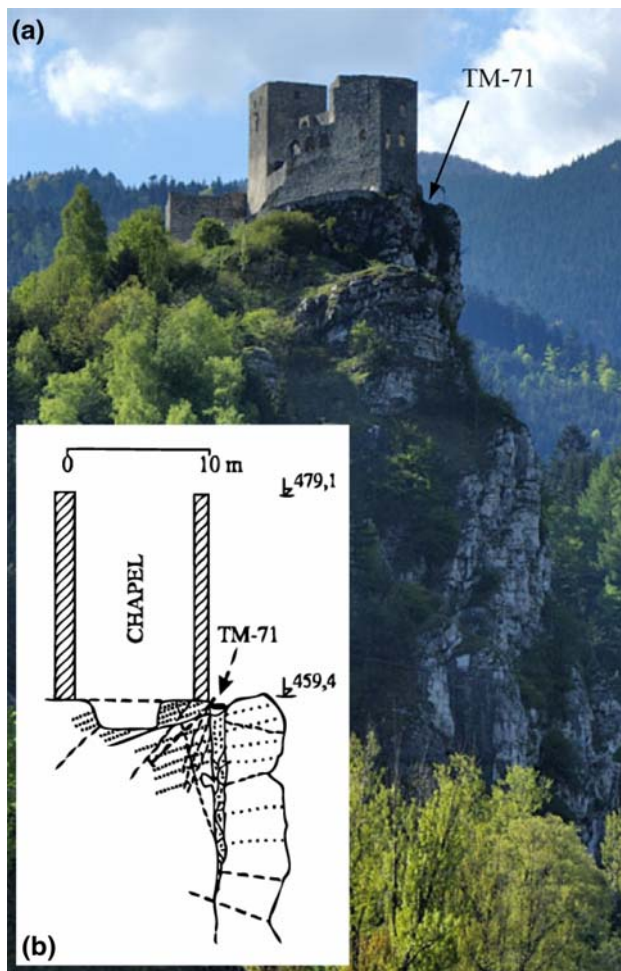
**Fig. 9** Strecno Castle with typical cross-section showing the location of the crack-gauge TM71 in an open tension crack

The Strecno Castle is located in Malá Fatra Mts at a cliff reaching 103 m above the flood plain of Váh River (Fig. 9). The castle rock is formed by overthrust lithological formations of the Choc nappe consisting of various carbonate rocks mainly limestones of Gutenstein type as well as grey limestones with intercalations of dolomitic limestones and dolomites (Middle Triassic). The castle rock has a character of a fault zone with intense manifestation of cambering

(gravitational loosening). The potential danger of instability generally occurs at places where tectonically disintegrated and weathered dolomite rocks prevail and where a great number of overhangs gradually losing their stability developed. From the structural point of view the Eastern part of the castle rock where several castle objects were built upon unstable overhangs represents potential danger. The monitoring site has been placed beneath the chapel in open tension crack reaching the width 148 cm, which separates the castle rock body and a gravitationally separated huge cliff. Since 1996, 10-year measurements have confirmed the tendency to extension of the tension crack along x-axis resulting in slight cliff tilting towards ESE. The cyclic course of the records is corresponding to climate conditions. The total crack opening reached the value of 4.24 mm (Fig. 10). The sudden change in the displacements in 1999 is probably response to the activity in a nearby quarry.

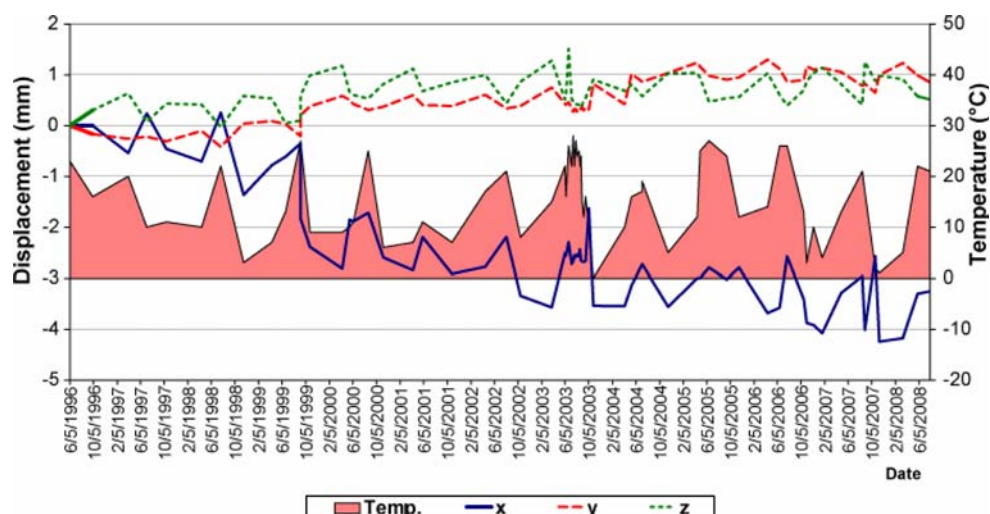
**Fig. 10** Records from crack-gauge TM 71 at Strecno Castle [x-direction = opening of the crack (positive values), closing (negative values); y-direction = horizontal shearing; z-direction = vertical shearing (down slip, positive values; uplift, negative values)]

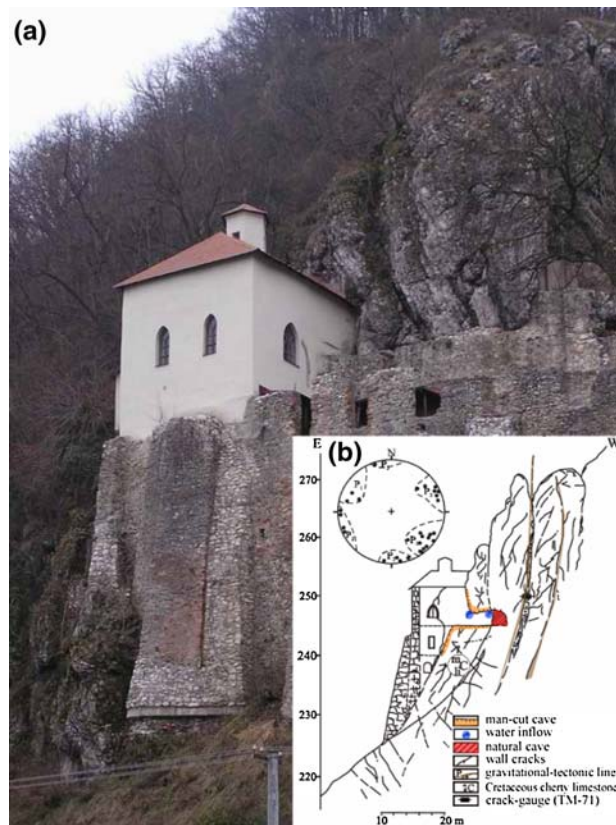
The Skalka Monastery, a well-known place of religious interest in Slovakia consists of six different buildings. In the most important building of the Monastery, Baroque chapel, serious failures and cracks in the chapel walls, which might be an evidence of deep-seated deformations were detected.

**Fig. 11** a Photo of Skalka Monastery with the b cross-section with location of the TM-71 crack-gauge

Along the prevailing gravitational-tectonic lines a cave developed, reaching 35 m in length and 4 m in width. At some places, the cave is man-cut and presents the only way of access to the chapel. Important gravitational-tectonic lines of N-S to NNE-SSW direction cut the bedrock beneath the northern part of the chapel and

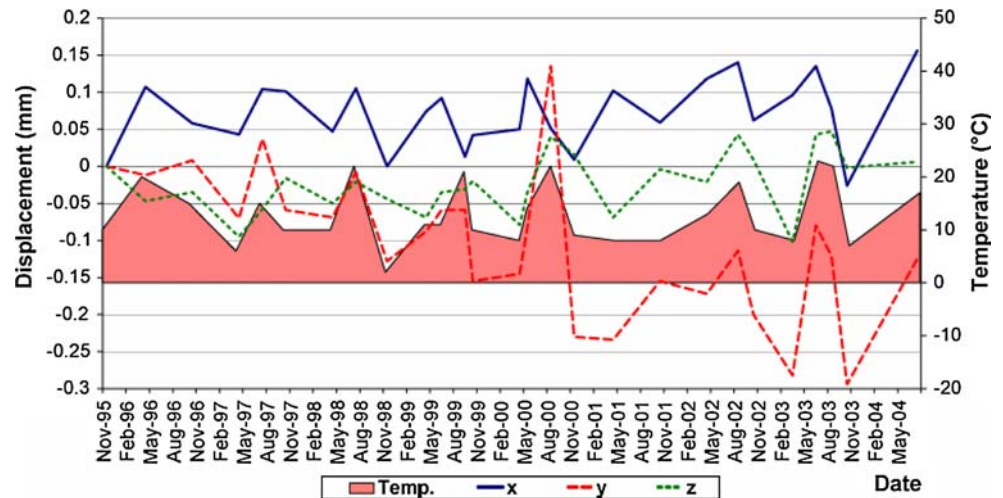
**Fig. 12** Records from TM 71 crack-gauge Skalka Monastery. [x-direction = opening of the crack (positive values), closing (negative values); y-direction = horizontal shearing; z-direction = vertical shearing (down slip, positive values; uplift, negative values)]

caused open cracks in the walls. Since November 1995, a crack-gauge of the type TM-71 was installed in an open discontinuity (Fig. 12). The initial setting was carried out in November 1995. Since that time no distinct displacement was recorded, the crack-width proved to be constant and rock mass stable. A small displacement along the y-axis could indicate some tendency to horizontal slip. The total recorded displacement up to year 2006 is 0.29 mm.

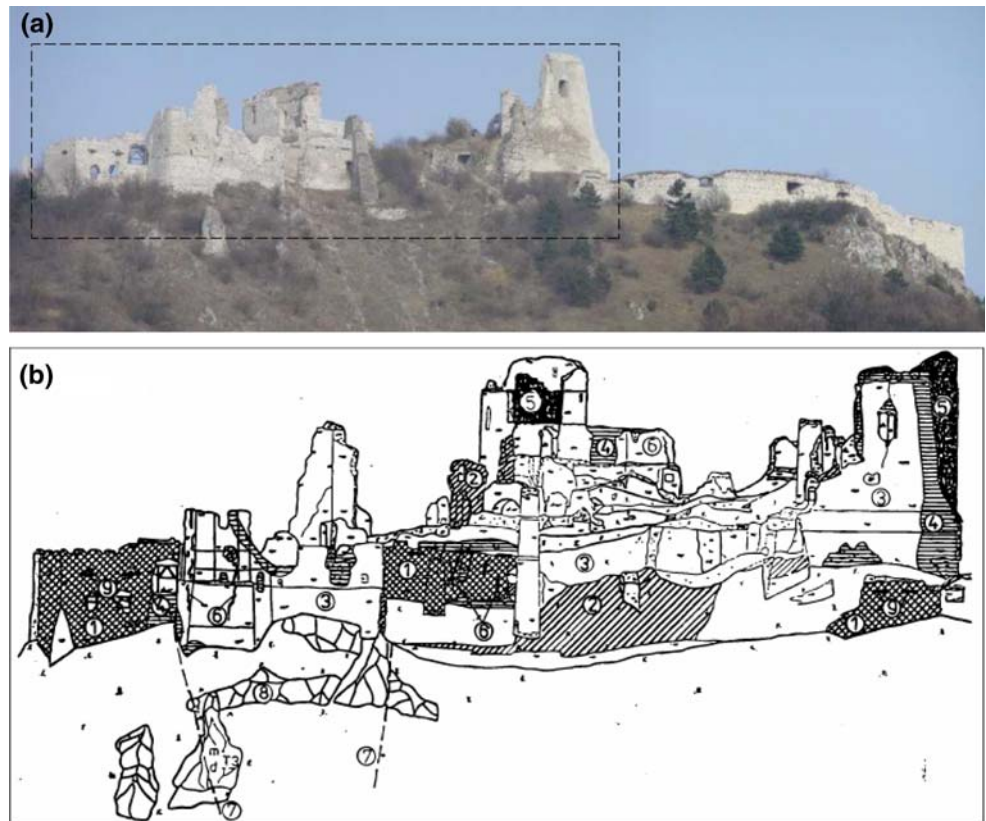
**Fig. 13** a Čachtice Castle, b zoning of western walls at Čachtice Castle. Failures in the walls: 1 major, 2 moderate, 3 minor, 4 walls reconstructed in 1992, 5 fallen down walls, 6 open cracks, 7 faults, 8 Triassic dolomites, 9 supporting wooden beams

Failures of quite different origin brought about the destruction of the Čachtice Castle in Male Karpaty Mts (Fig. 13a). The castle rock is formed by Triassic dolomites (Hauptdolomite) in which the main discontinuities are the bedding planes. A constant dynamic process of loosening and damages associated with the collapse can be observed on the castle ruins. The main reason for this process is an active earth pressure of anthropogeneous fills of great thickness occurring at critical places. Calculation proved that the coefficient of earth pressure at rest reaches 80% of limiting state of equilibrium.

The western part of the castle ruin manifests signs of destruction illustrated in Fig. 13b. For restoration purposes, we have delineated in the western castle walls zoning units in terms of their physical state, where the highly endangered parts (1) are affected by active earth pressure of anthropogeneous fills and by the presence of bedding

planes (7) which have resulted in the formation of open cracks found in the castle walls (6). The stability of the castle walls (1) has been temporarily secured by means of supporting wooden beams. The zoning of the deterioration grade (physical state) of the castle objects has been carried out on all investigated castles in a similar way as in the case of Čachtice Castle: either with the use of photogrammetric photography or in a ground plan. The castle has not been restored yet.

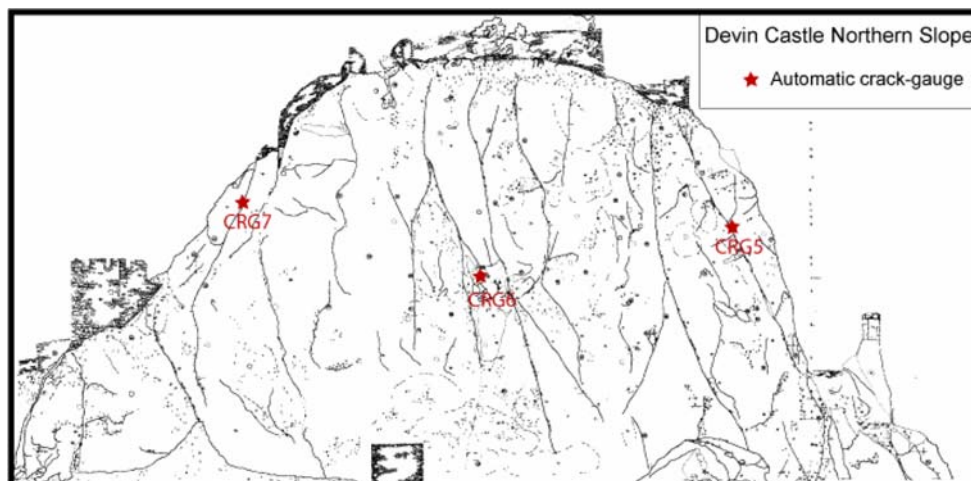
**Fig. 14** Schematic view of the northern slope cliff of the Devin Castle showing the locations of automatic crack-gauges

Several potentially unstable rock blocks were located on the northern slope of the castle (Fig. 14), as well as on the southern slope (Fig. 15) where automatic crack-gauges were installed. Regular monitoring of discontinuities started in 2004 using portable crack-gauges SM1–SM4, followed with fully autonomous monitoring system composed of inductive transducer crack-gauges located at seven potentially unstable blocks in 2005. The portable crack-gauges were installed on the castle wall near the staircase to the citadel. This wall, originally free-standing, was recently filled with fill material from the back side, which caused the origin of cracks due to active earth pressure. The monitoring records are shown in Fig. 16. Permanent displacements were recorded at the crack behind smaller block in the central part of the northern slope, where the automatic crack-gauge CRG 6 is installed. Recent results from other crack-gauges (Fig. 17) do not show any significant displacements deviating from usual temperature induced changes.

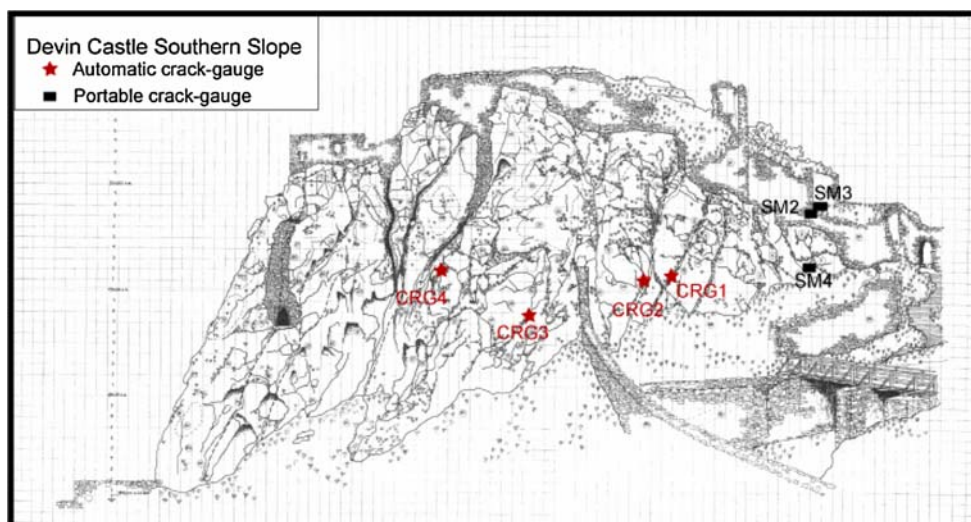
**Fig. 15** Schematic view of the southern slope of the Devin Castle hill with the locations of automatic and portable crack-gauges measurements

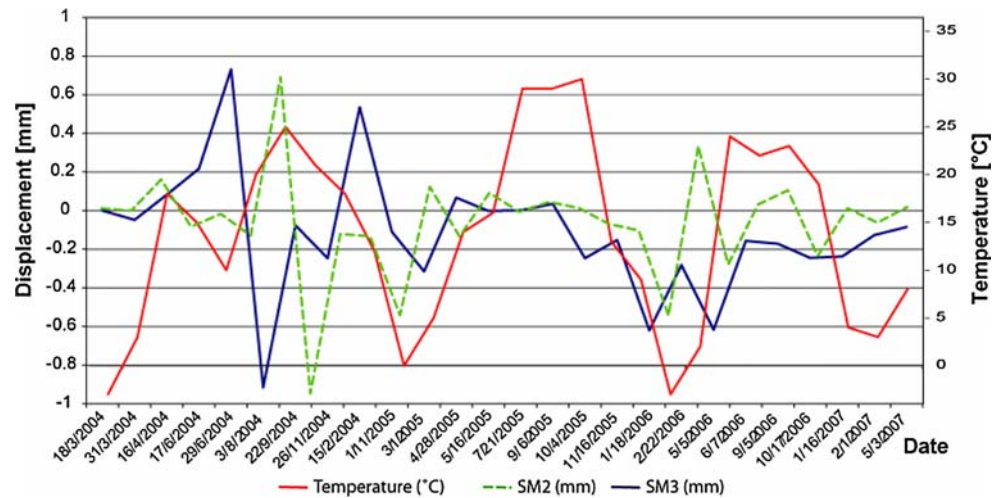
**Fig. 16** Records from portable crack-gauge measurements SM2 and SM3 at Devin Castle in the period 2004–2007

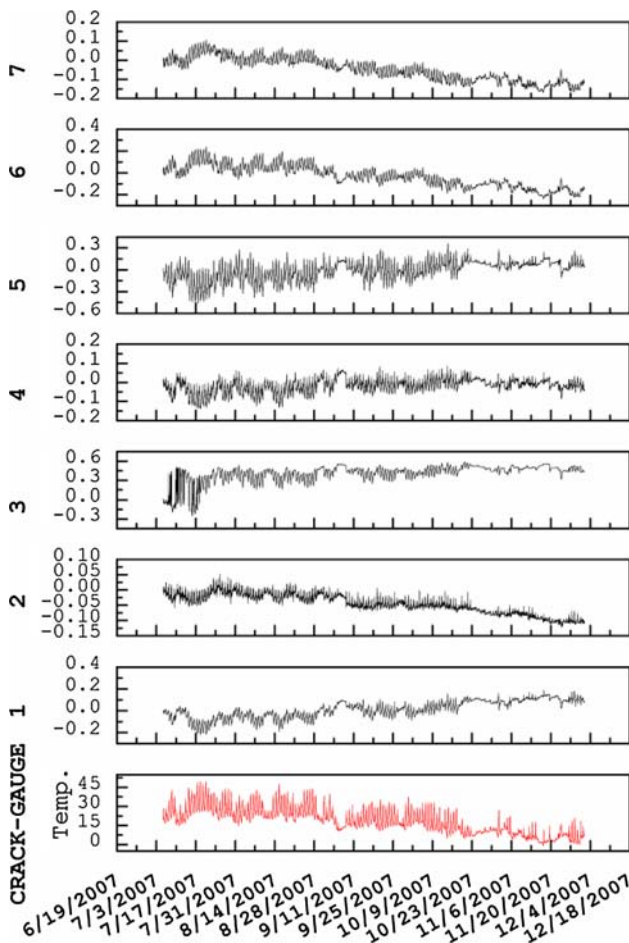
**Fig. 17** Records from automatic crack-gauges CRG 1–7 located at the Devin Castle hill during the second half of the year 2007
