# **12<sup>th</sup> International Congress on the Deterioration and Conservation of Stone**

# CONSERVATION OF ARCHITECTURAL MARBLE AT THE NEW YORK PUBLIC LIBRARY

Timothy Allanbrook<sup>1</sup> and Andrew Wilson<sup>2</sup>

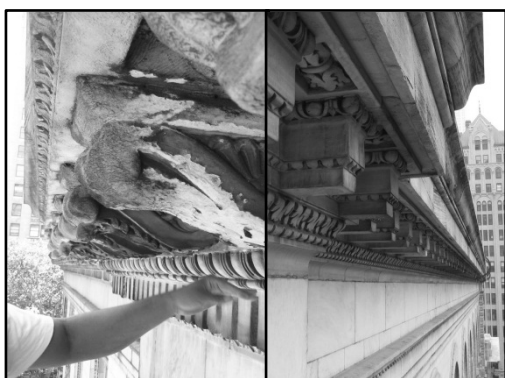
**Figures 5a and 5b.** Deteriorated modillions at main cornice without drip groove (left) and sound modillions at high cornice (right) with drip groove.

One of the more straightforward lessons learned from the library was the importance of drip edges. The high Reading Room cornice with its bold block modillions was provided with a sizable drip groove that prevented water running off the ledge above to wash back under across the modillions. The main cornice below with its decorative scroll modillions had no drip groove. There were no significant repairs required at the upper cornice – on the other hand, almost all of the scroll modillions under the main cornice required appreciable repairs (Figures

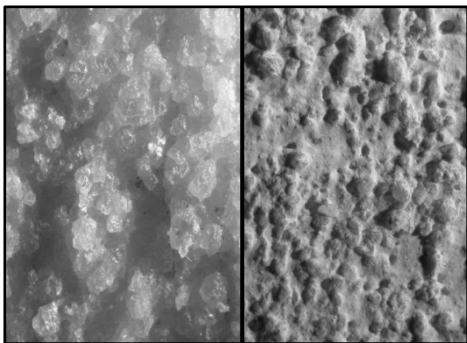
**Figures 6a and 6b.** Photomicrograph of disaggregated marble crystals before (left) and after treatment (right).

Spray application of an ammonium oxalate solution was found to assist in the mitigation of intensive sugaring of the marble. Localized treatments using ammonium oxalate were evaluated both in the laboratory and later, through field trials on friable surfaces. To further protect the eroded surfaces, a lime based shelter coat was applied over the oxalate-protected surfaces. This method proved to be quite compatible with the marble substrate and in the end, provided a viable level of sacrificial protection to the material substrate (Figure 6a and 6b).

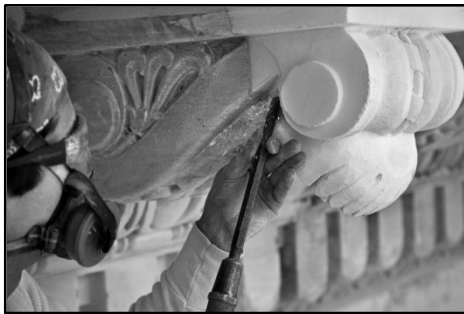
**Figure 7.** Marble dutchman patches were carved in place

Dutchman patch repairs are generally considered to be an appropriate restoration technique in the repair of distressed architectural stone work, particularly where stone elements are missing or are too severely deteriorated for other repairs to be effective. Some two thousand dutchman repairs were executed in the course of the work (Figure 7).

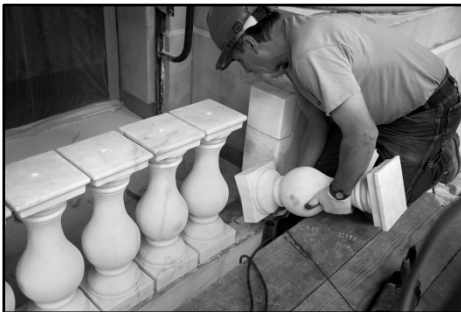
**Figure 9.** New turned marble balusters were installed at all balconies and parapets

Localized stone repair & replacement work was then conducted (Figure 9) along with the fine arts statuary conservation & cleaning work. Stone treatments such as the Ammonium Oxalate and Lime Shelter coats were then applied and a final wash-down performed. Final inspection, cleaning and/or treatment adjustments, and installation of bird netting in selected areas wrapped up the work in any given area. Due to the size of the building many of these procedures were being performed simultaneously at various areas.

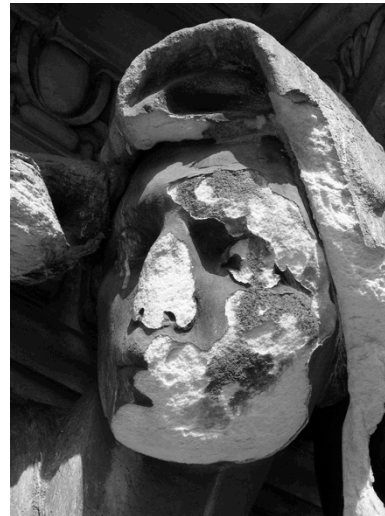
**Figure 4 (above):** Barnard pediment group detail showing extent of deterioration prior to treatment.

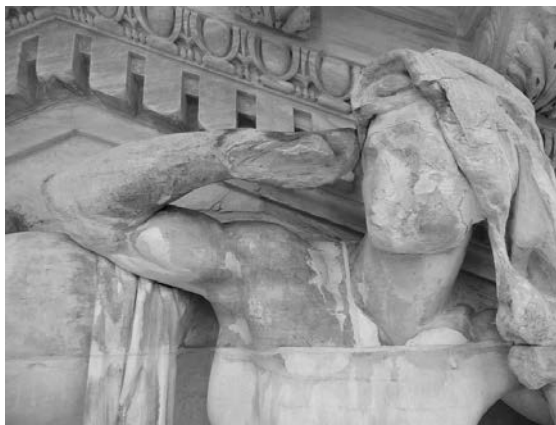
**Figure 7 (below):** Conditions of same figure after laser cleaning showing extent of erosion and loss.

Incipient spalls were pinned using alumina ceramic pins with B-72 adhesive. To increase viscosity the dissolved adhesive solution was bulked with ultra-fine precipitated calcium carbonate at 40% by weight of the dissolved adhesive solution. Once the adhesive was set, the holes were patched using Lithos Arte composite patching material. Small cracks were filled with DHL-IM Injection Grout as distributed by US Heritage Group. The injection grout was delivered through a syringe.

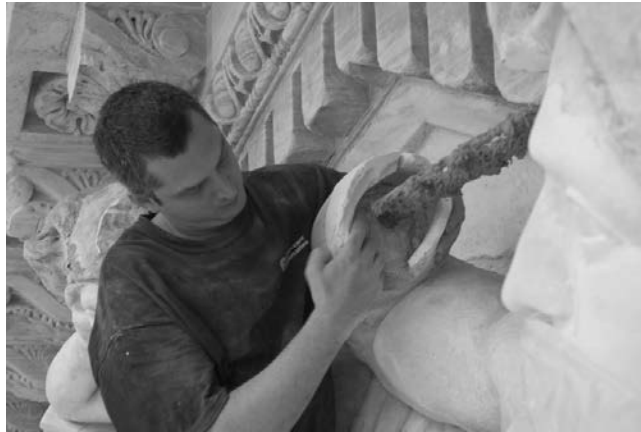
**Figure 8 (above):** Fitting replica casting at Barnard Pediment Group

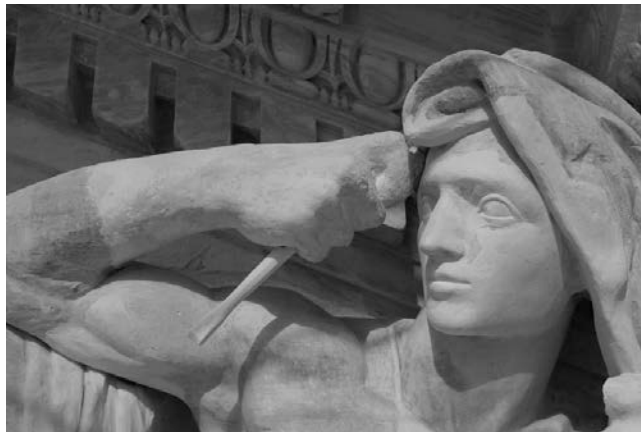
**Figure 9 (below):** Same figure after treatment.

condition required removal of significantly more material than originally anticipated. Where necessary, stainless steel threaded rods and/or fiberglass rod set in Sikadur® 31 Hi Mod Gel epoxy were installed before the application of the patching material to provide structural support.

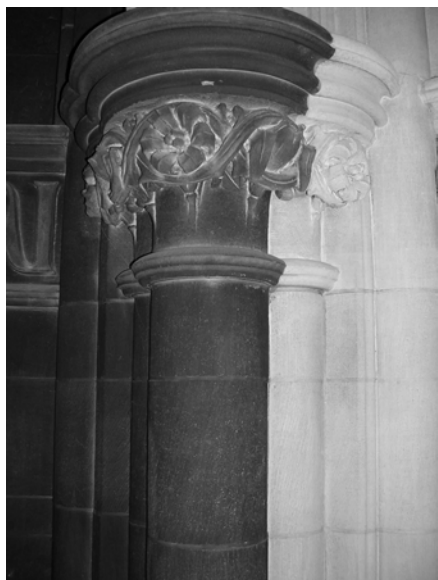
**Figure 4.** Detail of limestone surface cleaned by Arte Mundit adjacent to uncleaned section of stone. Photograph by Andrew Wilson.

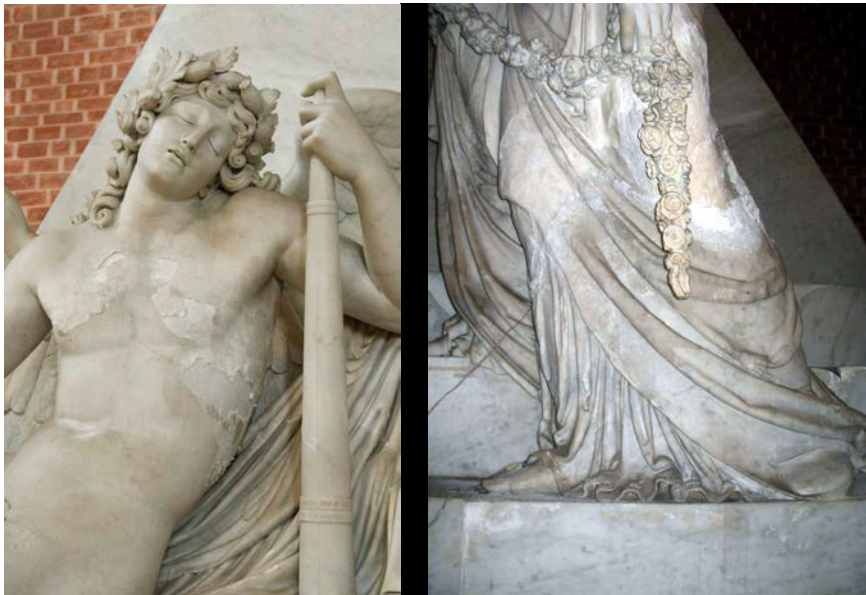
Fig. 2, 3. Details of exfoliation on the Sleeping Genius and on the womens' dresses.

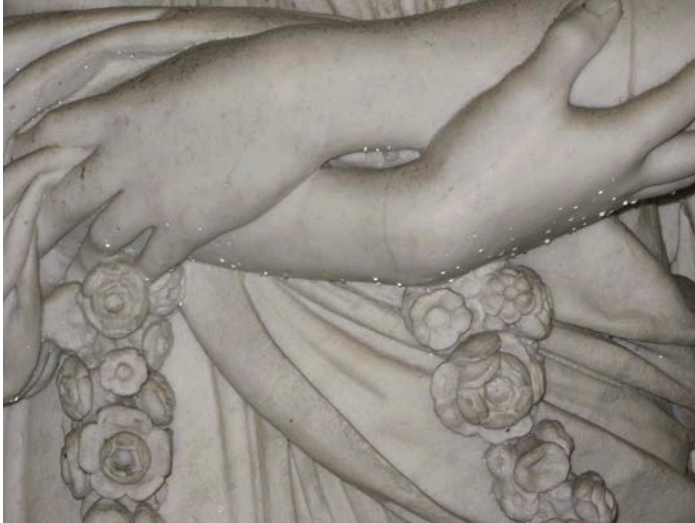
Fig. 4. Droplets visible on the marble surfaces

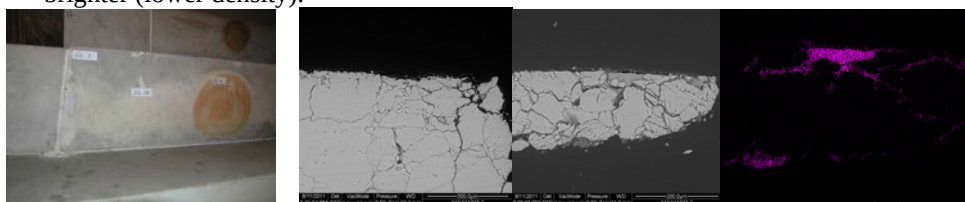
Fig. 7. a) whitish slightly eroded surface, b) cross section at ESEM showing micro-cracks at an initial stage, c) cross section at ESEM showing more numerous micro-cracks caused by sodium chloride crystallization, d) X ray map distribution of sulphur showing gypsum on the surface and its penetration inside micro-cracks.

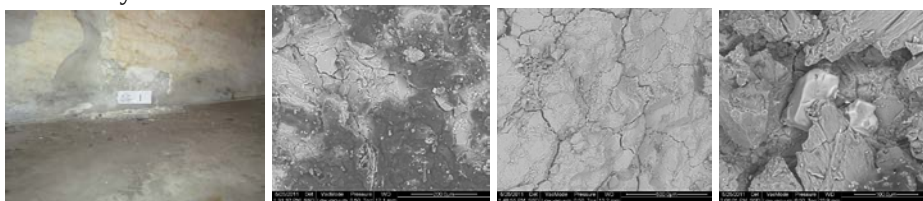
micro-cracks. The same scale observed from the back which, before sampling, was in contact with the sound substratum, shows many micro-cracks associated with sodium chloride crystals.

Fig. 8. a) sample location. b) external surface of the marble scale (wax is visible in the dark areas). c) back side of the marble scale shows a marked decohesion of grain crystals. d) sodium chloride crystal

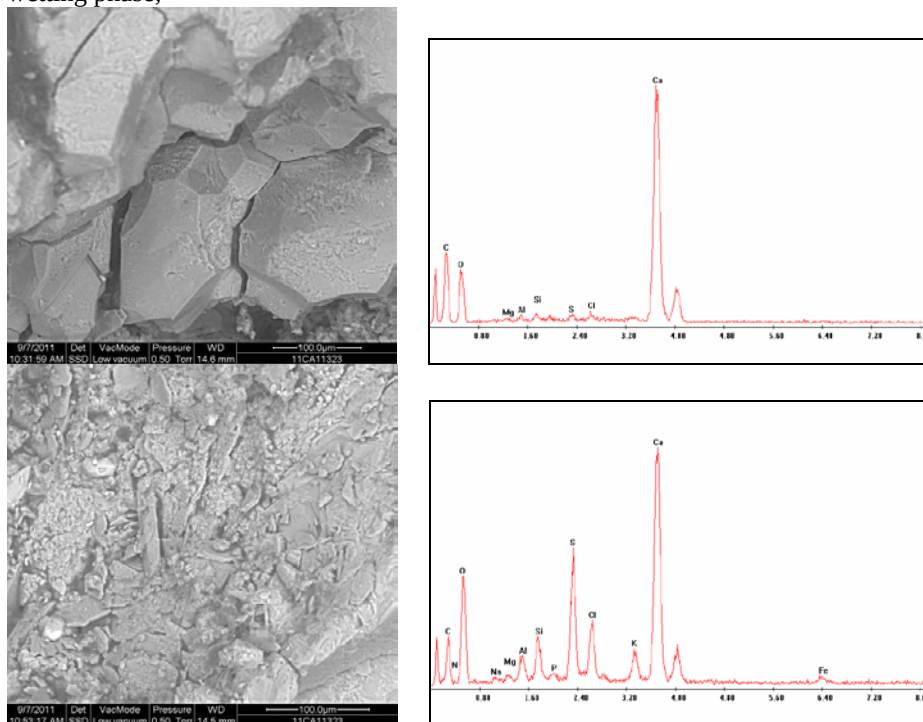
Fig. 10. a) level: marked micro-fissures in between calcite, b) EDS microanalysis enhancing mainly presence of calcium, c) small crystals of secondary gypsum formation, d) In addition to calcium, sulphur and chloride indicates the presence of gypsum and halite crystals coming respectively from atmospheric pollutants and rising damp of lagoon chloride-rich water.

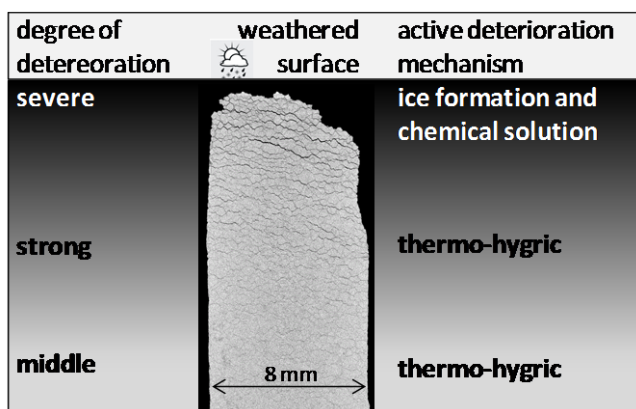
**Figure 4:** The x-ray ct-image of a drilling core shows a pronounced damage profile with a distinct cracking near the surface. The condition of the material is related to the depth and to the assumed deterioration mechanism.
