# **MARA -PROJECT**

## **DEVELOPING LONG-TERM DURABILITY OF MARBLE FACADES**

# **FINAL REPORT**

30.4.2001

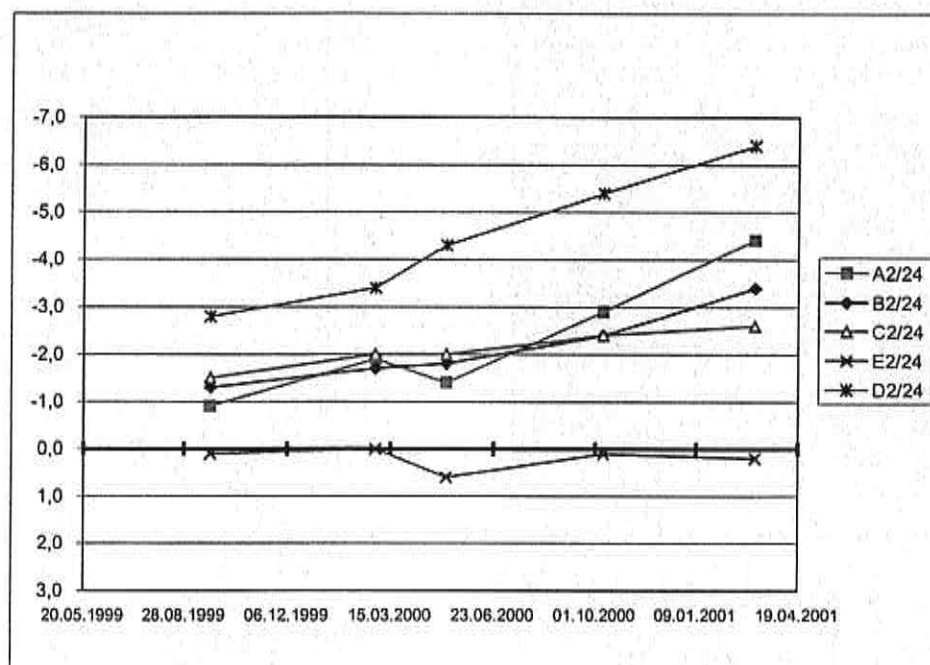
**Figure 24.** Measured bowings on wall 24. Massive marble panels.

The magnitude of bowing seems to be following the degree of homoblasticity, the most bowed is product D, which is presenting pure homoblastic marbles, and the less bowed –or practically straight- is product E presenting pure xenoblastic marbles. Same phenomena can also be seen on walls 23 and 202, the former facing east and the latter facing south (see figures 25 and 26).

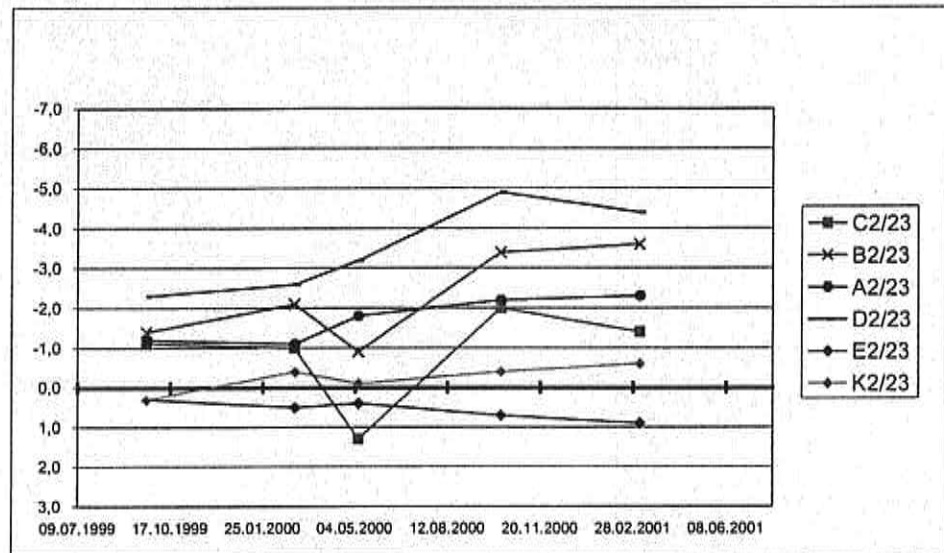
**Figure 25.** Measured bowings on wall 23. Massive marble panels.

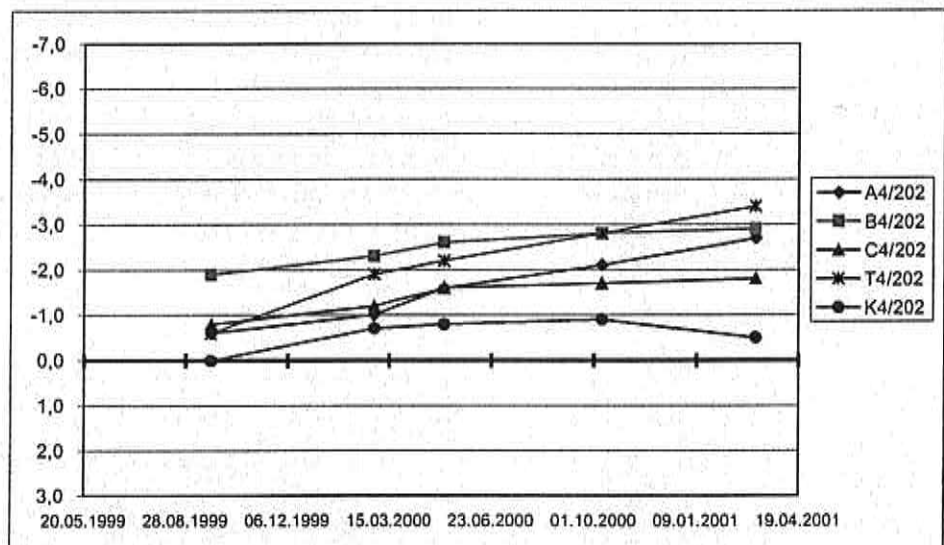
**Figure 26.** Measured bowings on wall 202. Massive marble panels.

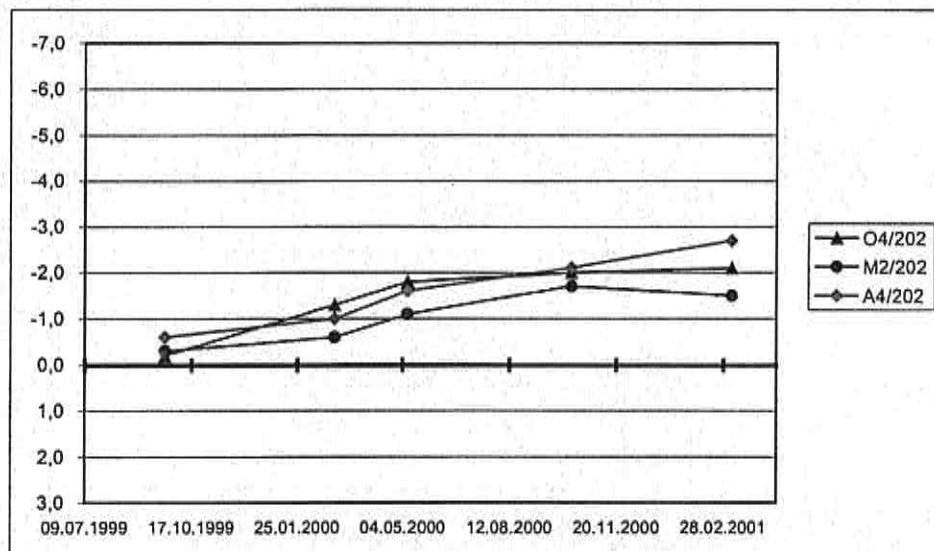
Bowing measurements show also quite clearly the function of two different protective agents. In figure 27 are presented the bowing measurements from the wall 202. Product A is also added in the figure for comparison since products M and O are derived from it by adding protective agent. These measurements confirm, although they can be considered as indicative due to the relatively short observation time, the results introduced later in this report. Protective agent seems not to be able to prevent marble from bowing.

Figure 27. Measured bowings on wall 202. Protective agents.

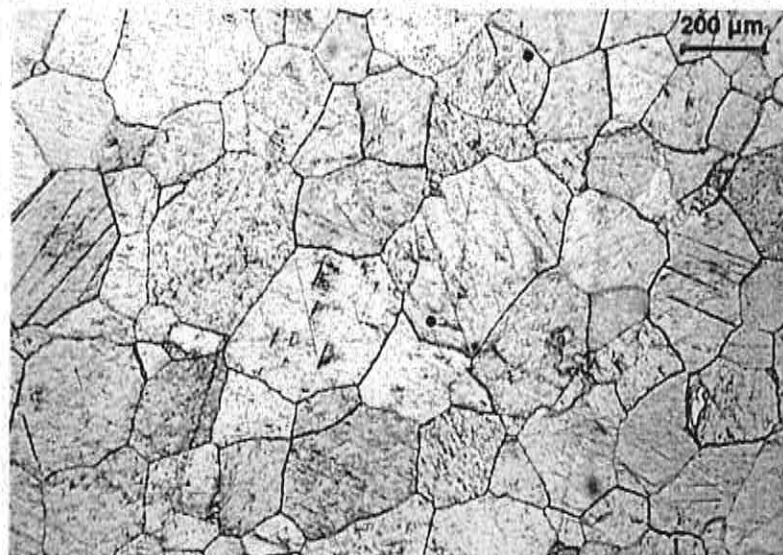
**Figure 36.** Microstructure of marble D. 1 year on the test wall. Plane-polarized light.

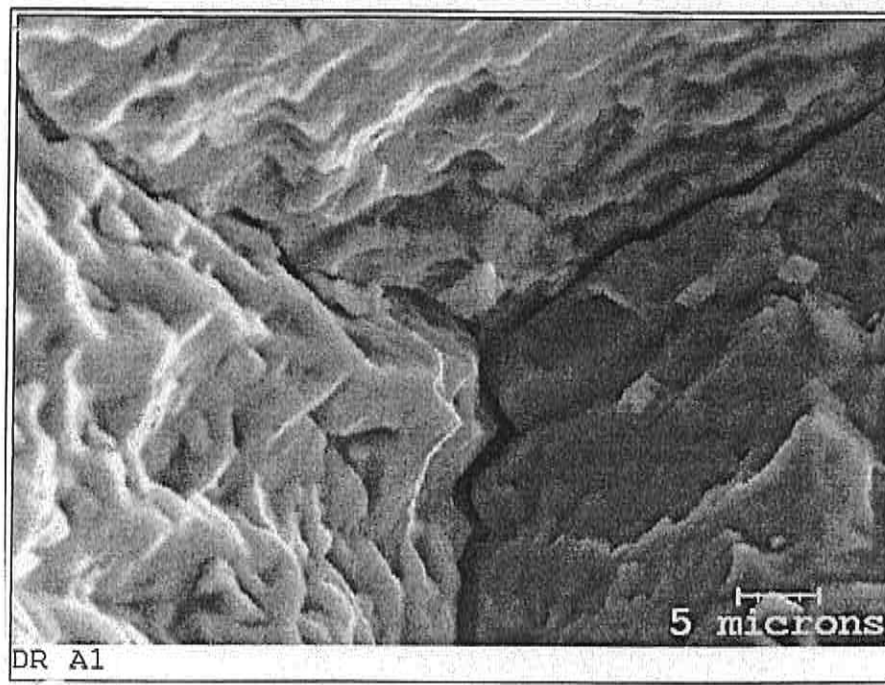
Figure 43. Marble D, 1 year on the test wall. SE-image of fractured surface. 500x.

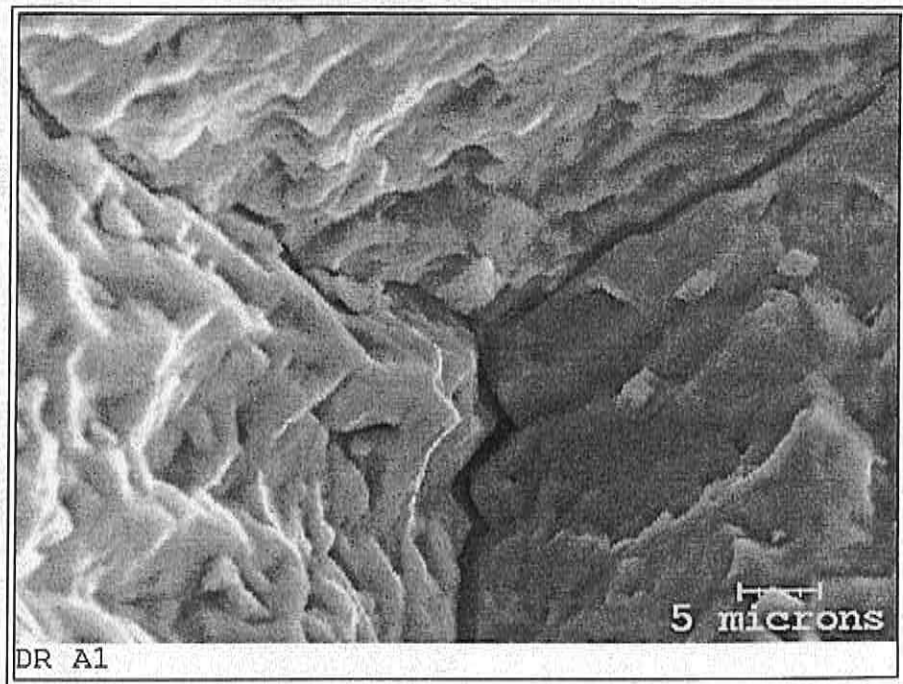
**Figure 43.** Marble D, 1 year on the test wall. SE-image of fractured surface, 2500x.

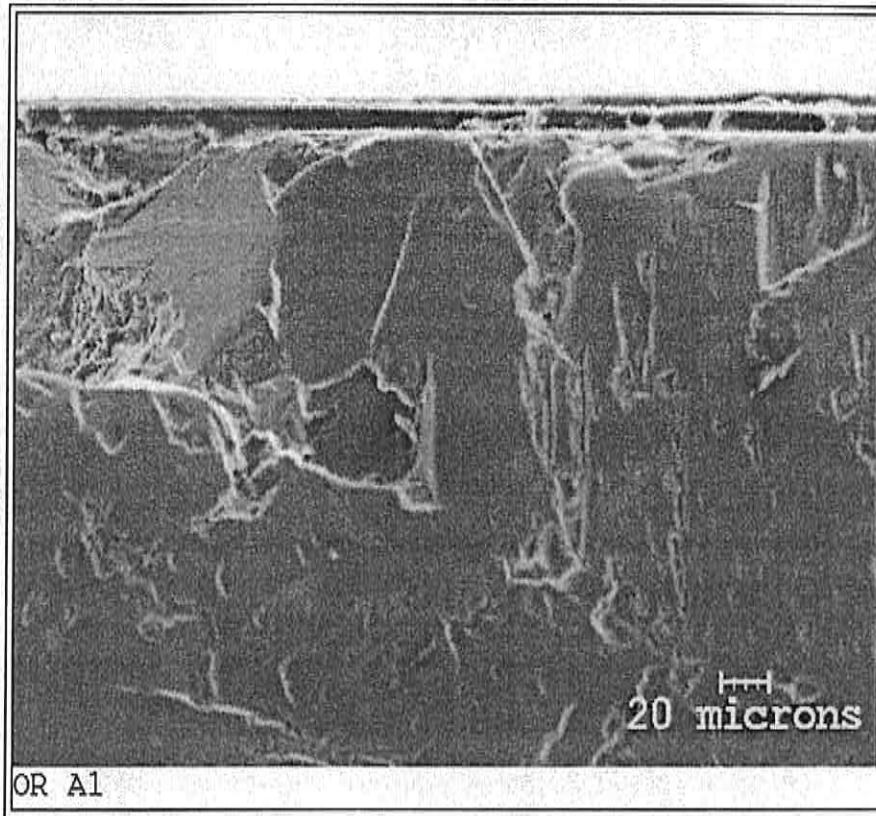
**Figure 84.** Marble A + Dyny. A layer of protective agent on the surface of the panel having a thickness 15-30 $\mu$ m. 1 year on the test wall. SE-image, 300x.
