# VTT BUILDING AND TRANSPORT

### Developing long term durability of marble facades

#### Subproject "Test wall"

Espoo, April 20, 2001

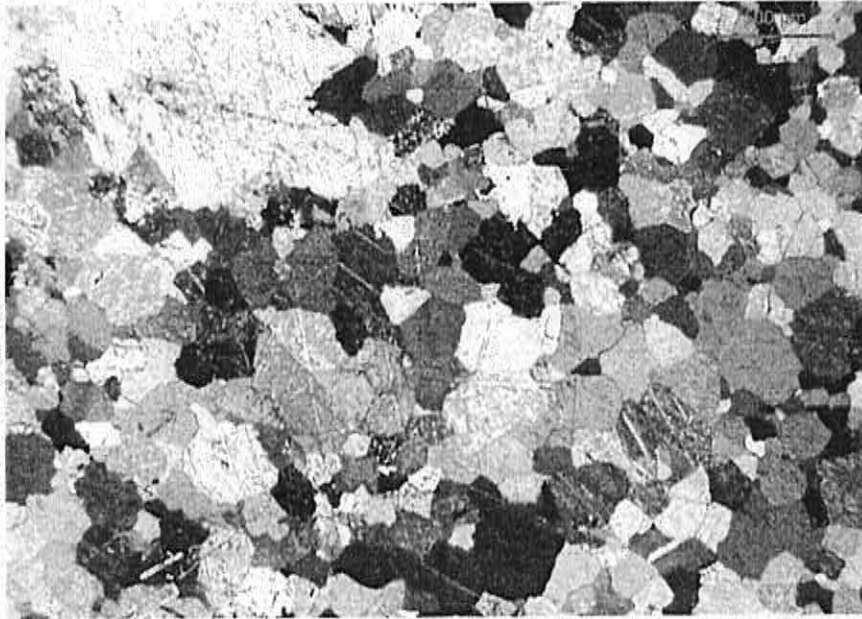
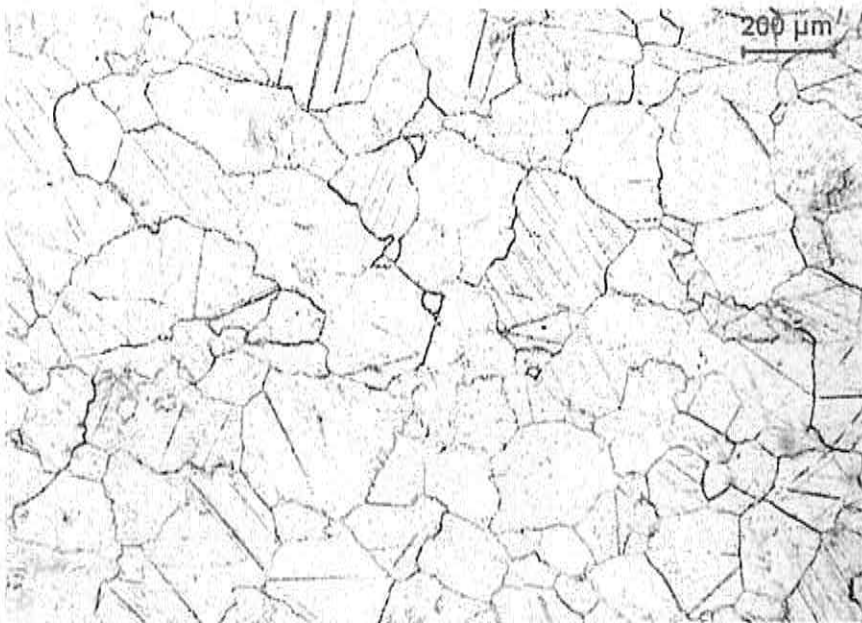
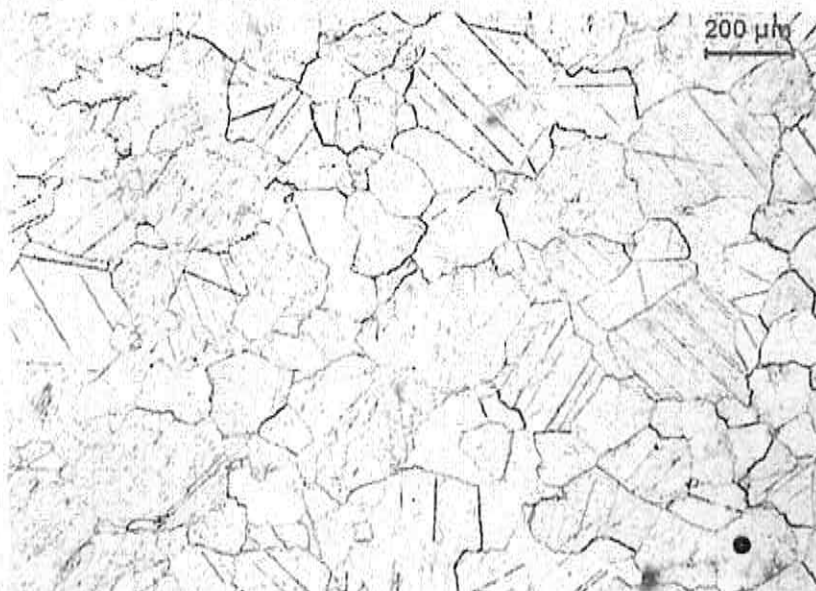
Photographs of the microstructure of marble A, unused and after 1 year on the test wall, are shown in Figs. 21-23. Following observations were made:

- groundmass fine-grained, fairly even-grained, not oriented, massive
- average grain size 200-300  $\mu\text{m}$
- slightly porphyroblastic, some larger porphyroblasts (max  $\varnothing$  6 mm) in the groundmass
- nearly pure carbonate rock, contains only very little opaque minerals
- alteration of the grains insignificant
- no changes observable after 1 year on the test wall

**Figure 21.** Microstructure of marble A. Unused. Cross-polarized light.

**Figure 22.** Microstructure of marble A. Unused. Plane-polarized light.

**Figure 23.** Microstructure of marble A. 1 year on the test wall. Plane-polarized light.

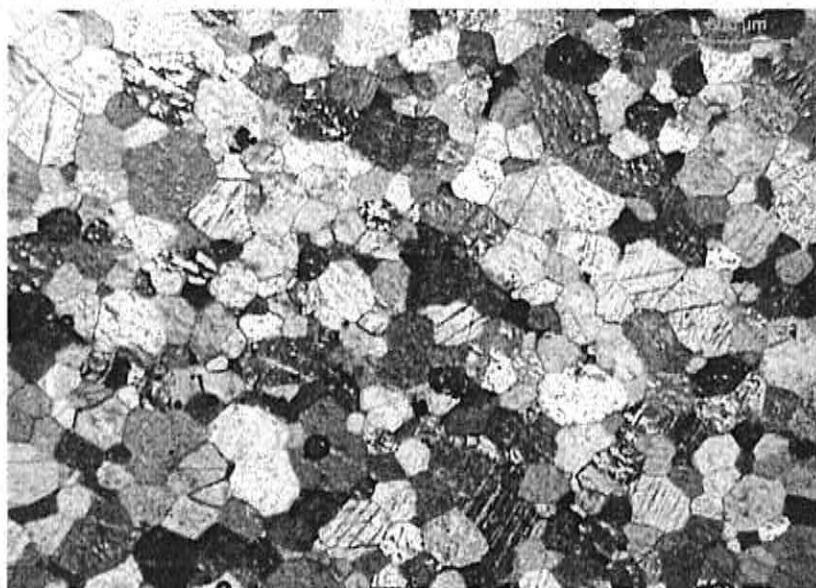
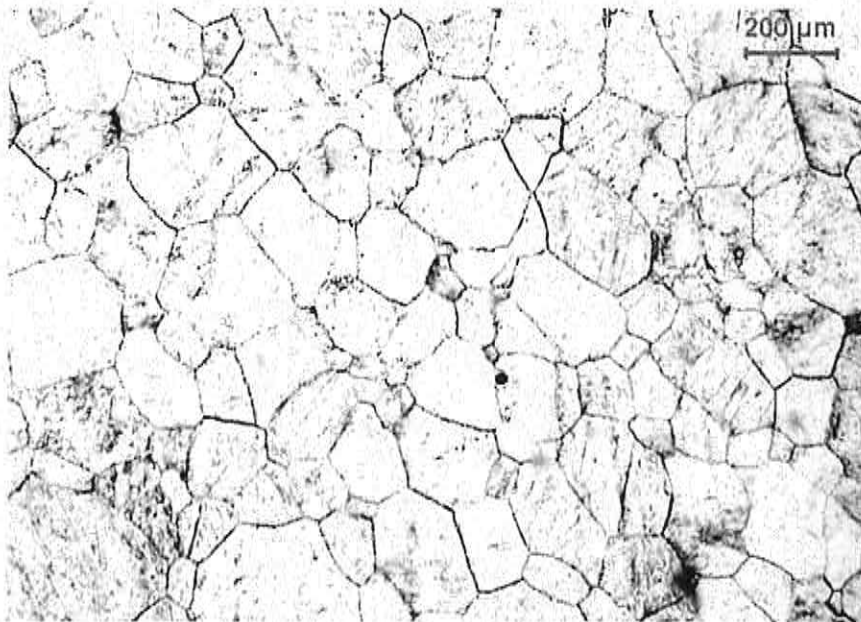
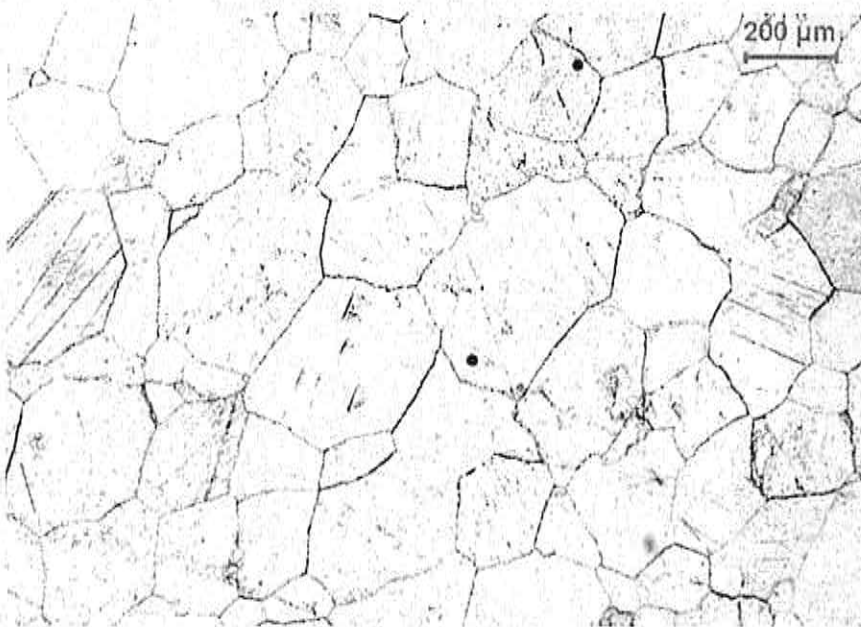
Photographs of the microstructure of marble D, unused and after 1 year on the test wall, are shown in Figs. 24-26. Following observations were made:

- fine-grained, fairly even-grained, not oriented, massive
- average grain size 200-300  $\mu\text{m}$
- nearly pure carbonate rock, contains very little mica type minerals
- some alteration of the grains
- no changes observable after 1 year on the test wall

**Figure 24.** Microstructure of marble D. Unused. Cross-polarized light.

**Figure 25.** Microstructure of marble D. Unused. Plane-polarized light.

**Figure 26.** Microstructure of marble D. 1 year on the test wall. Plane-polarized light.

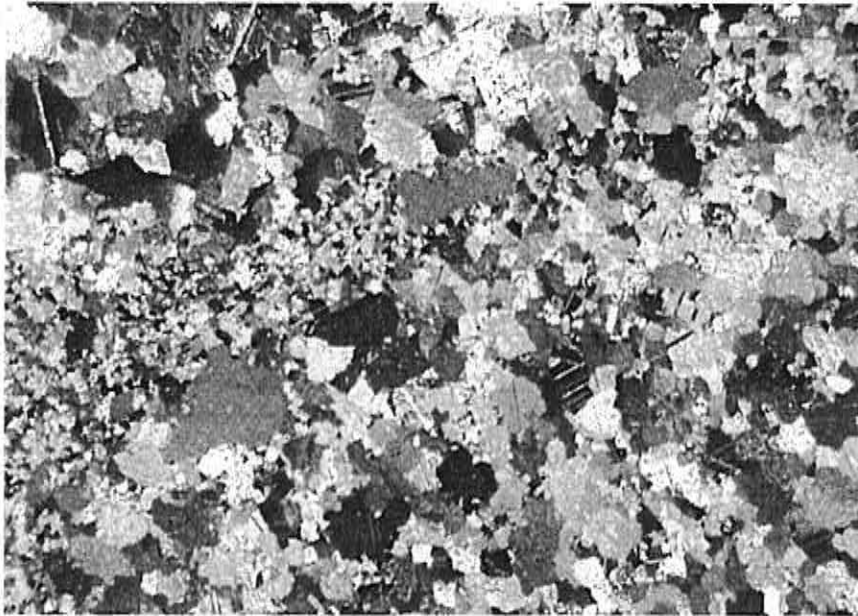
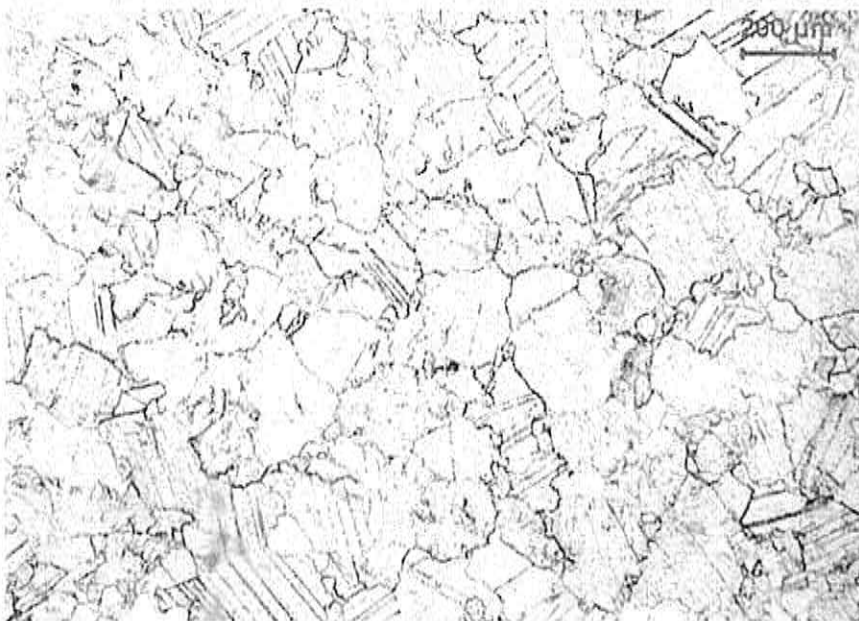
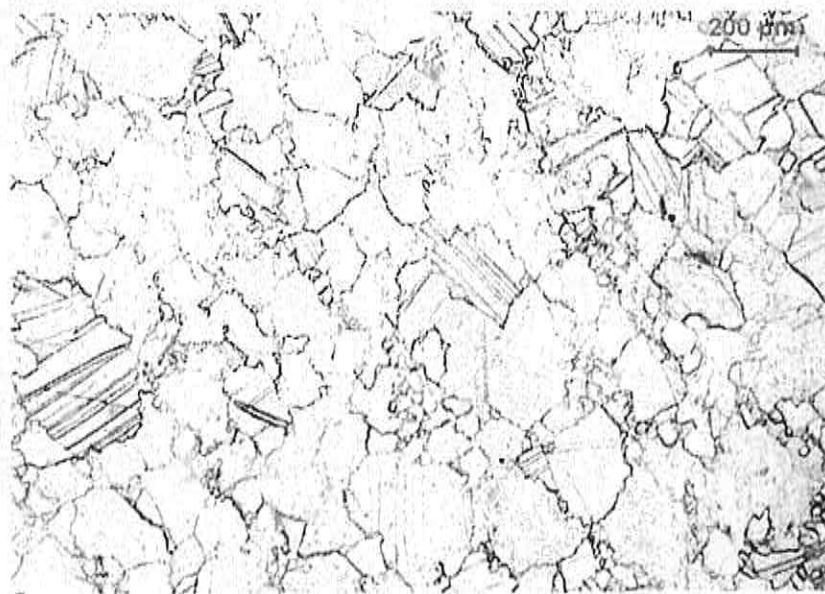
Photographs of the microstructure of marble E, unused and after 1 year on the test wall, are shown in Figs. 27-29. Following observations were made:

- very fine-grained (cryptocrystalline) lenses among the groundmass, the lenses pass gradually into groundmass
- nearly pure carbonate rock, contains some opaque and mica type minerals
- some alteration of the grains
- no changes observable after 1 year on the test wall

**Figure 27.** Microstructure of marble E. Unused. Cross-polarized light.

**Figure 28.** Microstructure of marble E. Unused. Plane-polarized light.

**Figure 29.** Microstructure of marble E. 1 year on the test wall. Plane-polarized light.

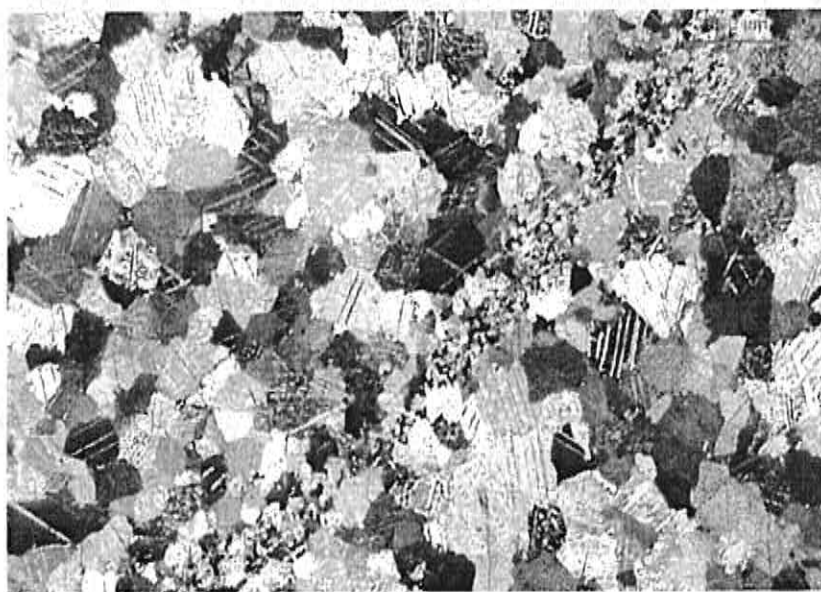
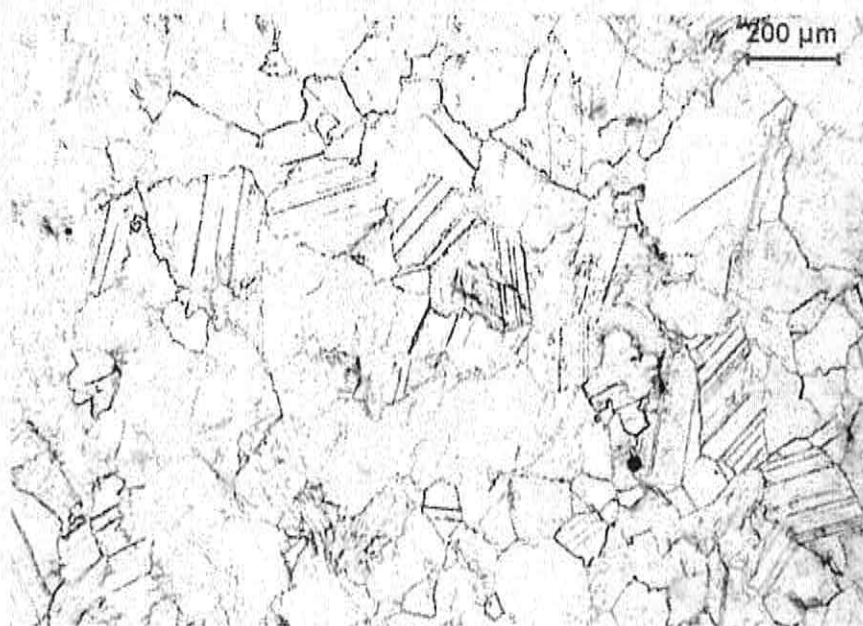
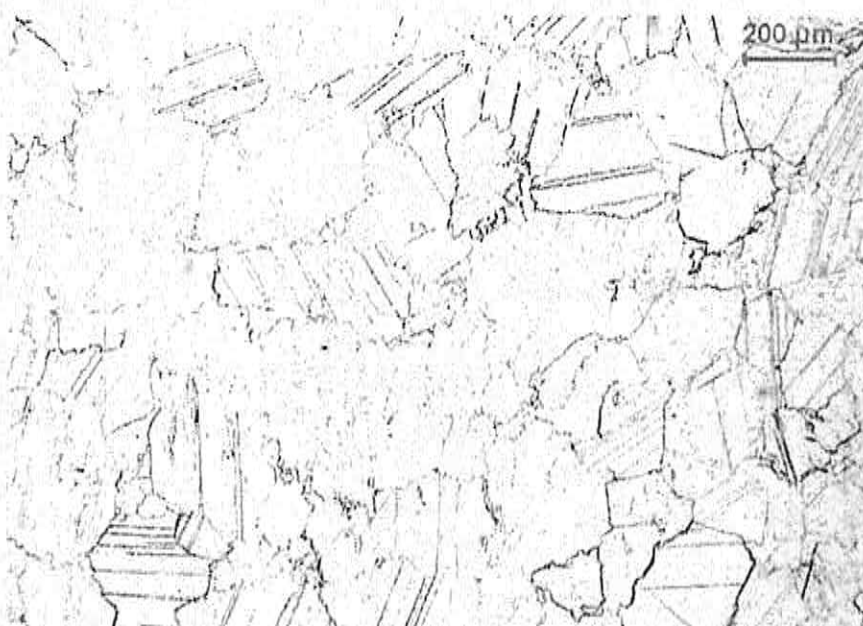
Photographs of the microstructure of marble K, unused and after 1 year on the test wall, are shown in Figs. 30-32. Following observations were made:

- fine-grained, not oriented
- average grain size about 200 μm
- very fine-grained (cryptocrystalline) lenses and veins among the groundmass, the lense boundaries are usually distinguished from the groundmass
- nearly pure carbonate rock, contains some opaque minerals
- little alteration of the grains
- no changes observable after 1 year on the test wall

**Figure 30.** Microstructure of marble K. Unused. Cross-polarized light.

**Figure 31.** Microstructure of marble K. Unused. Plane-polarized light.

**Figure 32.** Microstructure of marble K. 1 year on the test wall. Plane-polarized light.

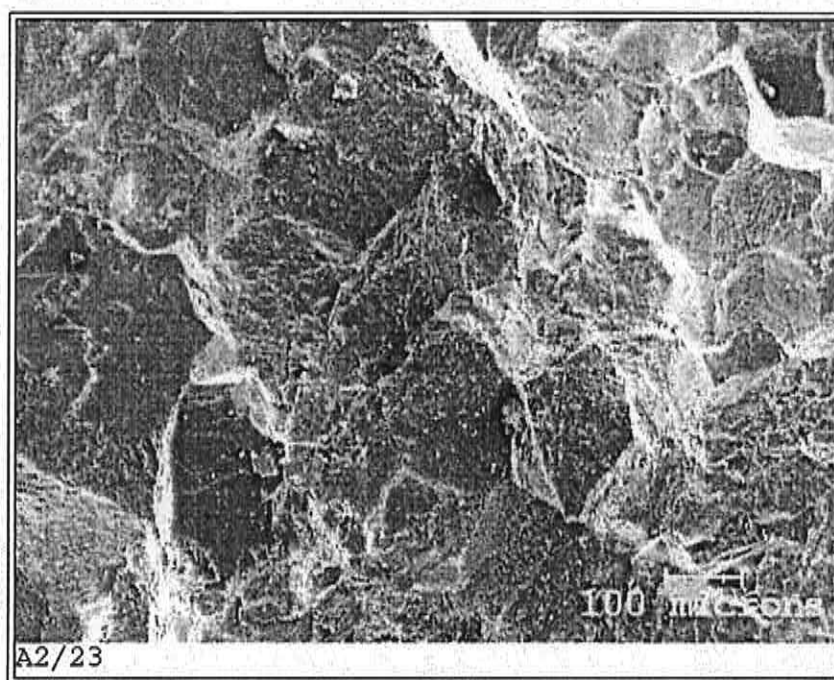
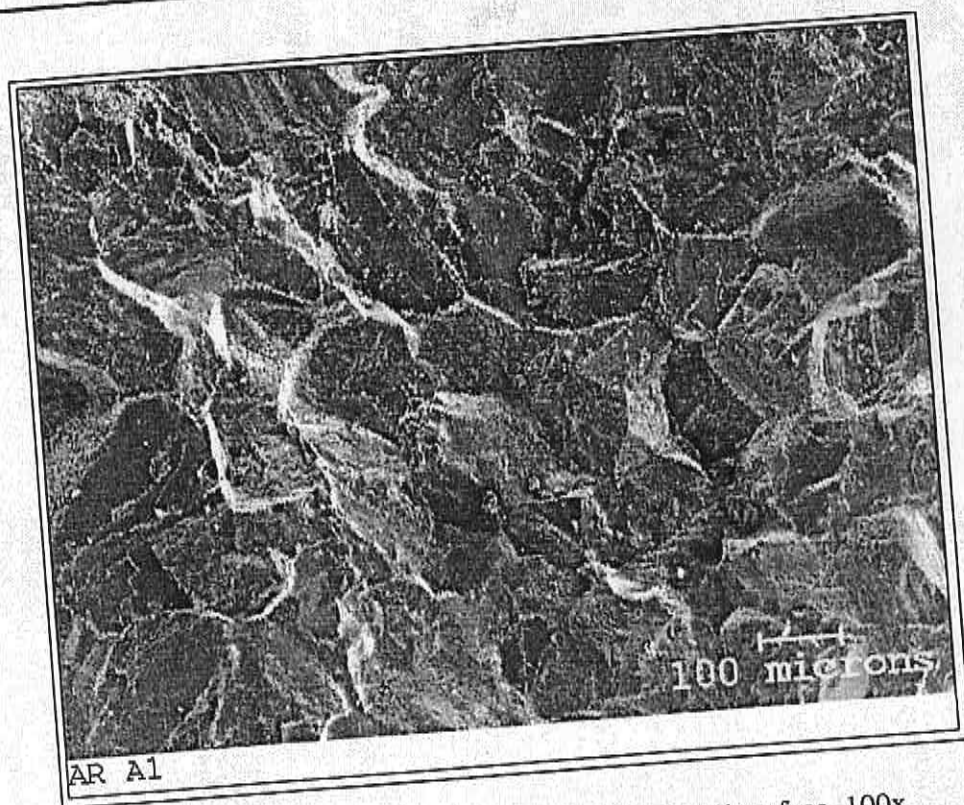
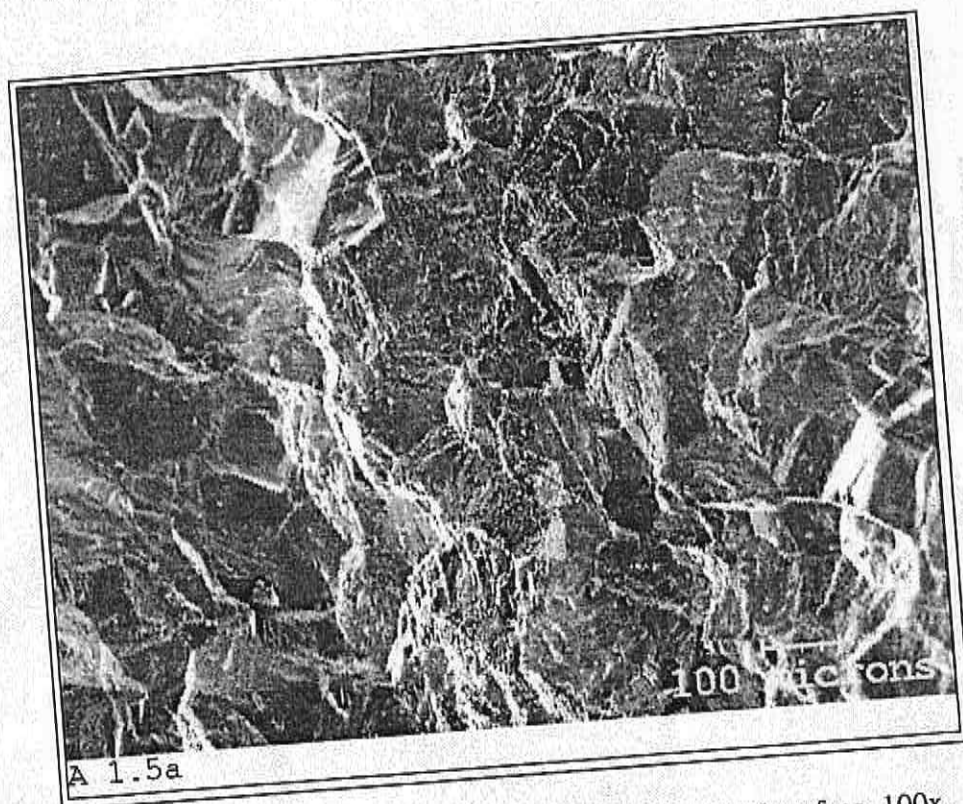
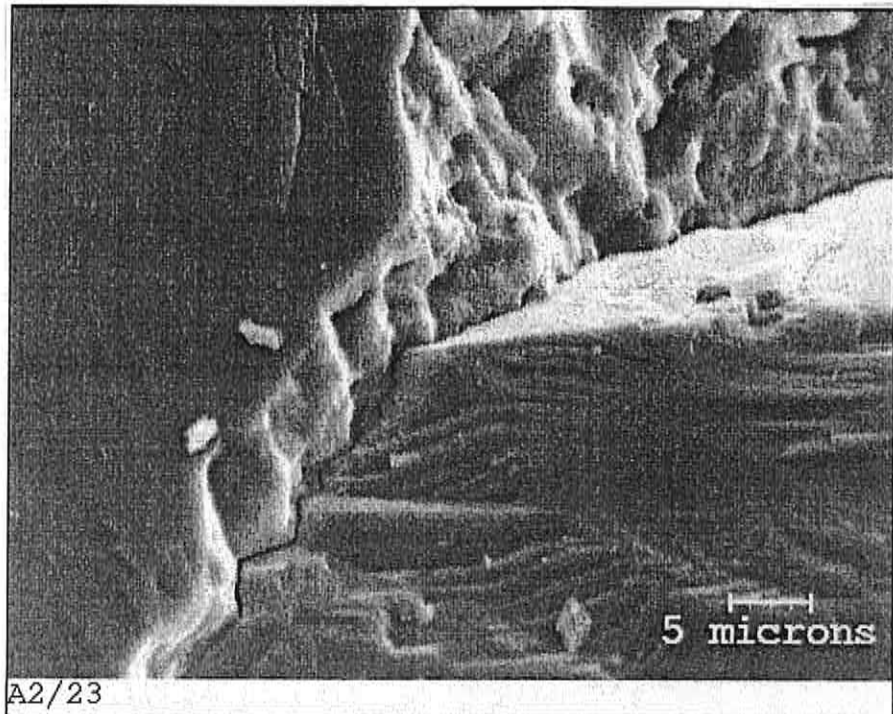
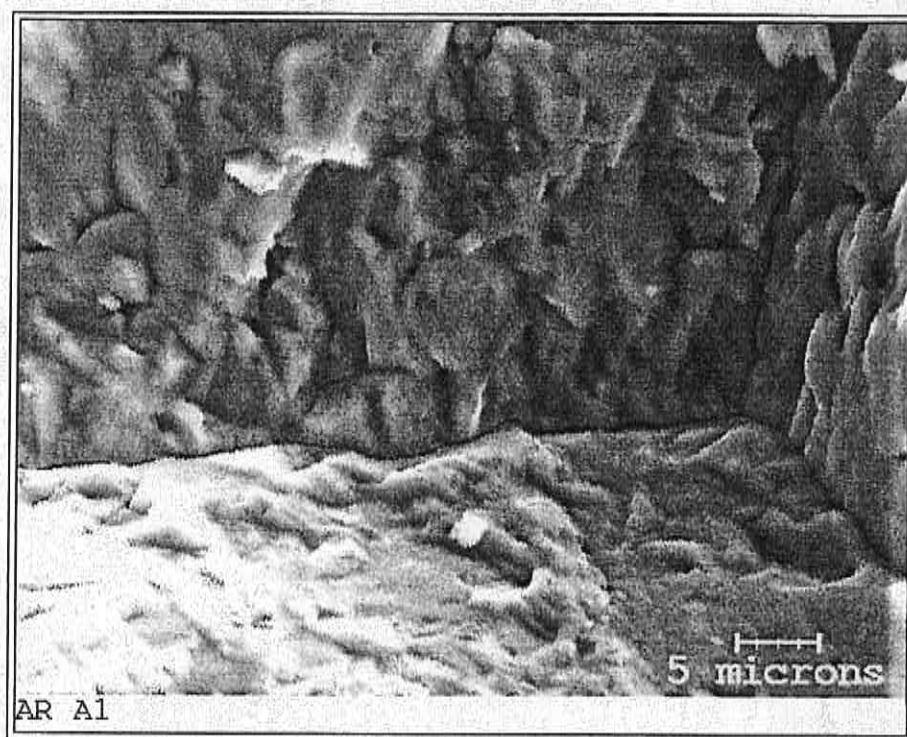
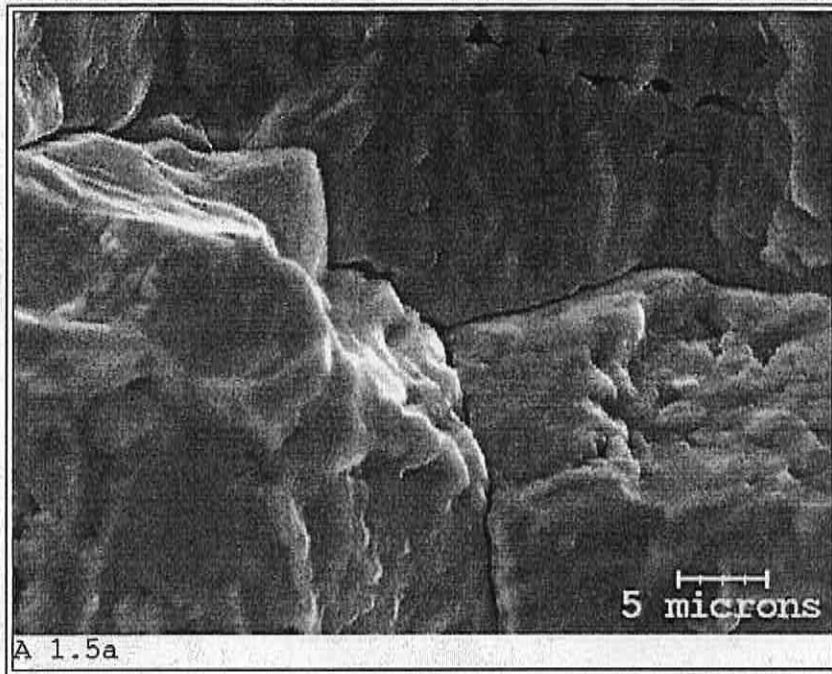
SEM-pictures of fractured surfaces of marble A, both unused and after 1 and 1.5 years on the test wall, are shown in Figs. 53-58. The individual grains can at least partly be distinguished from each other. Narrow cracks can also be noticed between some of the grains. More and wider cracks were detected when the marble had been exposed to the environmental stresses on the test wall. The maximum crack width after 1.5 years on the test wall is around 0.6-0.7  $\mu\text{m}$ .

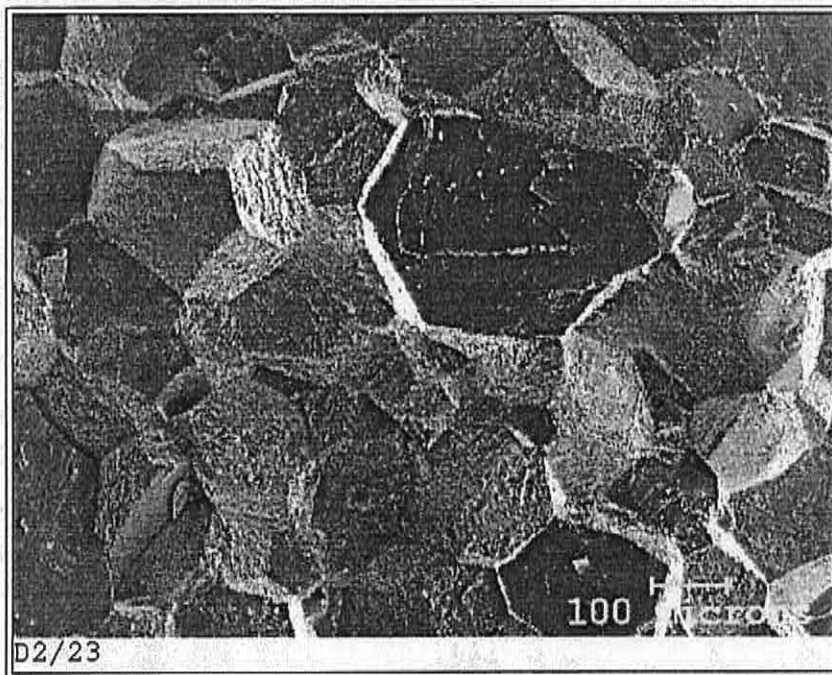
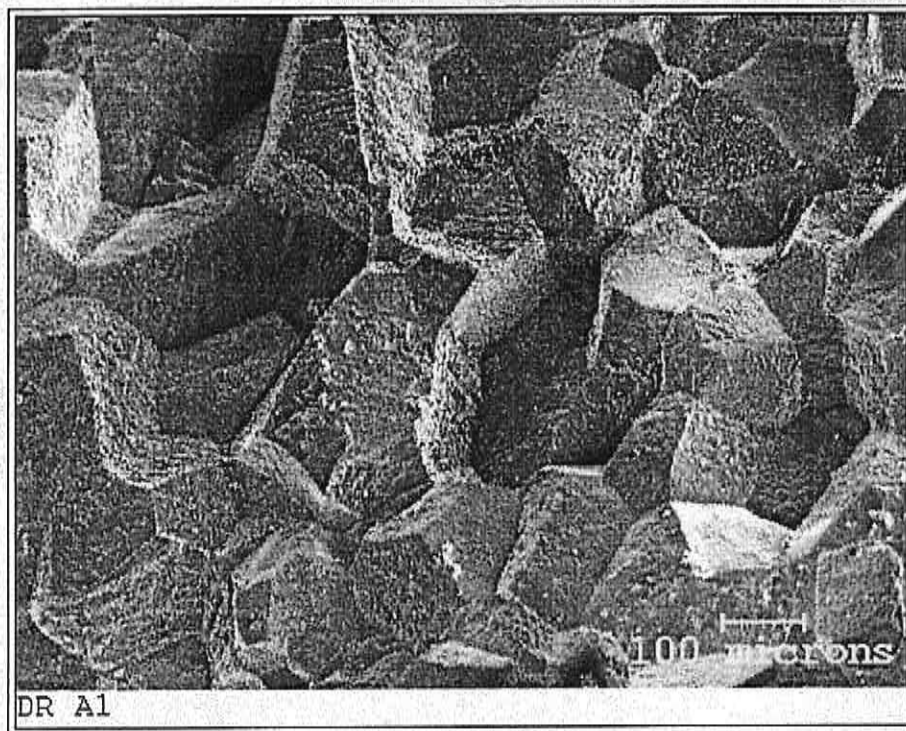
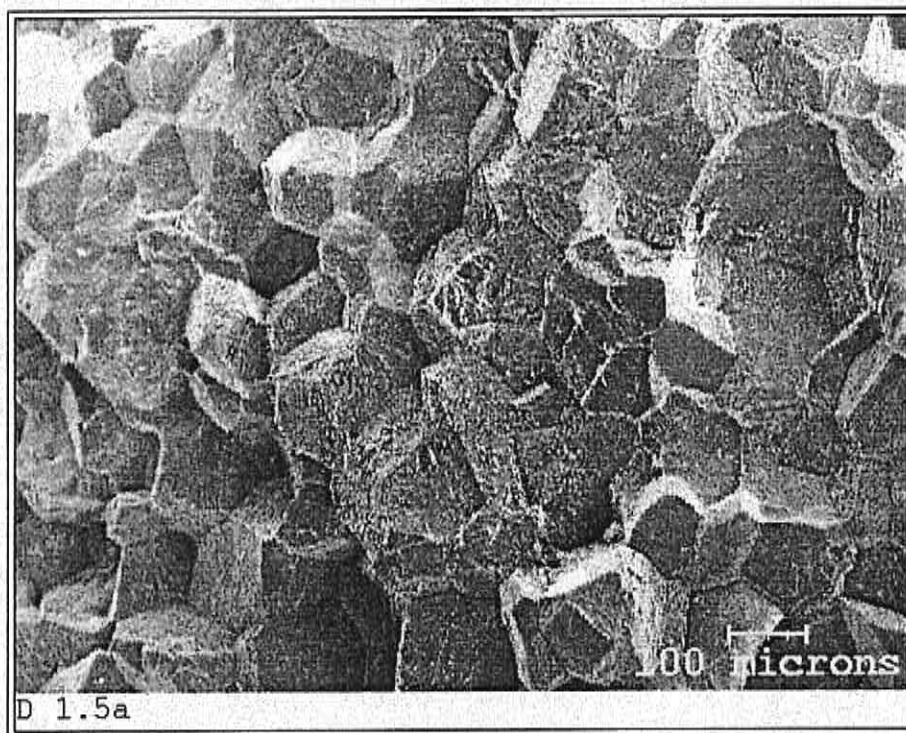
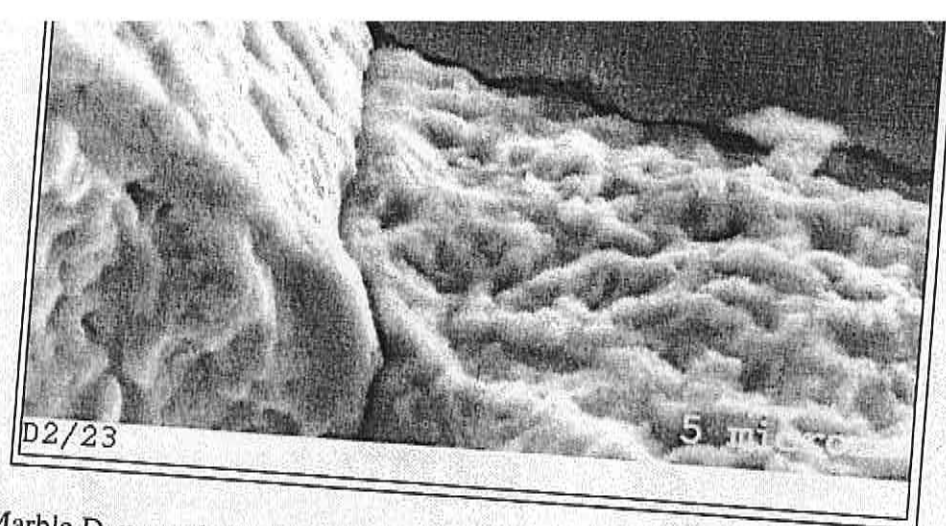
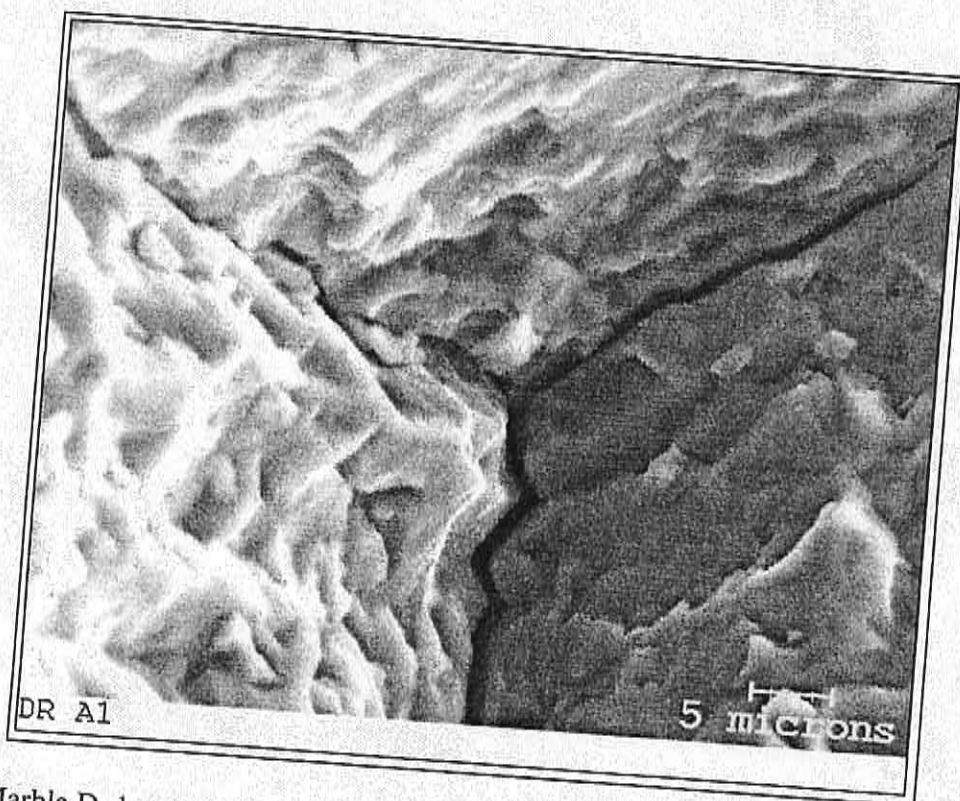
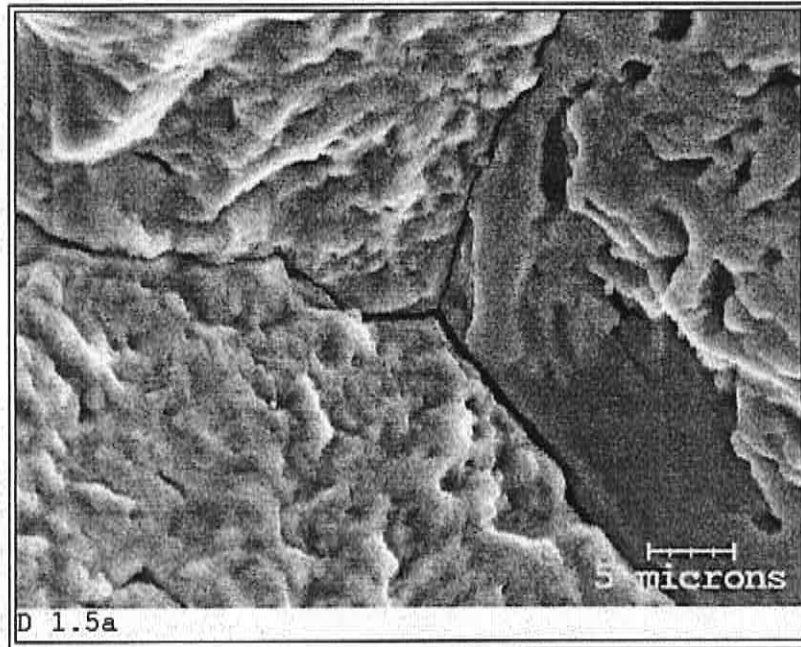
SEM-pictures of fractured surfaces of marble D, both unused and after 1 and 1.5 years on the test wall, are shown in Figs. 59-64. The individual grains can easily be distinguished from each other. Clear cracks can also be noticed between all the grains. These cracks were wider when the marble had been exposed to the environmental stresses on the test wall. The maximum crack width after 1.5 years on the test wall is around 1  $\mu\text{m}$ .

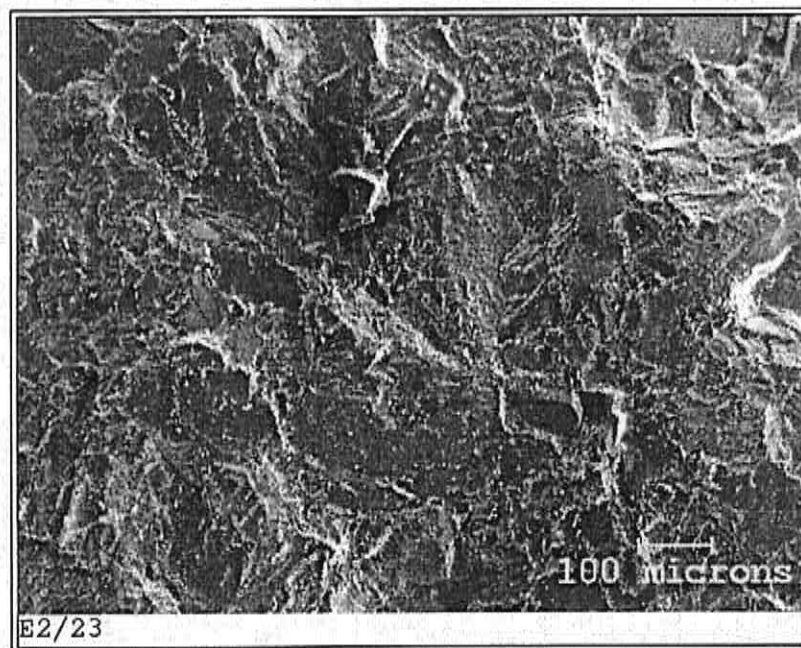
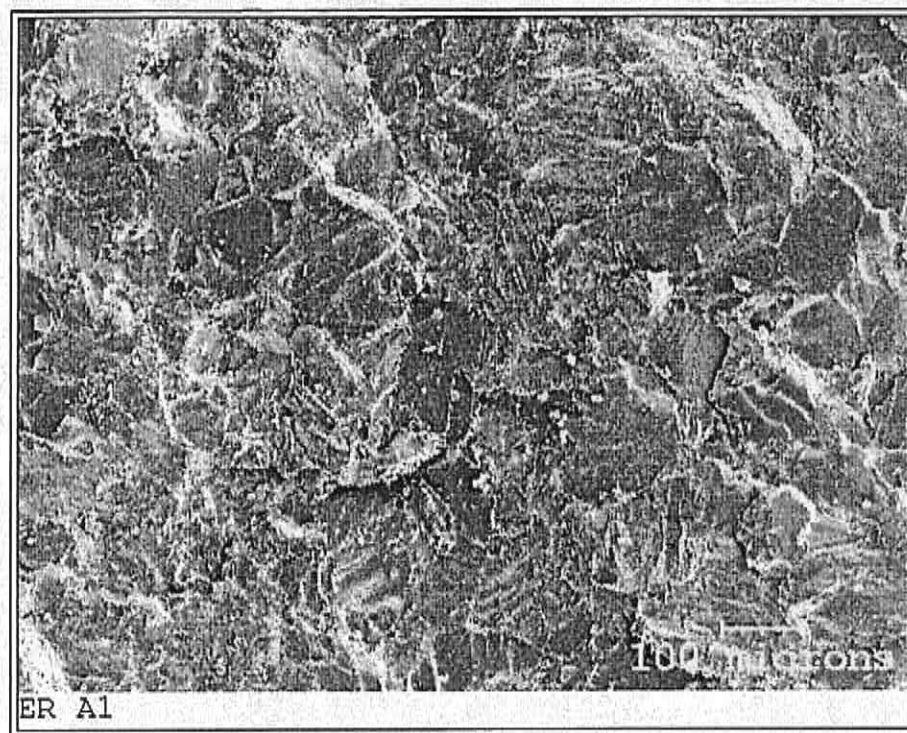
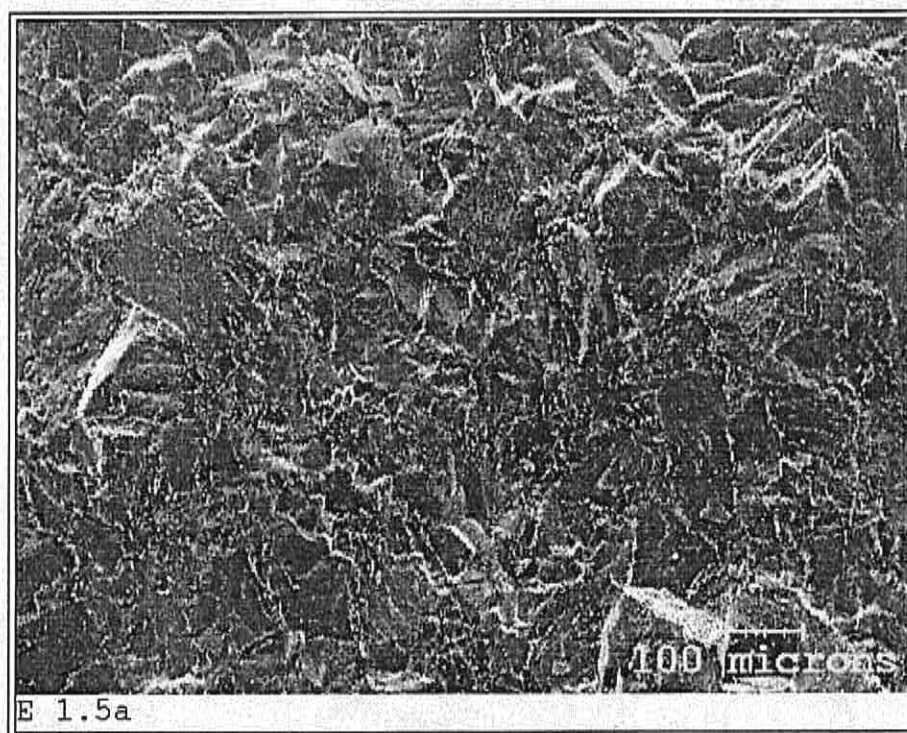
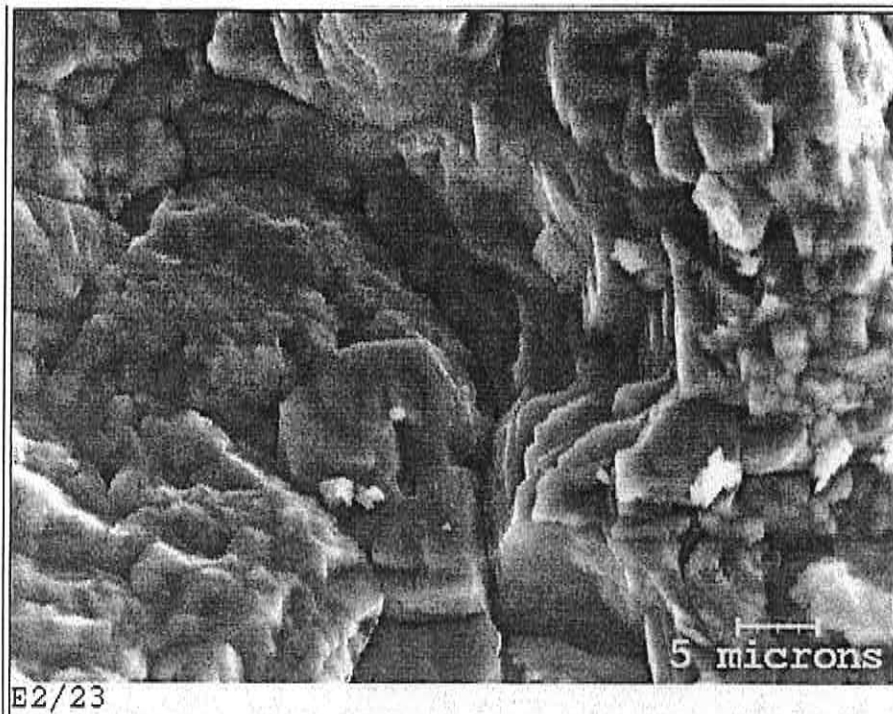
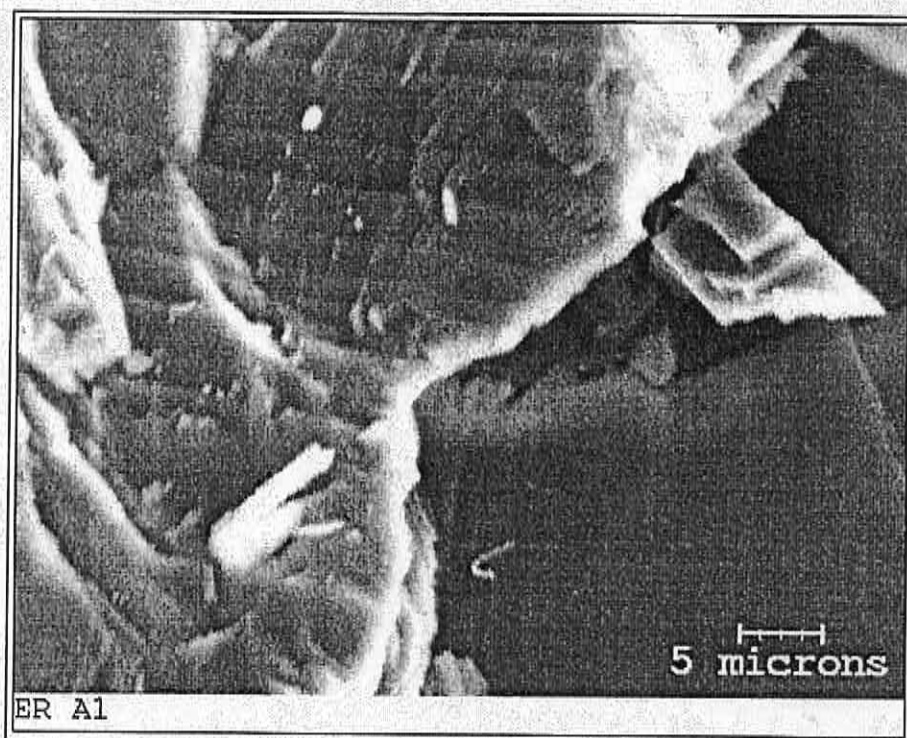
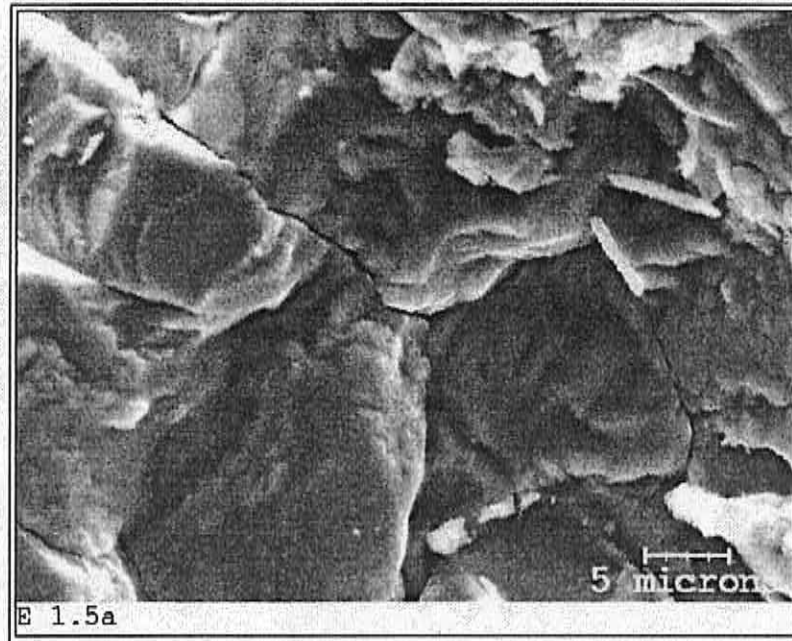
SEM-pictures of fractured surfaces of marble E, both unused and after 1 and 1.5 years on the test wall, are shown in Figs. 65-70. The grain boundaries can be seen only in some places. Thus, it is impossible to distinguish the grains from each other. Some very narrow cracks can be noticed between some of the grains. Some more and a little wider cracks were detected when the marble had been exposed to the environmental stresses on the test wall. The maximum crack width after 1.5 years on the test wall is around  $0.3\ \mu\text{m}$ .

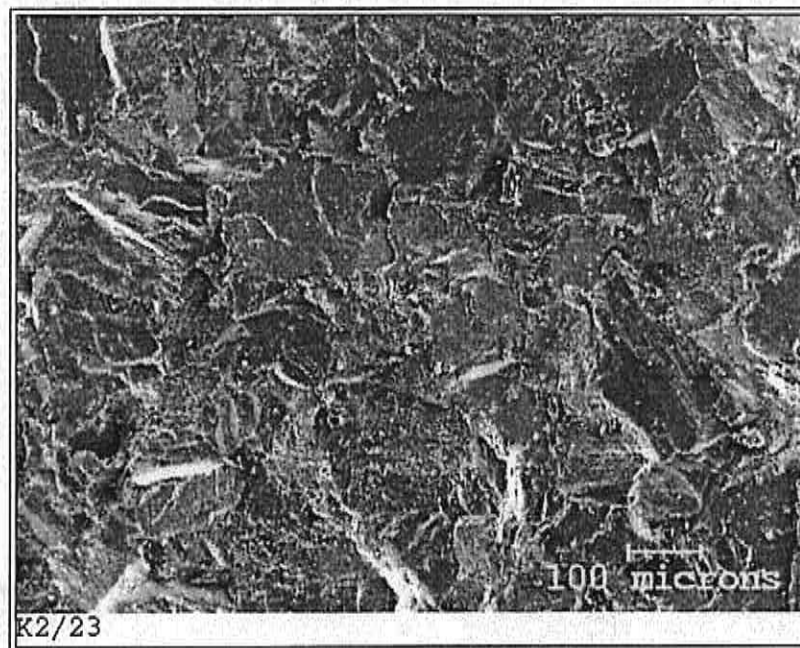
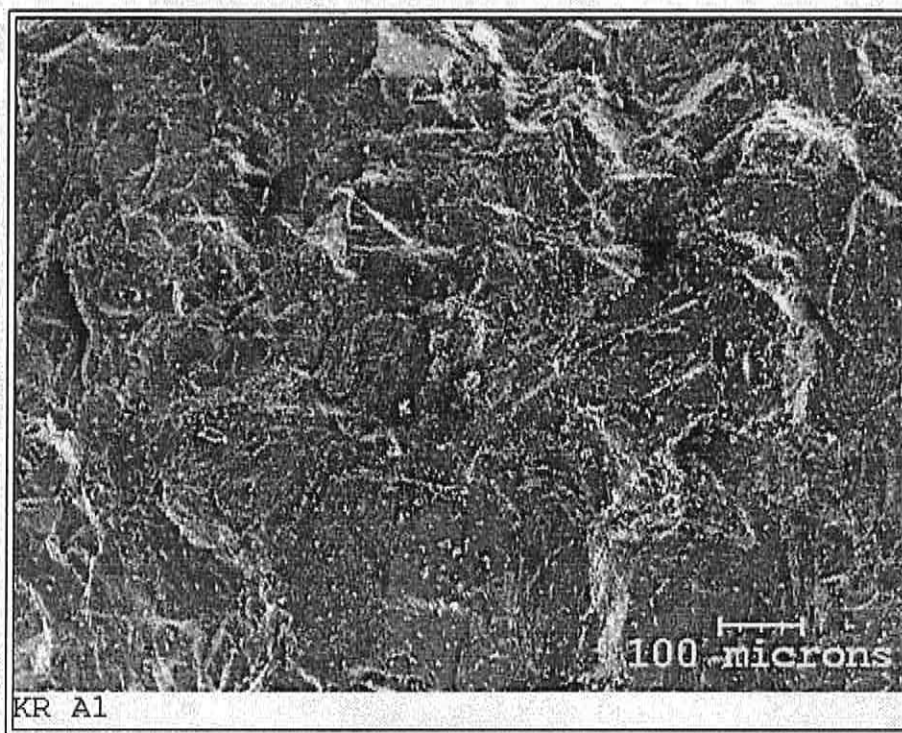
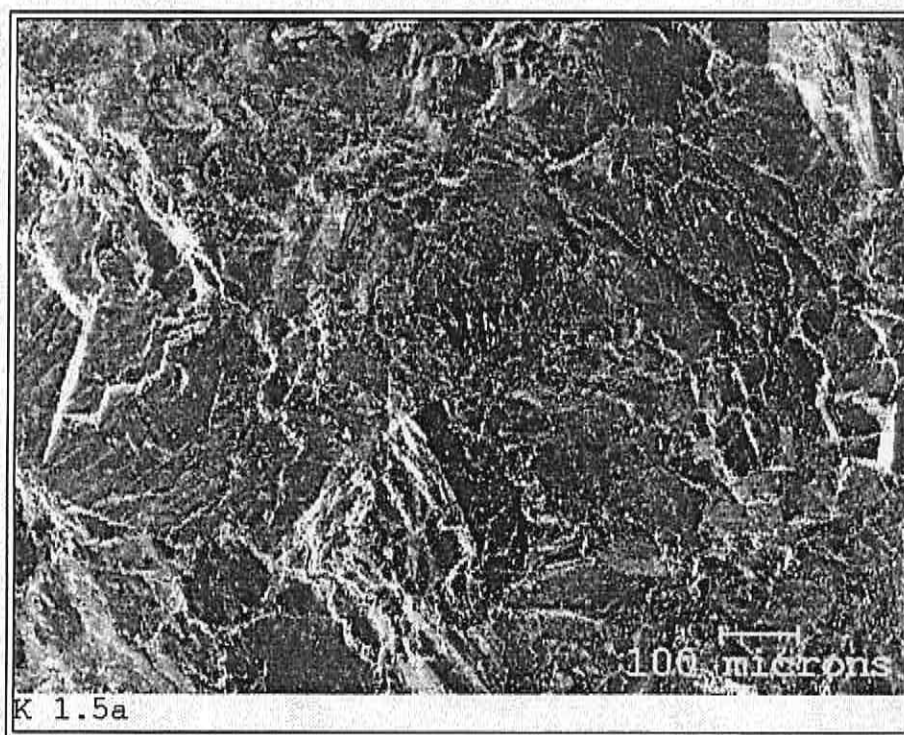
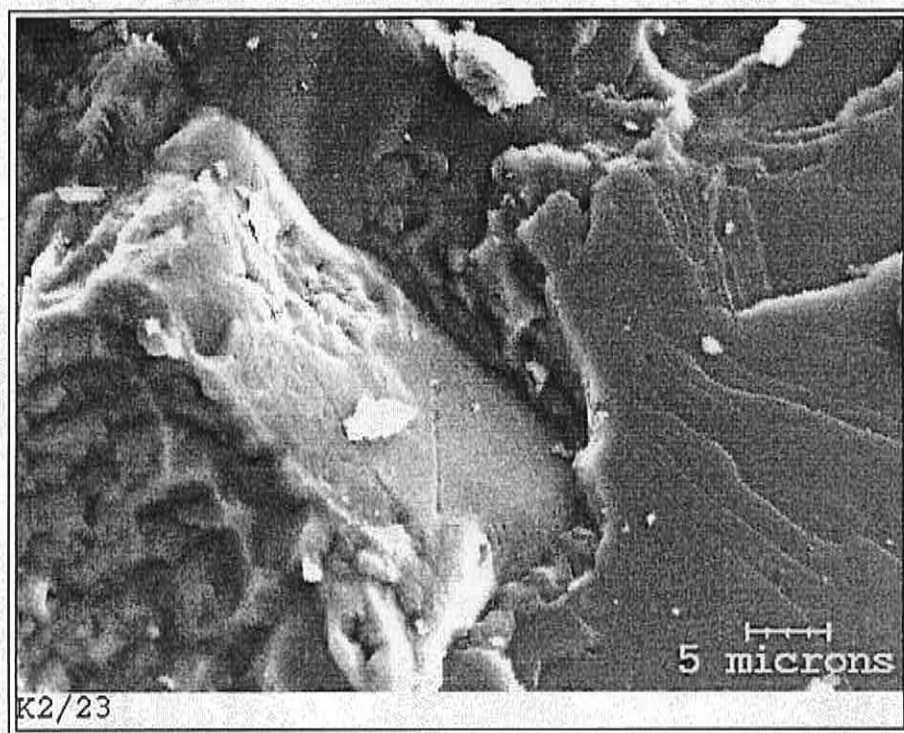
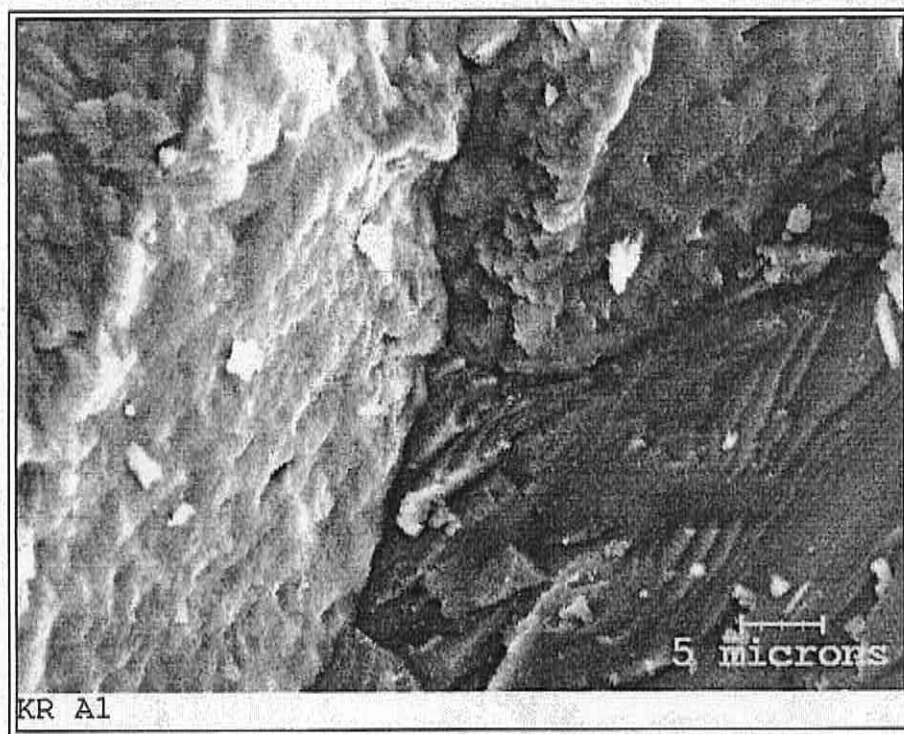
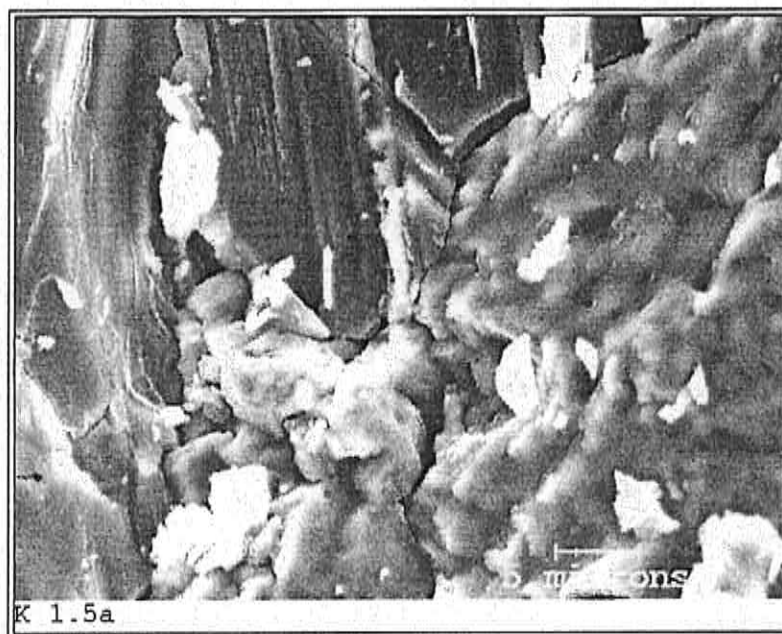
SEM-pictures of fractured surfaces of marble K, both unused and after 1 and 1.5 years on the test wall, are shown in Figs. 71-76. The grain boundaries can be seen only in some places. Thus, it is impossible to distinguish the grains from each other. Some very narrow cracks can be noticed between some of the grains. Some more and a little wider cracks were detected when the marble had been exposed to the environmental stresses on the test wall. The maximum crack width after 1.5 years on the test wall is around  $0.3\ \mu\text{m}$ .
