# VTT BUILDING AND TRANSPORT

### Developing long term durability of marble facades

#### Subproject "Test wall"

Espoo, April 20, 2001

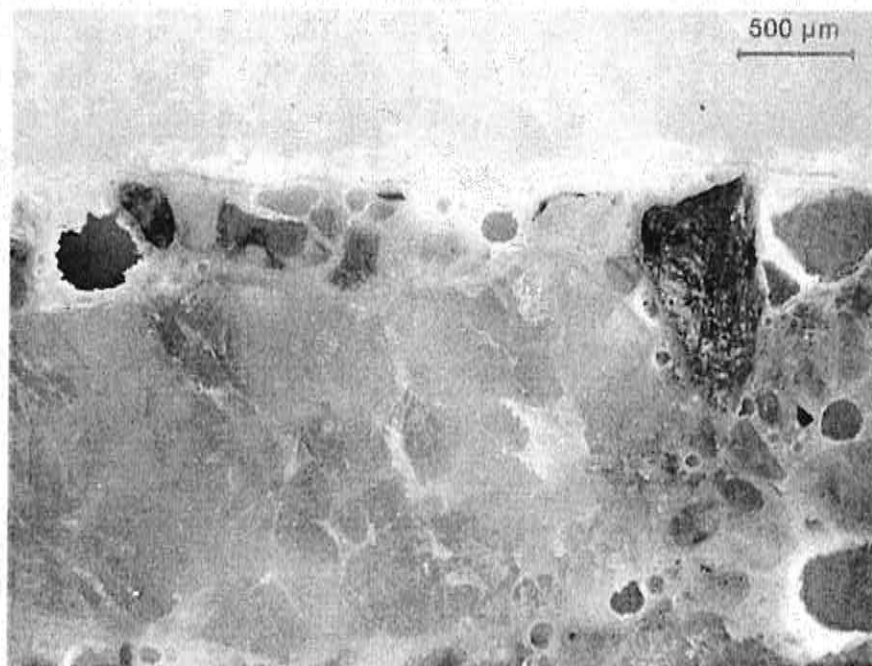
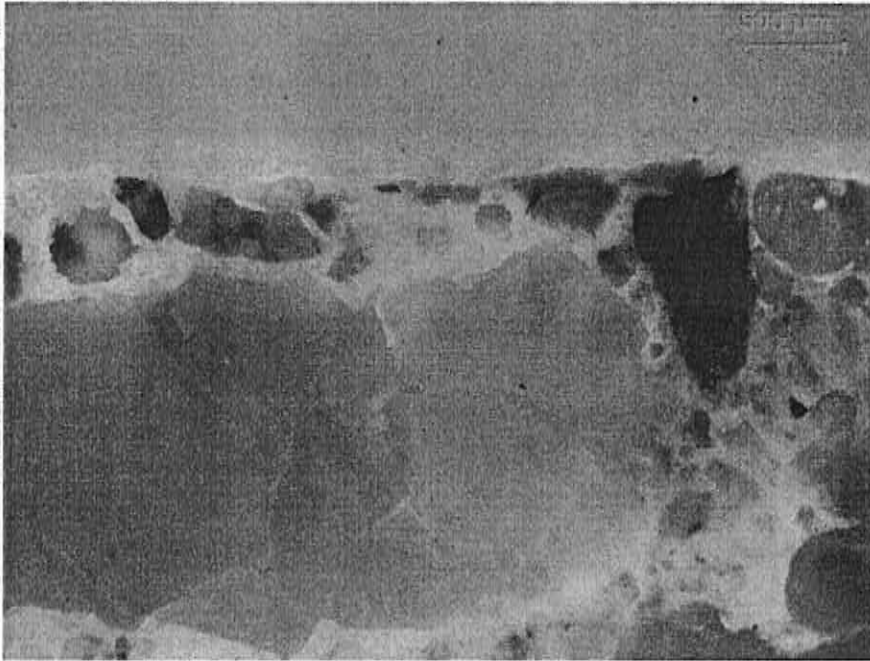
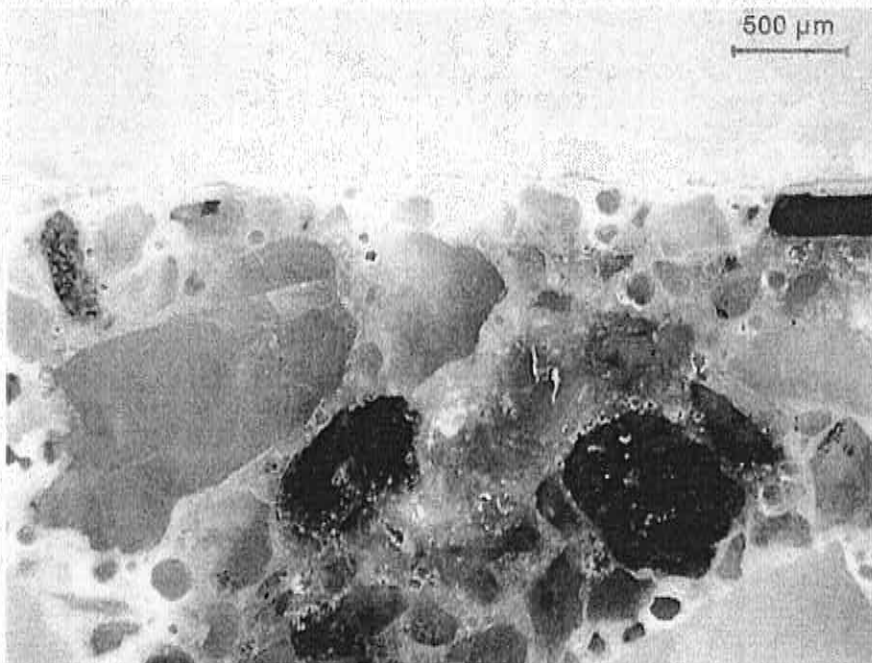
In the element type F the breaking point was usually the interface between marble and concrete. Only in a couple of cases the loosening took place, at least partly, deeper inside concrete.

Photographs of the microstructure of marble clad element F, unused and after 1.5 years on the test wall, are shown in Figs. 78-81. Following observations were made:

- contact between marble and concrete tight and cohesive
- a thin layer of third material, probably primer, between marble and concrete
- material (primer) layer rather continuous, though pores are common; thickness of the layer generally 20-30  $\mu\text{m}$ , in places even 60  $\mu\text{m}$
- in the unused element only a few very tiny cracks along the marble/concrete contact zone
- in the element stressed for 1.5 years on the test wall some slight and narrow cracking at the marble/concrete contact zone

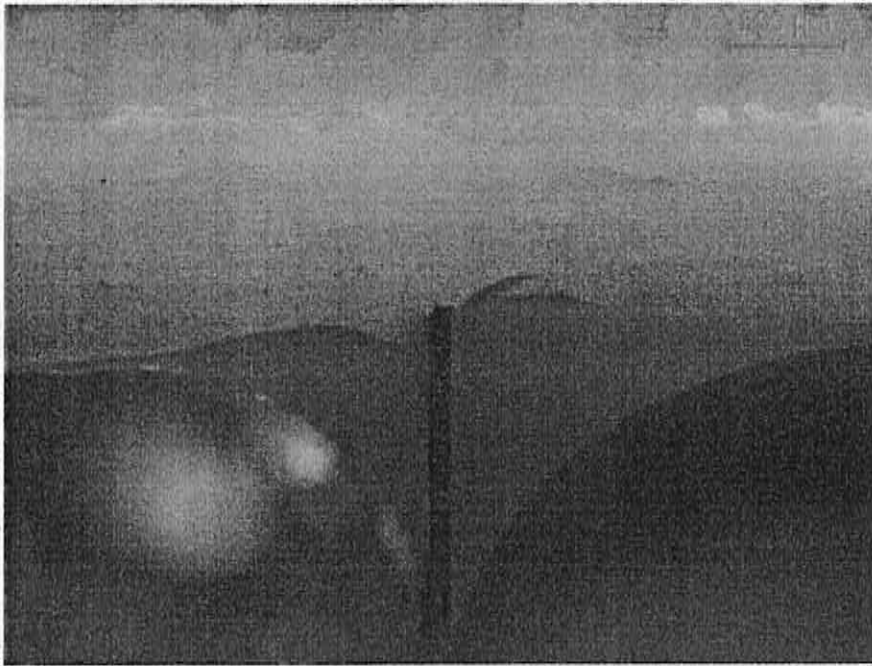
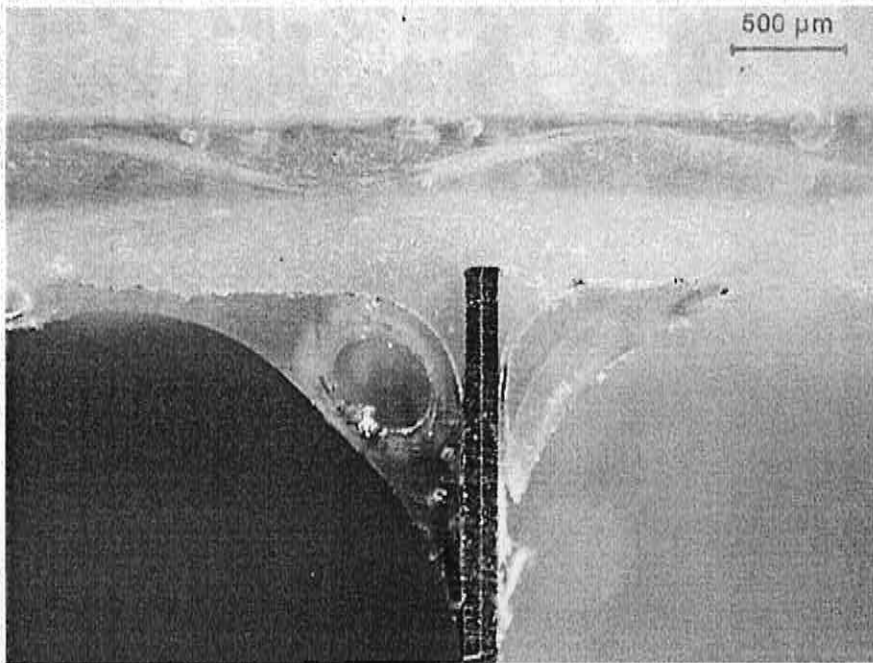
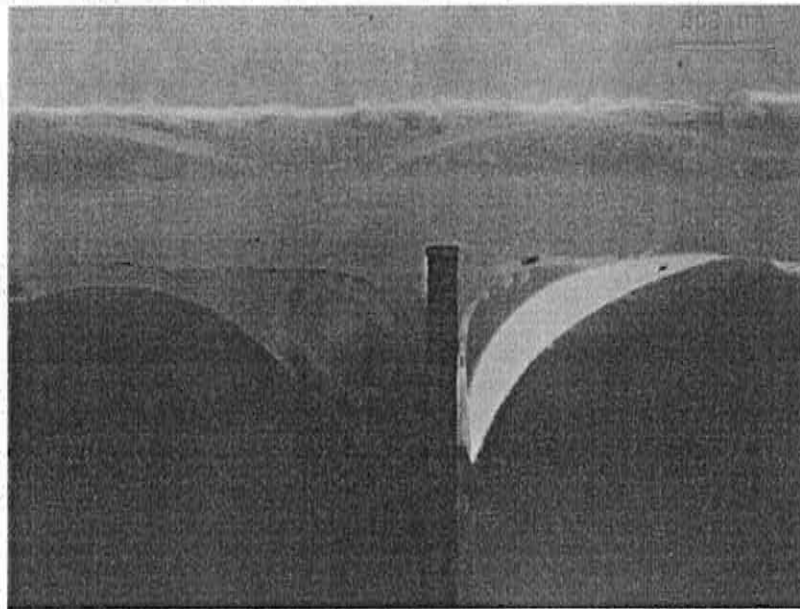
Photographs of the microstructure of marble clad element H, unused and after 1.5 years on the test wall, are shown in Figs. 82-85. Following observations were made:

- a layer of glue between marble and metal structure, thickness of the layer approximately 1 mm
- structure of the unused element partly cracked along the contact zone marble/glue
- in the unused element the upper half of the glue layer tinted yellowish
- in the element stressed for 1.5 years on the test wall the upper half of the glue layer tinted brownish
- in the element stressed for 1.5 years on the test wall open crack on about 60% of the contact zone marble/glue

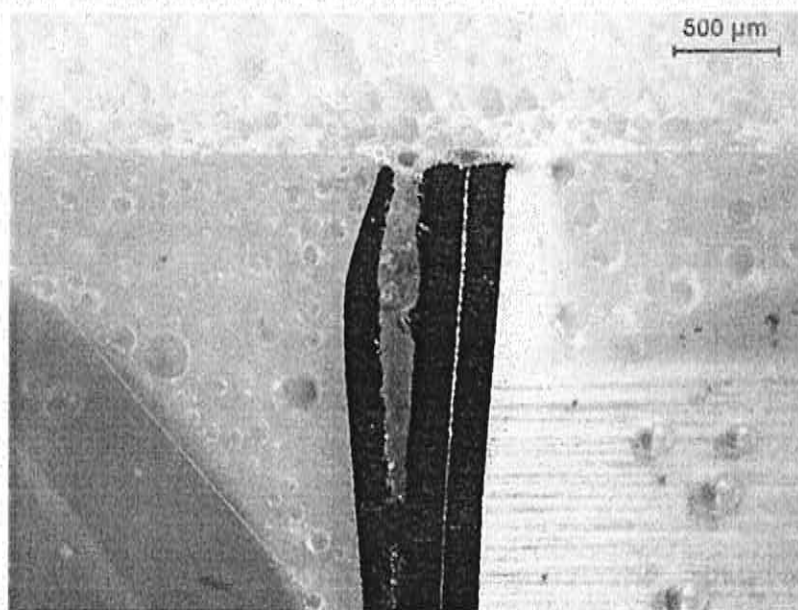
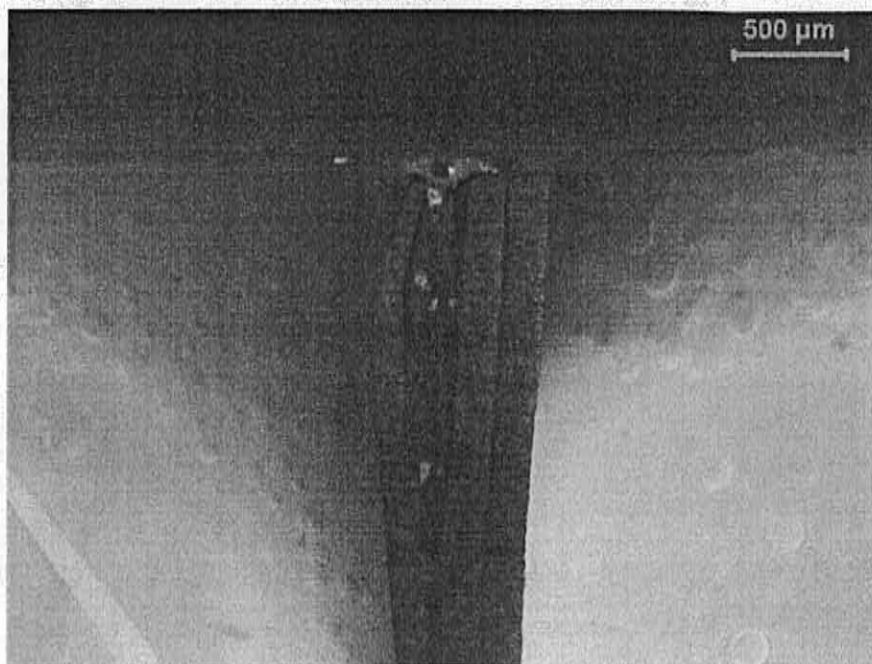
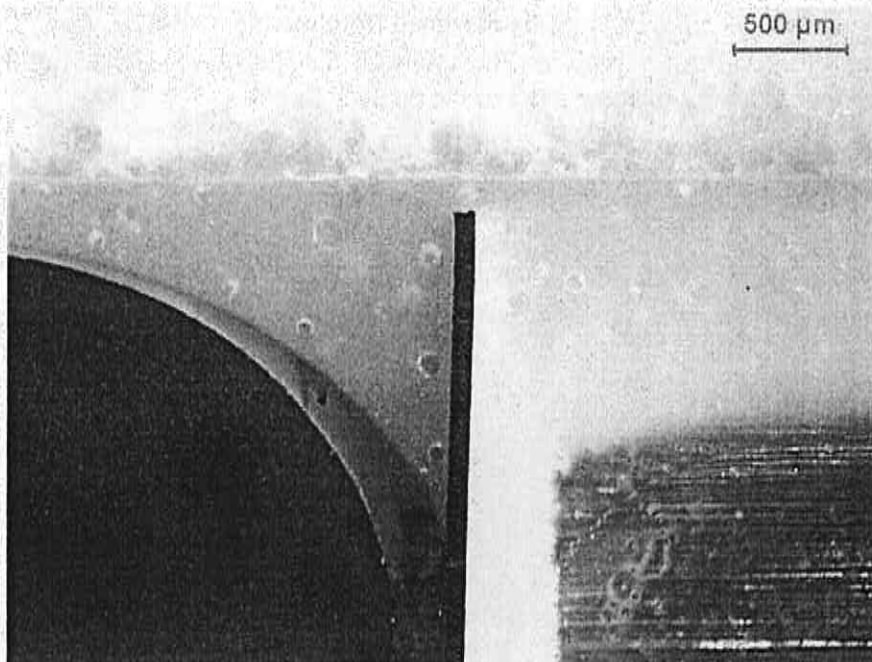
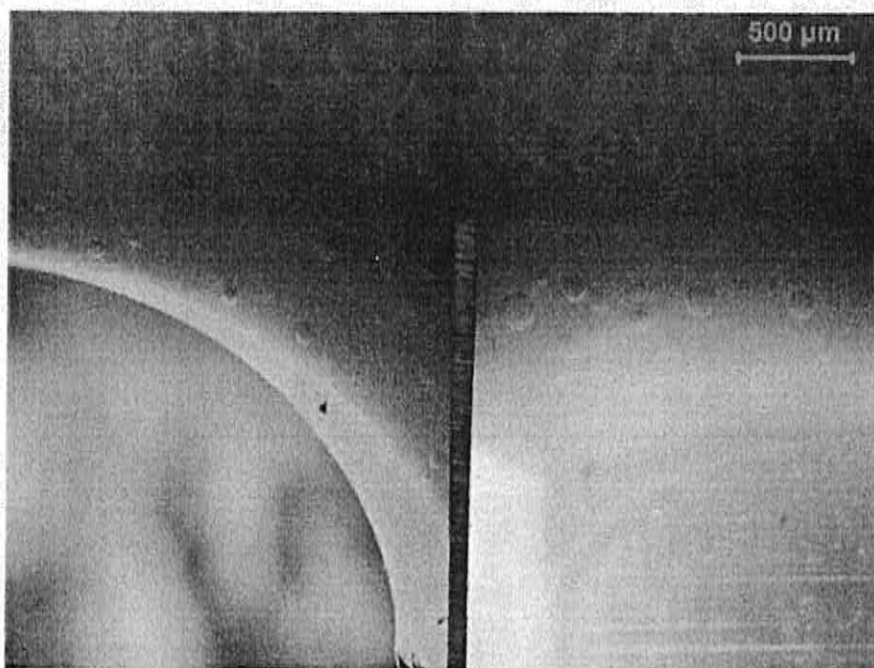
In the element type L the breaking point was always the interface between marble and the rest of the structure. Thus, the loosening of marble took place from the top of the glue layer.

Photographs of the microstructure of marble clad element L, unused and after 1.5 years on the test wall, are shown in Figs. 86-89. Following observations were made:

- a layer of glue between marble and metal structure, thickness of the layer approximately 0.5 mm
- the glue contains a lot of porosity
- in the unused element the glue layer partly detached from marble
- in the element stressed for 1.5 years on the test wall the glue layer rather tightly attached to marble, only minor cracking in some parts of the contact zone

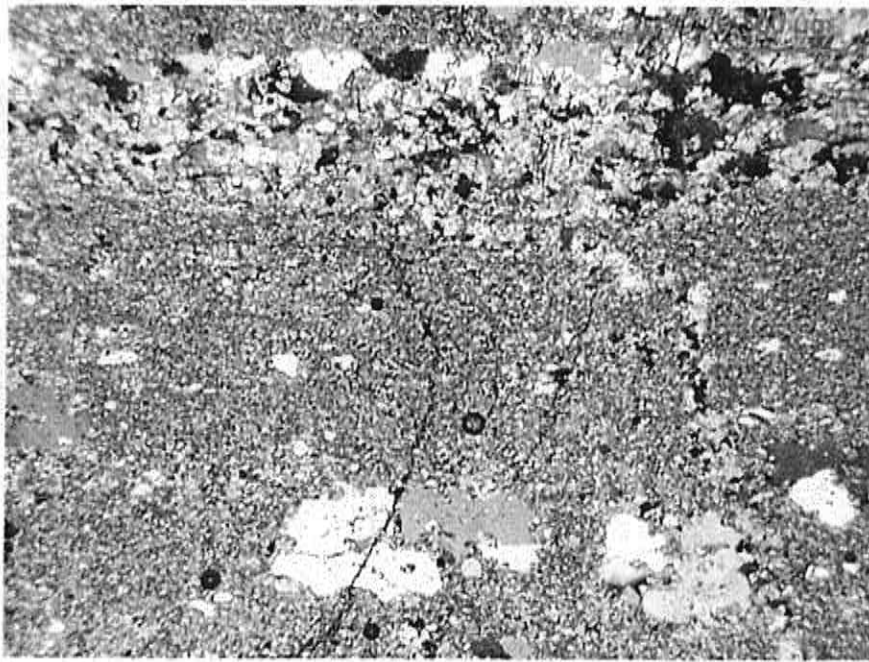
A photograph of the microstructure of dolomite from the case 3 is shown in Fig. 118. Following observations were made:

- ground mass very fine-grained, microcrystalline, dense
- clearly oriented, layered
- in places more coarse-grained veinlets with a thickness of about 1 mm, mostly oriented parallel to layering, a few also cross the layering
- some separate fine- to medium-grained quartz grains in rows, parallel to layering
- mainly carbonate rock, moderate content of quartz, other minerals include feldspar (probably plagioclase), mica (probably muscovite) and opaque minerals
- in places mica forms veinlets, partly with opaque minerals

**Figure 118.** Microstructure of dolomite from case 3. Cross-polarized light.

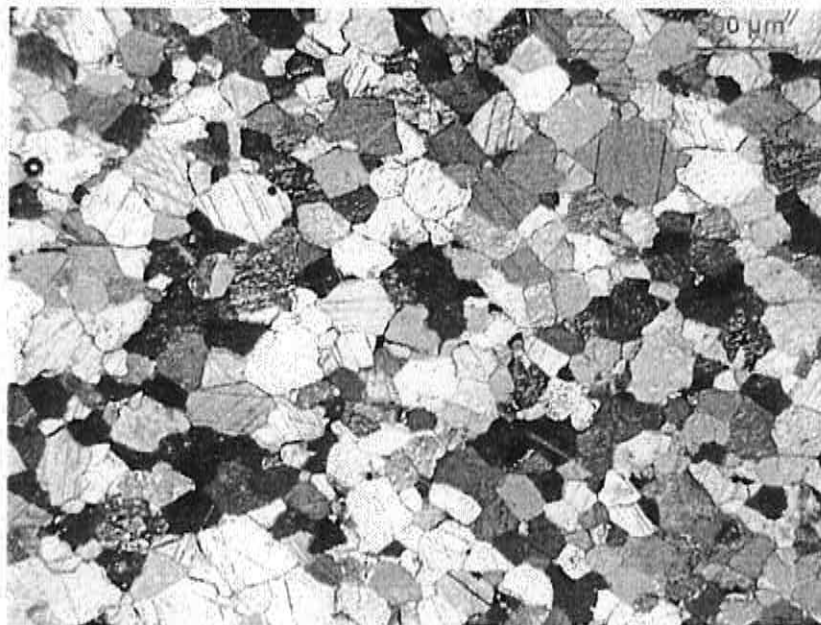
- fine-grained, fairly even-grained, slightly oriented
- average grain size 0.2-0.3 mm
- grain boundaries clear, straight, grains easily distinguished
- nearly pure carbonate rock, a little quartz and opaque minerals

**Figure 119.** Microstructure of marble from Finlandia Hall. Cross-polarized light.

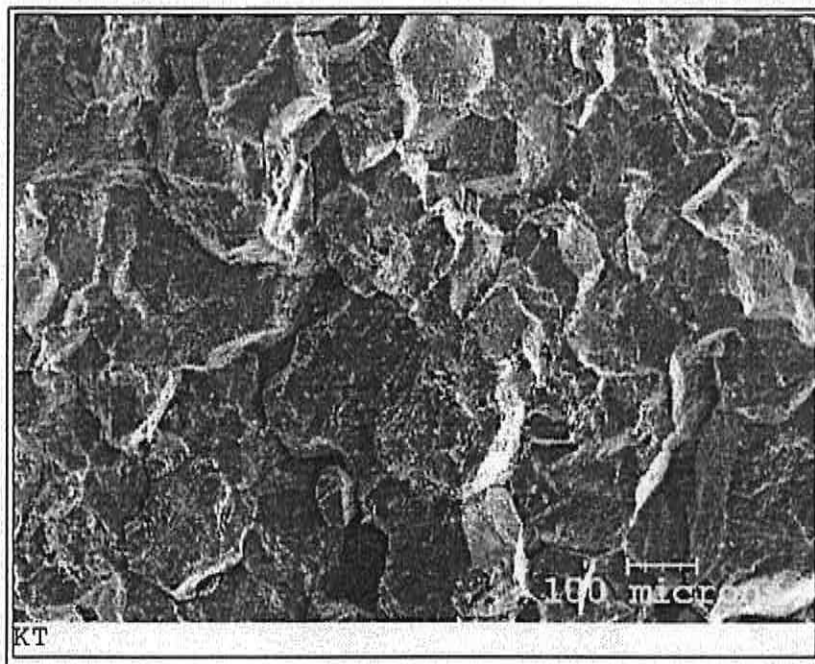
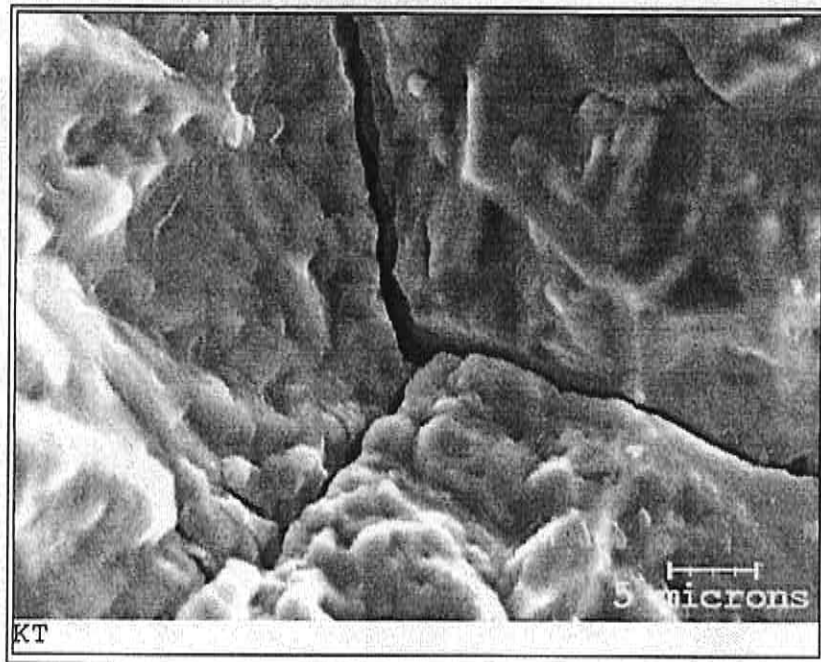
SEM-pictures of fractured surfaces of marble from the case 1 are shown in Figs. 120 and 121. The individual grains can at least for the most part be distinguished from each other. Cracks can be noticed practically between all the grains. The maximum crack width is around 2 μm. The average grain size of marble is about 200 μm.

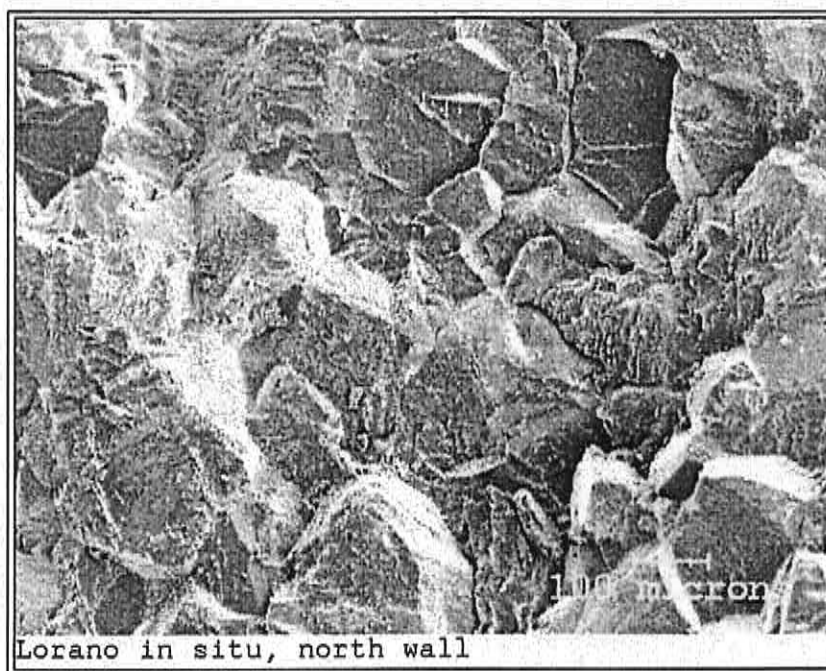
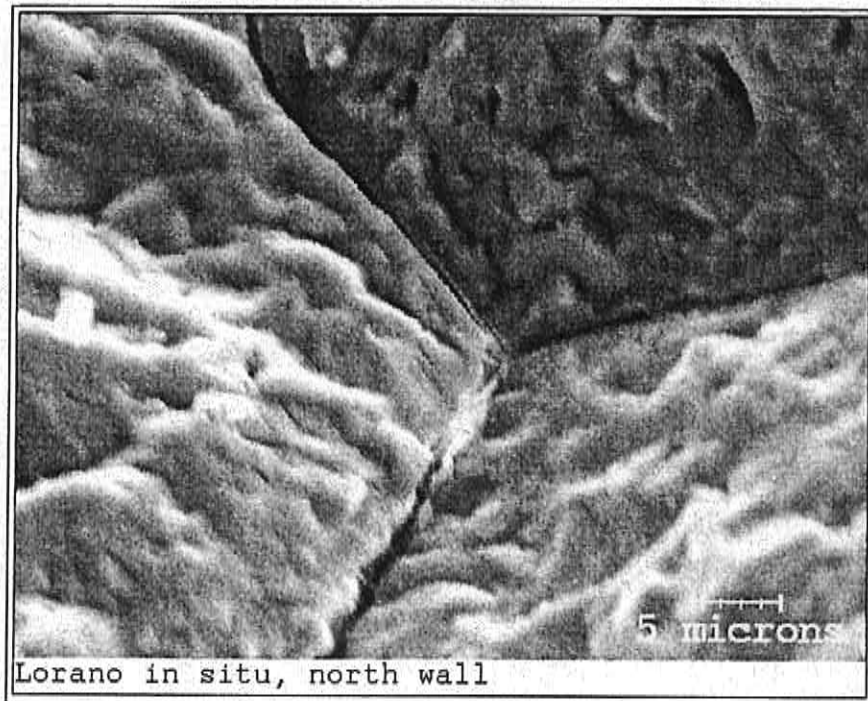
SEM-pictures of fractured surfaces of marble from Finlandia Hall are shown in Figs. 126 and 127. The individual grains can at least partly be distinguished from each other. Cracks can be noticed between some of the grains. The maximum crack width is around 0.8-0.9  $\mu\text{m}$ . The average grain size of marble is about 200  $\mu\text{m}$ .
