3.4 Research on one-side weather resistance test

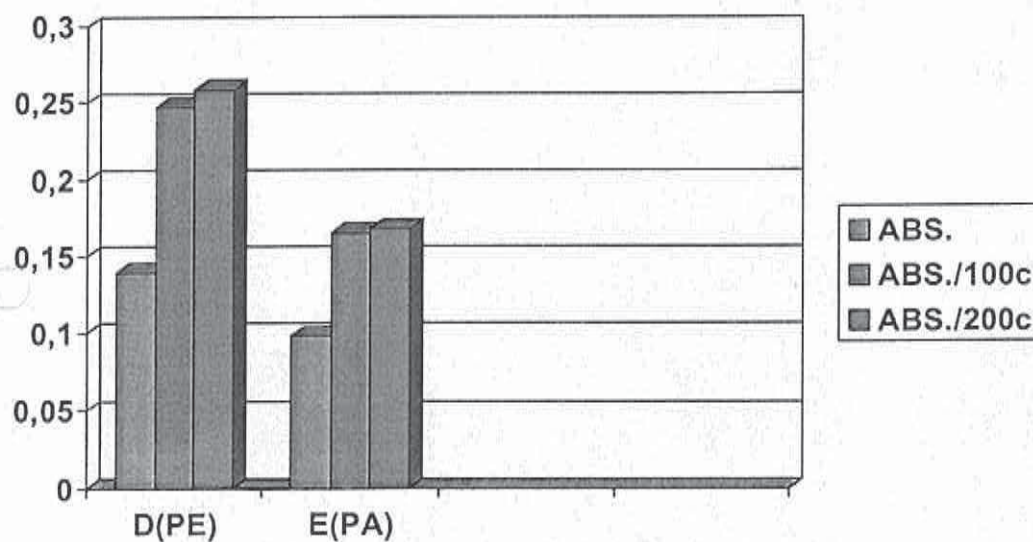
The water absorption and apparent porosity of marble type D (PE) at initial stage and after 100 and 200 cycles in the climate chamber is presented in Figures 90 and 91. A notable increase of the values could be measured after 100 cycles, but during the additional 100 cycles the values remained practically unchanged. The measurement results are shown in detail in Appendix 1.

Figure 90. Water absorption of the marbles D and E (w-%).

The water absorption and apparent porosity of both marble types increased considerably in the weather chamber. The relative increase in marble D was around 85%. The increase observed in the specimens taken from the test wall was practically the same. The relative increase in marble E was about 70%, which was considerably more than observed in the test wall specimens (9-13%). This can be due to the higher level of strains subjected to marbles in the weather chamber compared to the 18-month period on the test wall as discussed above in chapter 5.1. It is interesting, however, that the high increase in water absorption properties of marble E, which refers to crack formation in the structure, is not very extensively reflected in its strength properties. This could refer to the existence of other features in the microstructure of marble E that can compensate the weakening effect of cracking. It can be considered, however, that heavy cracking of marble forms a risk factor for durability properties in the long run.

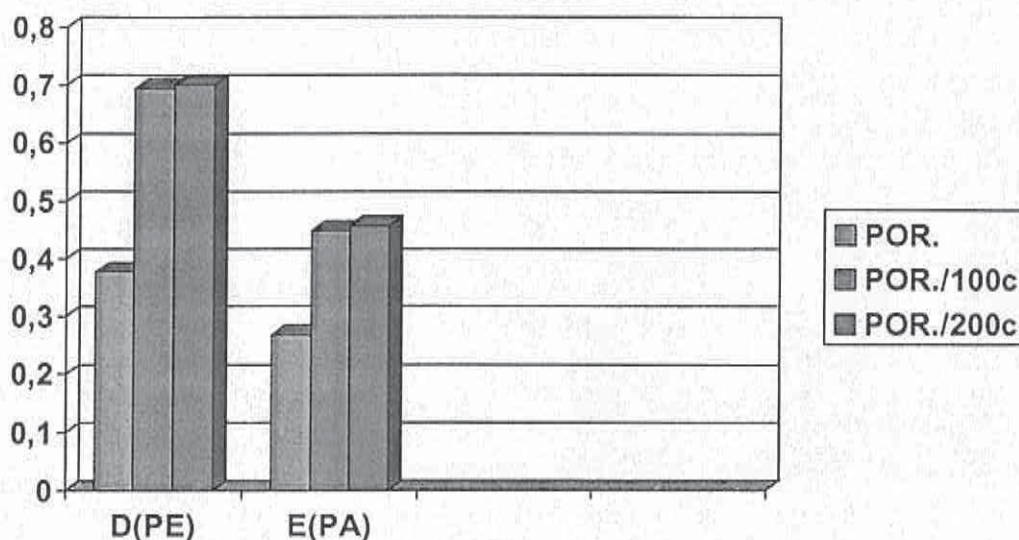
The water absorption and apparent porosity of marble type D (PE) at initial stage and after 100 and 200 cycles in the climate chamber is presented in Figures 90 and 91. A notable increase of the values could be measured after 100 cycles, but during the additional 100 cycles the values remained practically unchanged. The measurement results are shown in detail in Appendix 1.

Figure 91. Apparent porosity of the marbles D and E (vol-%).

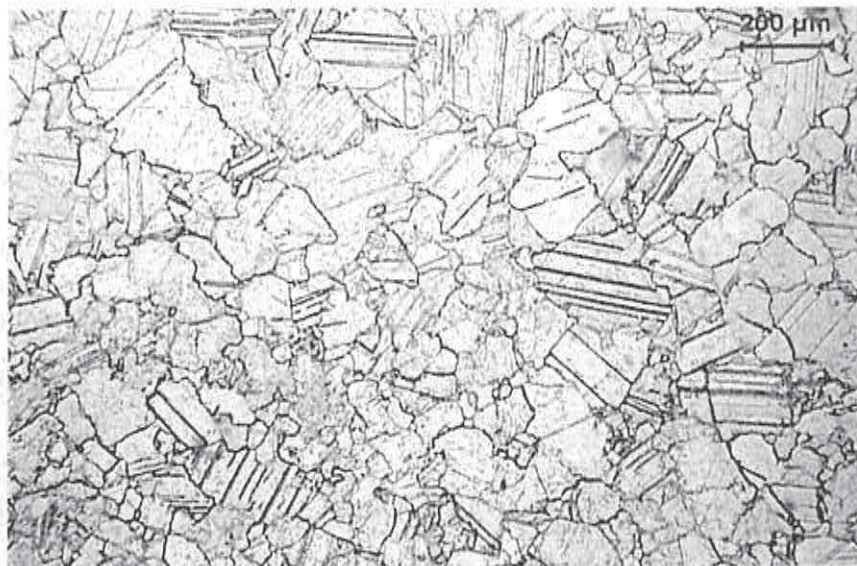
- fine-grained, not oriented
- grain size varies from microcrystalline up to 0.5 mm
- nearly pure carbonate rock, contains some quartz and opaque minerals
- some alteration of the grains
- no changes observable after 100 cycles in the climate chamber

Figure 95. Microstructure of marble E(PA). 100 cycles in the climate chamber. Plane-polarised light.

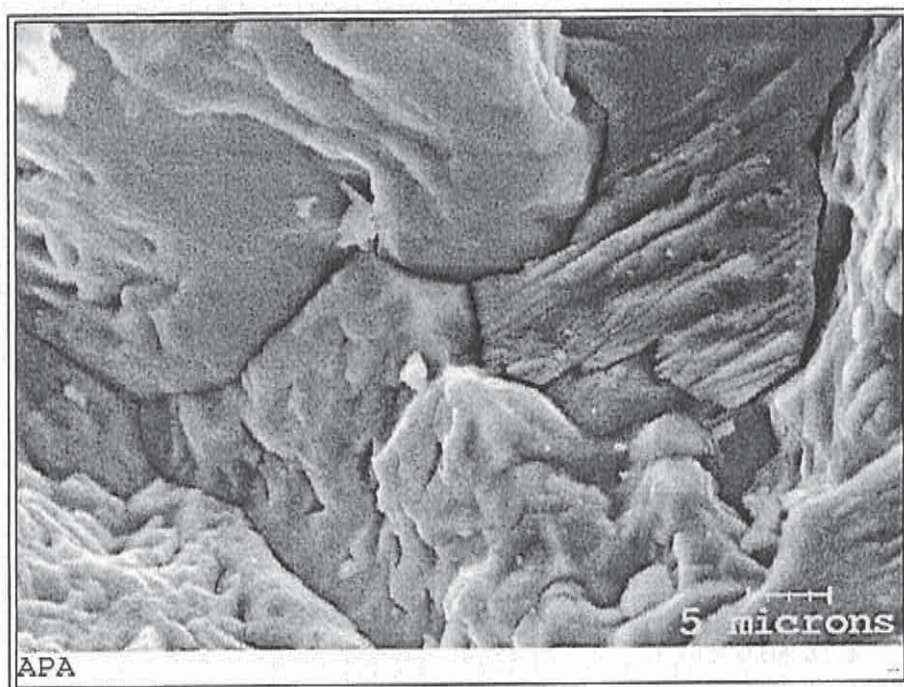
SEM-picture of fractured surface of marble E (PA) after 200 cycles in the climate chamber, is shown in Figure 98. The grain boundaries can be seen only in some places. Thus, it is impossible to distinguish the grains from each other. Some very narrow cracks can be noticed between some of the grains. Some more of these cracks exist and they become a little wider when the marble is exposed to the freeze/thaw strains in the climate chamber. The maximum crack width after cycling in the climate chamber is 0.2-0.3 μm . The xenoblastic structure of the marble can clearly be seen.

Figure 98. Marble E(PA), unused. SE-image of fractured surface, 2500x.

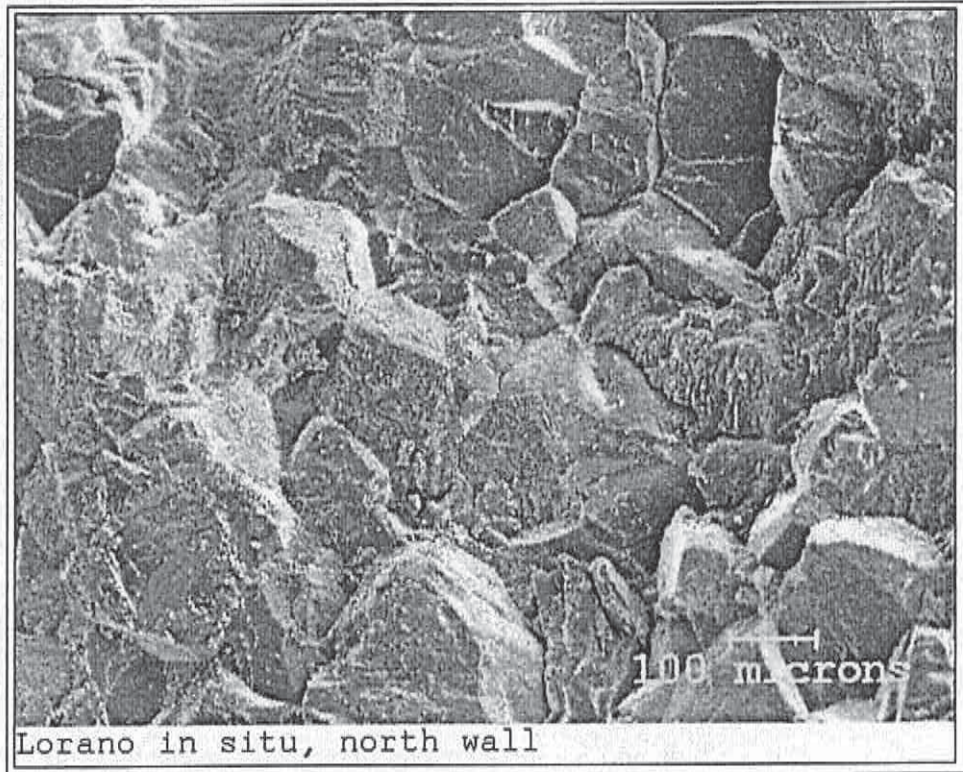
SEM-pictures of fractured surfaces of marble from Finlandia Hall is shown in Figure 111. The individual grains can at least partly be distinguished from each other. Cracks can be noticed between some of the grains. The maximum crack width is around 0.8-0.9 μm . The average grain size of the marble is about 200 μm .

Figure 111. Marble from Finlandia Hall, north wall. SE-image of fractured surface, 100x.

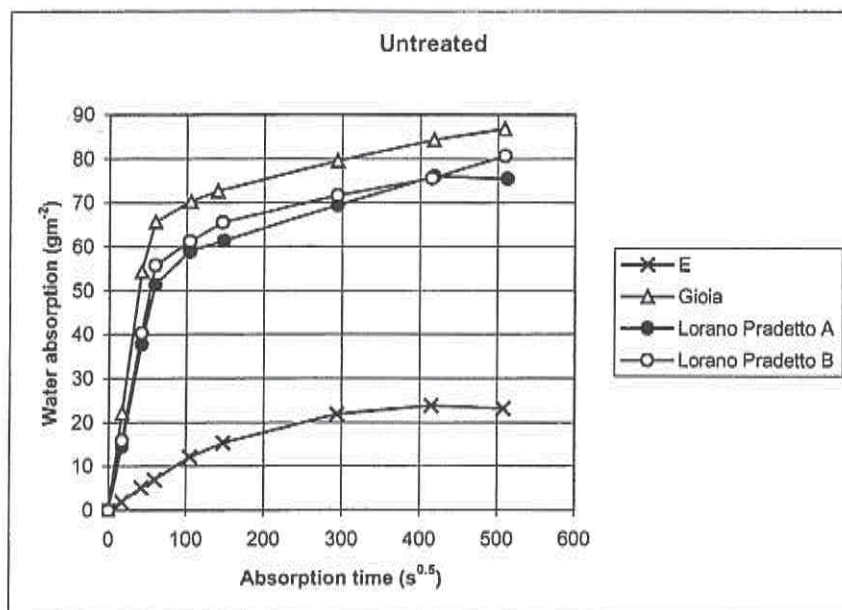
Figure 113 shows the average capillary water absorption curves of the untreated marble samples. Marble D has the highest speed and amount of capillary water absorption. Both E and APE samples have very similar behaviour despite of the different orientation of the specimens. Also the capillary absorption phase (the first linear part) and the diffusion phase (the latter linear part) are clearly distinguishable (see Hammecker et al. 1993). On the other hand E shows much slower capillary absorption and the two absorption phases are not easily distinguishable.

Figure 113. The average capillary water absorption curves of the untreated marble samples of E,D, Eand APE (N=24).

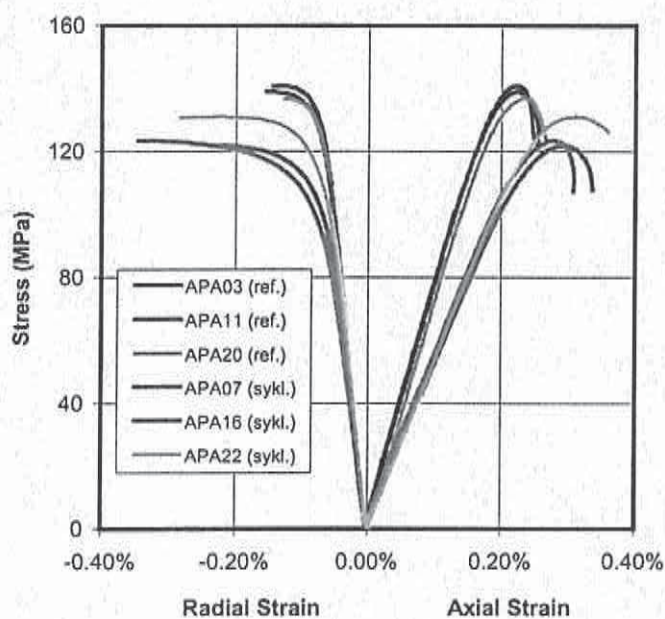
Figure 116. Uniaxial stress-strain behaviour of marble E.

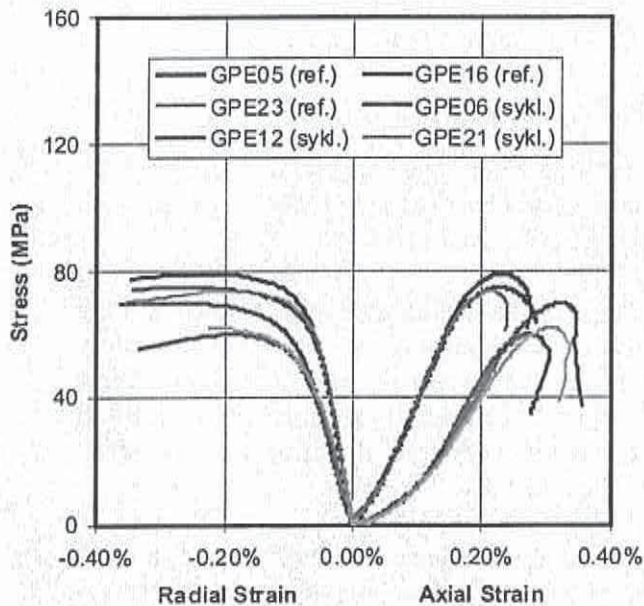
Figure 117. Uniaxial stress-strain behaviour of marble D.

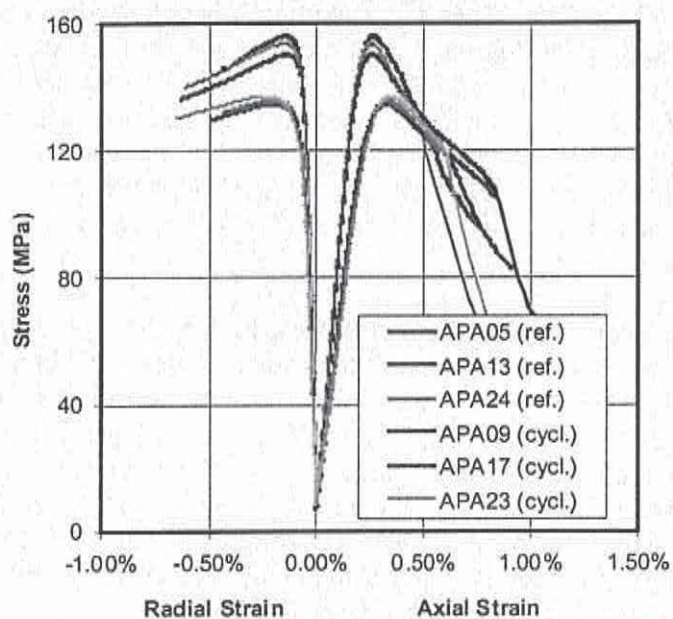
In triaxial test the differences between reference and cycled samples are smaller than in uniaxial tests.

Figure 118. Triaxial stress-strain behaviour of marble E.

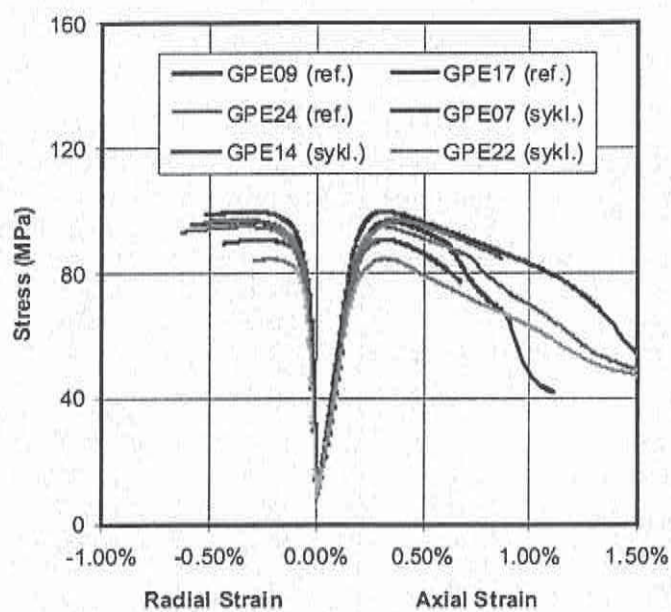
Figure 119. Triaxial stress-strain behaviour of marble D.

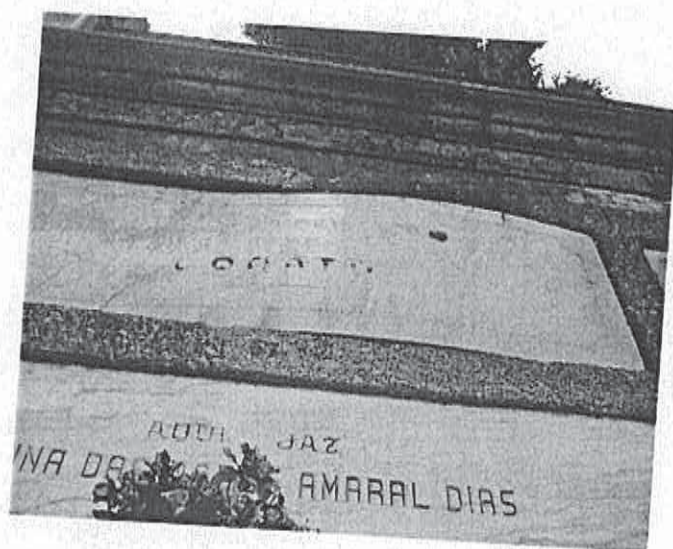
Figure 155. A gravestone in Braga (North Portugal) showing clear warping.
