2.11 Structural considerations

3 RESULTS AND DISCUSSION

3.1 Field test

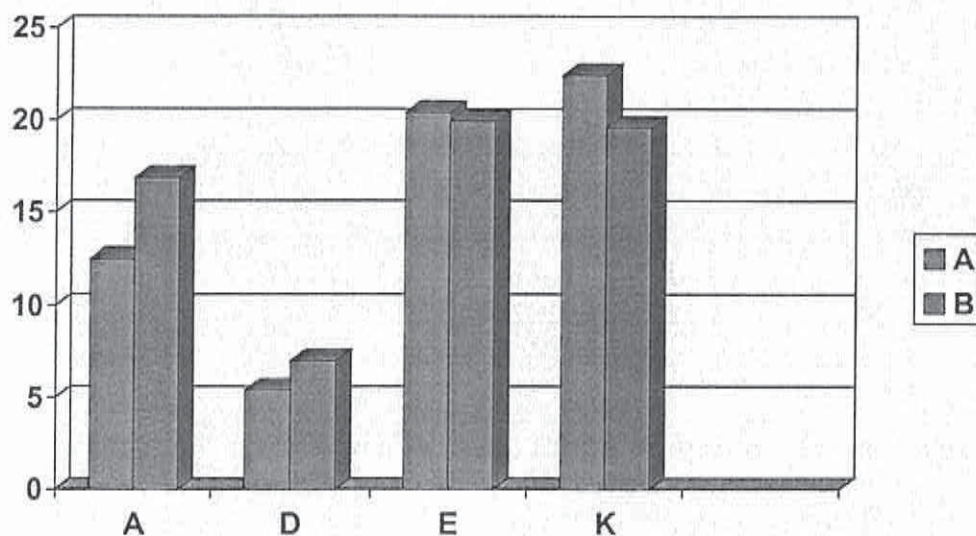
the comparison is in all cases the flexural strength of the unused marble.
Detailed measurement results are shown in Appendix 1.

Figure 31. The initial flexural strengths of the marbles (MPa).

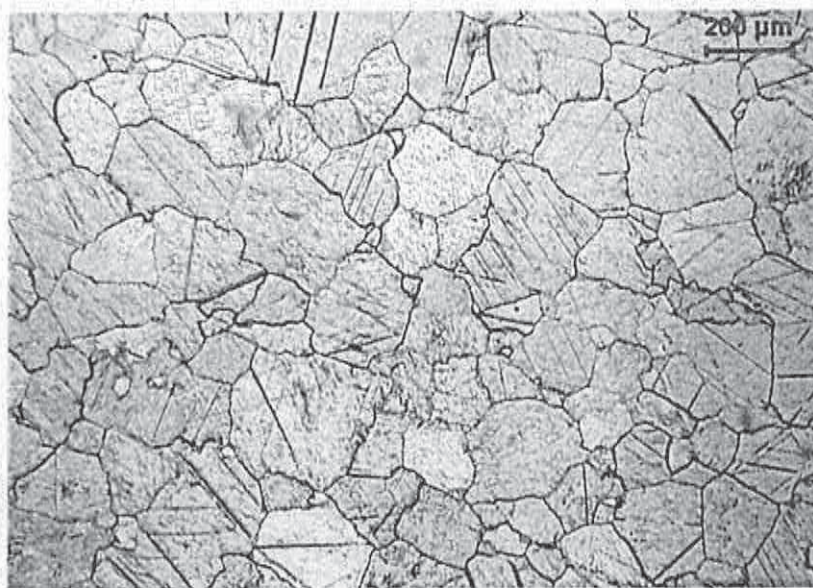
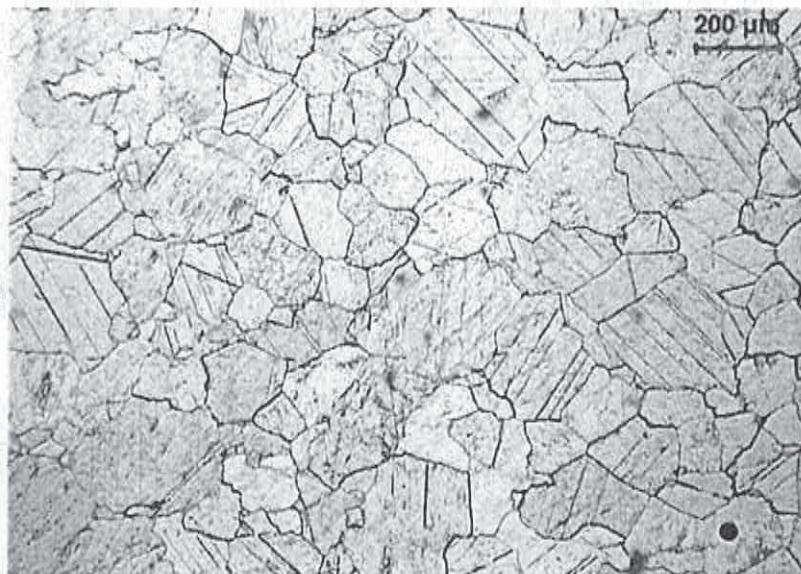
Photographs of the microstructure of marble A, unused and after 1 year on the test wall, are shown in Figs. 33-34. Following observations were made:

- groundmass fine-grained, fairly even grained, not oriented, massive
- average grain size 200-300 μm
- slightly porphyroblastic, some larger porphyroblasts (max \varnothing 6 mm) in the groundmass
- nearly pure carbonate rock, contains only very little opaque minerals
- alteration of the grains insignificant
- no changes observable after 1 year on the test wall

Figure 33. Microstructure of marble A. Unused. Plane-polarized light.

Figure 34. Microstructure of marble A. 1 year on the test wall. Plane-polarized light.

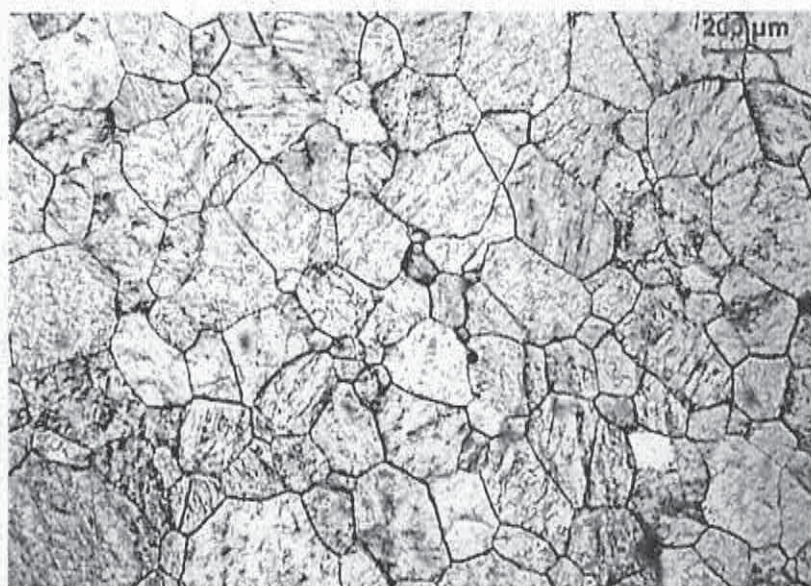
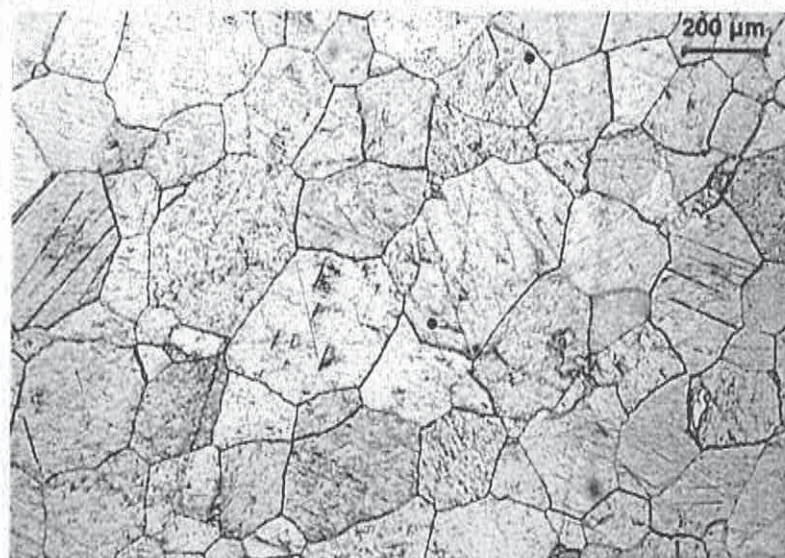
Photographs of the microstructure of marble D, unused and after 1 year on the test wall, are shown in Figs. 35-36. Following observations were made:

- fine-grained, fairly even grained, nor oriented, massive
- average grain size 200-300 μm
- nearly pure carbonate rock, contains very little mica type minerals
- some alteration of the grains
- no changes observable after 1 year on the test wall

Figure 35. Microstructure of marble D. Unused. Plane-polarized light.

Figure 36. Microstructure of marble D. 1 year on the test wall. Plane-polarized light.

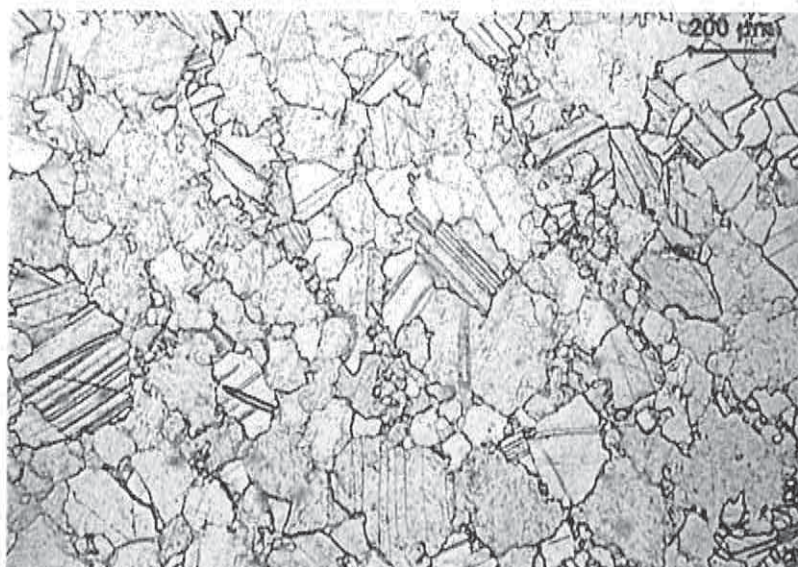
Photographs of the microstructure of marble E, unused and after 1 year on the test wall, are shown in Figs. 37-38. Following observations were made:

- fine-grained, not oriented
- grain size varies from microcrystalline up to 0.8 mm
- very fine-grained (cryptocrystalline) lenses among the groundmass, the lenses pass gradually into groundmass
- nearly pure carbonate, contains some opaque and mica type minerals
- some alteration of the grains
- no changes observable after 1 year on the test wall

Figure 37. Microstructure of marble E. Unused. Plane-polarized light.

Figure 38. Microstructure of marble E. 1 year on the test wall. Plane-polarized light.

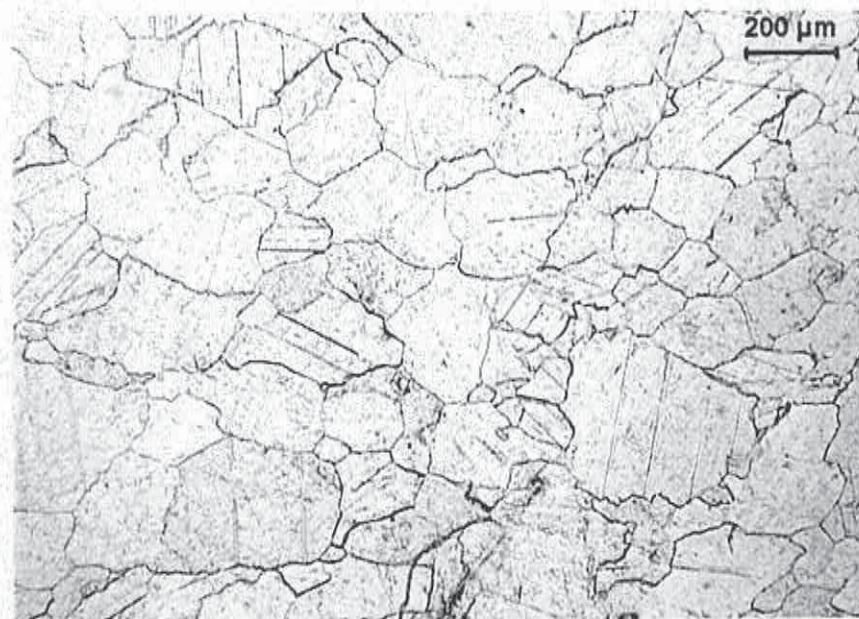
Figure 83. Microstructure of marble A protected with Prolapit. 1 year on the test wall. Plane-polarized light.
