# Dimension Stone Cladding

**Design,  
Construction,  
Evaluation,  
and Repair**

**STP 1394**

This publication, *Dimension Stone Cladding: Design, Construction, Evaluation, and Repair*, contains papers presented at the symposium of the same name held in New Orleans, Louisiana, on October 27, 1999. The symposium was sponsored by ASTM Committee C-18 on Dimension Stone. The symposium chairman was Kurt R. Hoigard of Raths, Raths & Johnson, Willowbrook, Illinois.

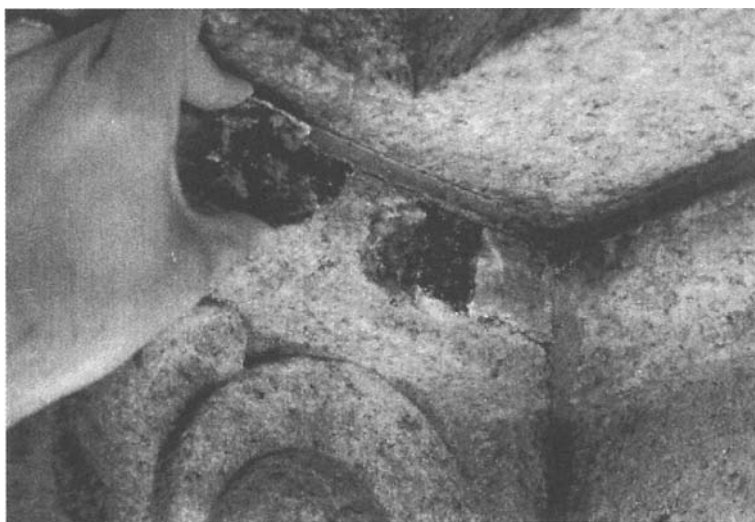
Figure 4 - *Organic growth present behind incipiently exfoliated granite*

Once stone surface has begun to exfoliate, water may collect behind the delaminated material. Plant life, an example of which is shown in Fig. 4, can also be supported by water that collects behind the incipient exfoliation. Plants can be a source for complex organic acids and can also accelerate the rate of deterioration.

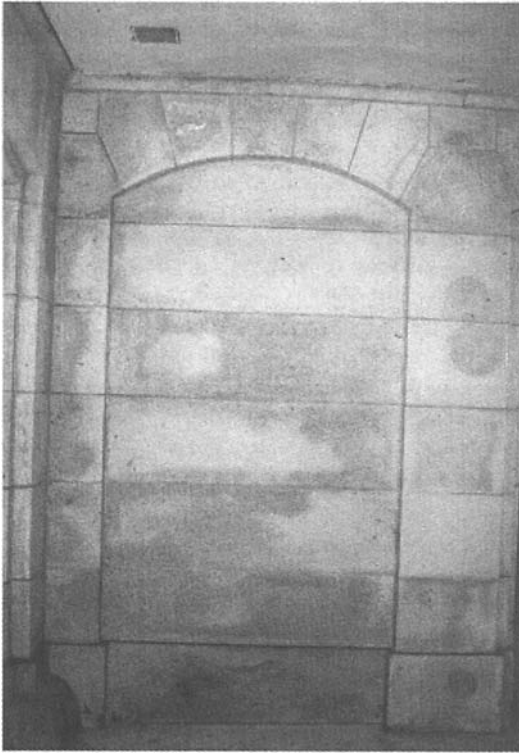
Figure 5 - *Heavily mottled granite surfaces below a landing with a history of water leakage problems*

The amount (depth) of surface deterioration varies greatly depending on the location of the stone on the building and exposure of the stone to moisture. For example, greater degrees of mottling and exfoliation were observed at areas where water can enter the stone from above, such as at parapets and watertables. Areas which are perpetually shaded exhibit higher degrees of exfoliation and surface loss, because these areas typically do not dry out completely. The most severe loss of surface is at locations subjected to water leakage from above, such as stone units situated below leaking gutters and failed waterproofing membranes, as shown in Fig. 5.

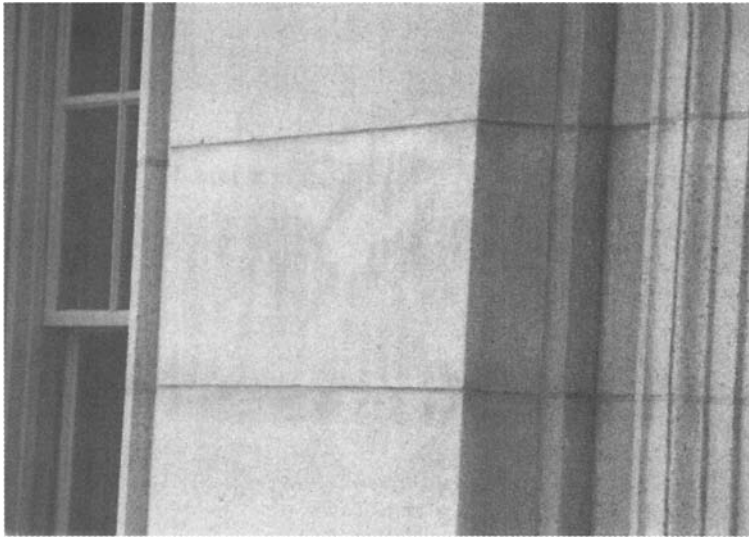
Figure 6 - *Pattern of deterioration and dirt accumulation resembles an uneven wash pattern such as would be created by cleaning with an acid soaked rag. Note how the pattern extends from stone to stone*

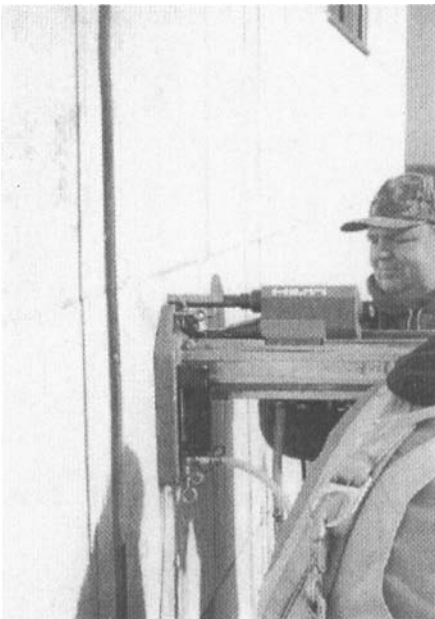
Figure 14 - *Supplemental anchor mock-up, coring countersink hole for supplemental anchor head*
