# Durability Considerations in the Design of Stone Facades

Gabriel A. Jimenez, Ph.D., P.E., Walter P. Moore, Houston, TX, gjimenez@walterpmoore.com

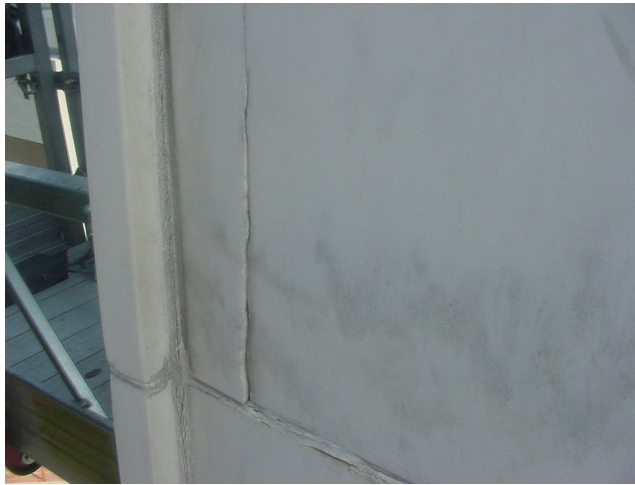
Building stones are liable to suffer from inherent natural defects which become apparent when the material in the building is exposed. Planes of weather weakness may exist along the veins in metamorphic marble stone and throughout the open texture of travertine, a sedimentary limestone. These material anomalies were less important in earlier thicker stone. With stone 50 mm or less, planes of weathering weakness can pass through the entire thickness; and if the building is located where freeze-thaw cycles occur, the stone pieces can separate. Photograph 1 is representative of this type of defect.

PHOTO 1- FISSURE IN STONE VENEER

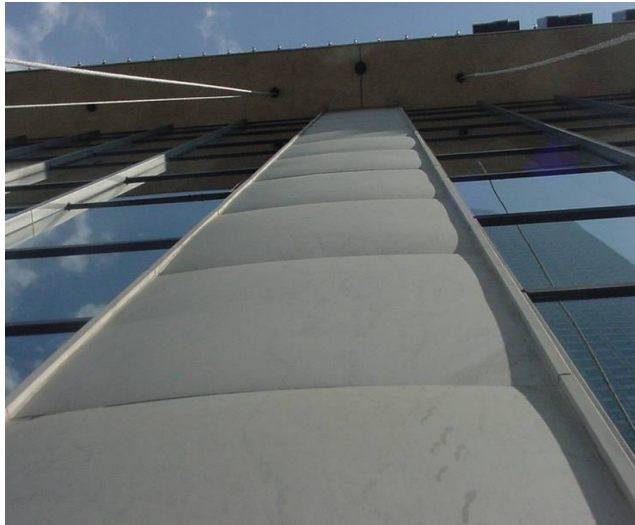
Bowing of thin marble can occur as shown in Photograph 2. This is caused by a permanent hysteresis growth in the stone due to a differential temperature or moisture change throughout its thickness. Generally convexed outward, the phenomenon can be concaved inward depending on boundary and gradient conditions.

PHOTO 2 - MARBLE BOWING DUE TO HYSTERESIS

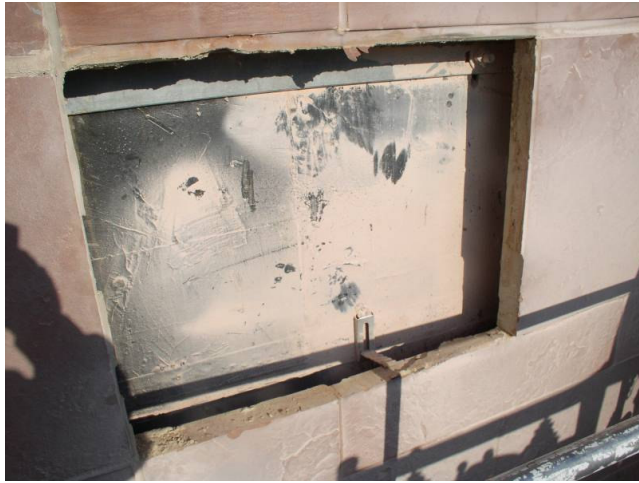
Photograph 3 shows a wall system where some of the anchors were missing.

PHOTO 3 - MISSING ANCHORS

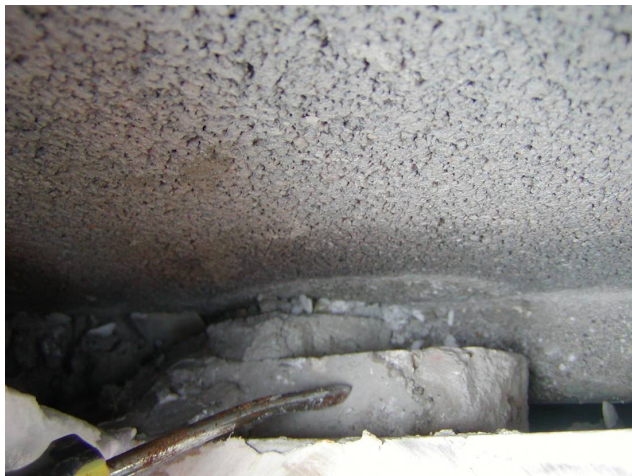
sometimes used in stone connections at kerfs at the top of stone panels to eliminate pockets in the kerfs where water can enter and freeze. Gypsum based mortar when coming into contact with moisture tends to expand and can cause cracks and fractures to develop in the stone at the connection kerfs. In addition, the material can disintegrate making the connection unstable and vulnerable for additional decay. Refer to Photograph 5.

PHOTO 5 - DISINTEGRATION OF GYPSUM (MORTAR) BETWEEN STONE AND BACKUP WALL.

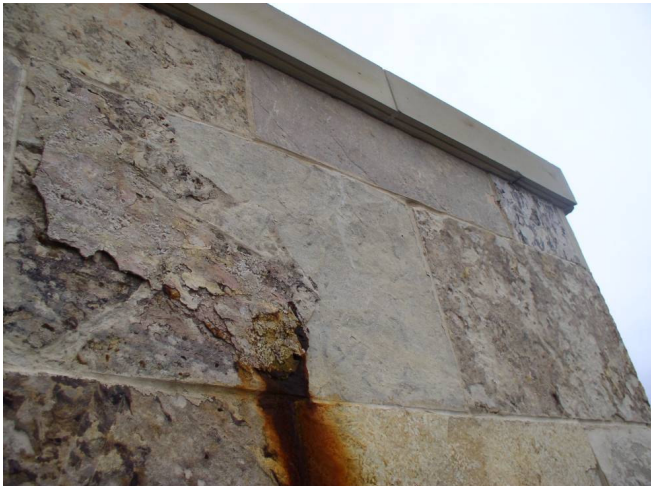
materials could alter feldspar minerals in granite at a much slower rate (25 to 100 years). Oxidation occurs when the oxygen assisted by moisture combines with iron-bearing minerals. Refer to Photograph 6.

PHOTO 6 - STONE DETERIORATION DUE TO MINERAL DEPOSITS WITHIN THE STONE

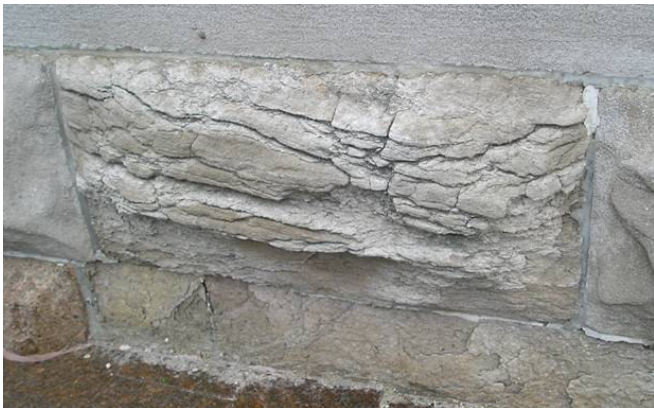
Deterioration of natural stone due to frost action, commonly referred to as freeze/thaw cycles, occur when water within the pore structure or cracks freezes to ice. It has been estimated that when water freezes it expands approximately 10%. The expansion force created by the freezing action combined with repeated freeze/thaw cycles produces micro-fissures, cracks, flaking and spalling. Refer to Photograph 7.

PHOTO 7 - FREEZE-THAW DAMAGE EXACERBATED WITH THE USE OF DE-ICING PRODUCTS
