# **12<sup>th</sup> International Congress on the Deterioration and Conservation of Stone**

# MASS BALANCE EVIDENCE FOR HYDROCHLORIC ACID VAPOR ATTACK ON THE MARBLE OF THE STATUE OF PHOENICIA BY SEA SALT DECHLORINIZATION

# MONITORING FROST SUSCEPTIBILITY OF LIMESTONE FACIES

# FABRIC INFLUENCES ON MICROCRACK DEGRADATION OF MARBLES

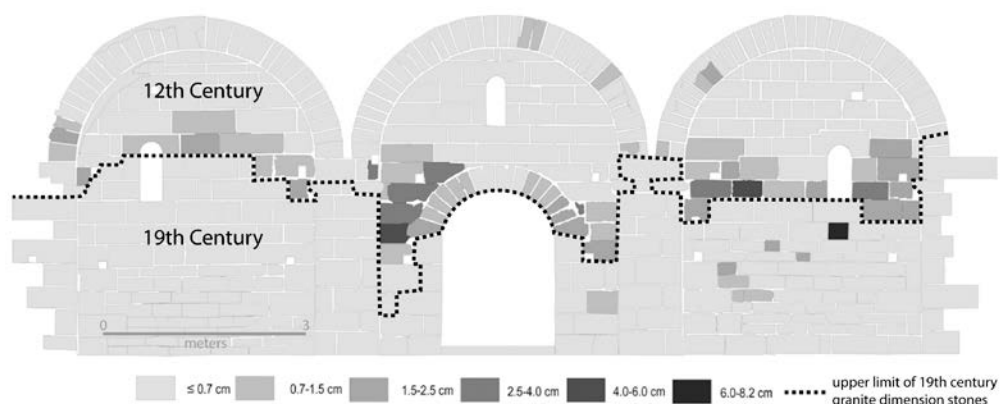
proceeded very fast (0.2 mm per year on average and up to almost 1 mm per year). By contrast, most of the same historic gneissic stones located higher on the wall, which have been exposed for almost nine centuries to the atmospheric attacks but have not been impacted by the 19<sup>th</sup> c. restoration, still display their medieval ‘fishbone finish’: the overall decay has affected less than 2 mm, with resulting stone recession rates lower than 0.002 mm per year.

**Figure 5.** Accelerated stone recession just above the underpinned part of the arches based on 3D-modeling of stone decay by laser scanning. © Olivier Voldoire / Franck Vautier
