RESEARCH REPORT

Developing long term durability of marble facades

Subproject "Test wall"

Espoo, April 20, 2001

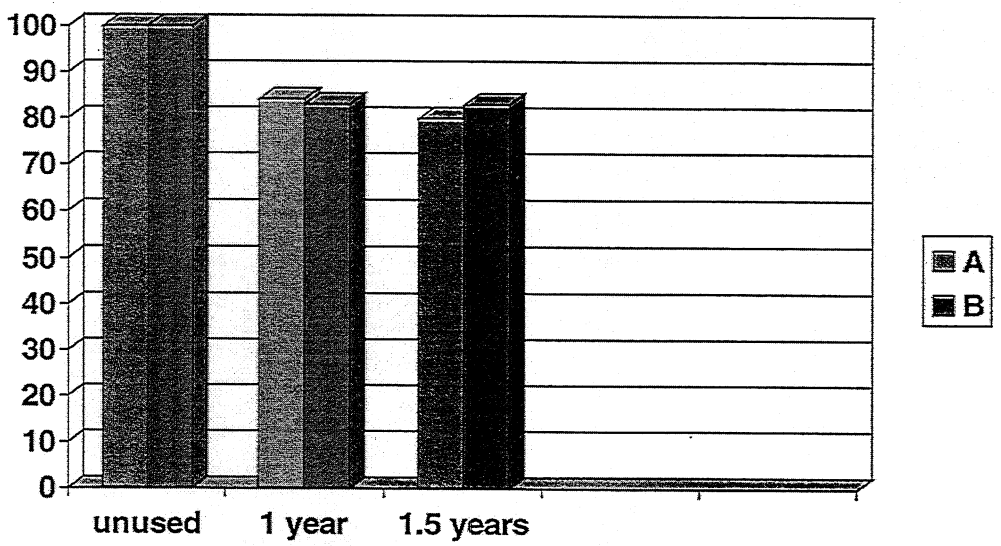
The loss of marble strength on the test wall is illustrated also in Figs. 3-6. In each case the flexural strength of unused marble has been given the value of 100.

Figure 3. Flexural strength of marble A. A relative scale.

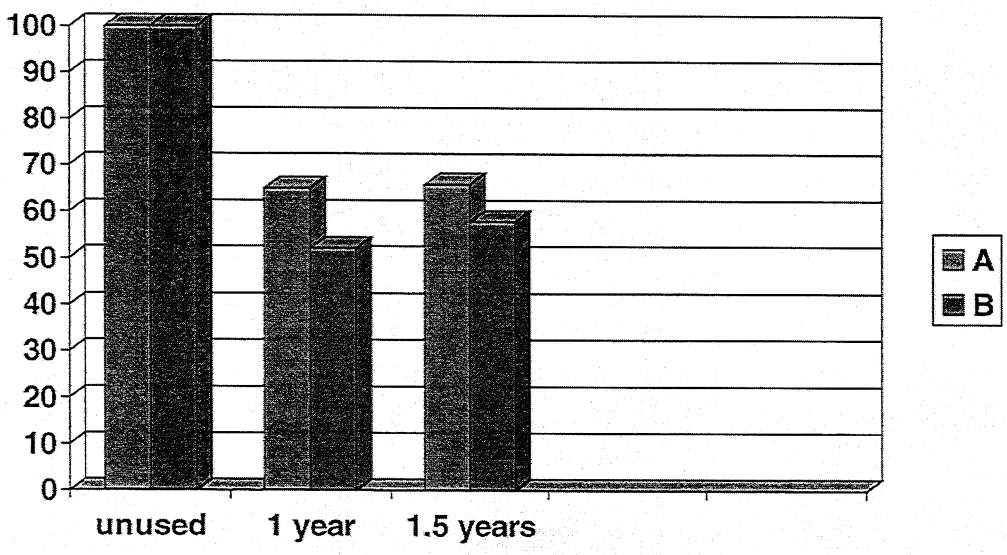
Figure 4. Flexural strength of marble D. A relative scale.

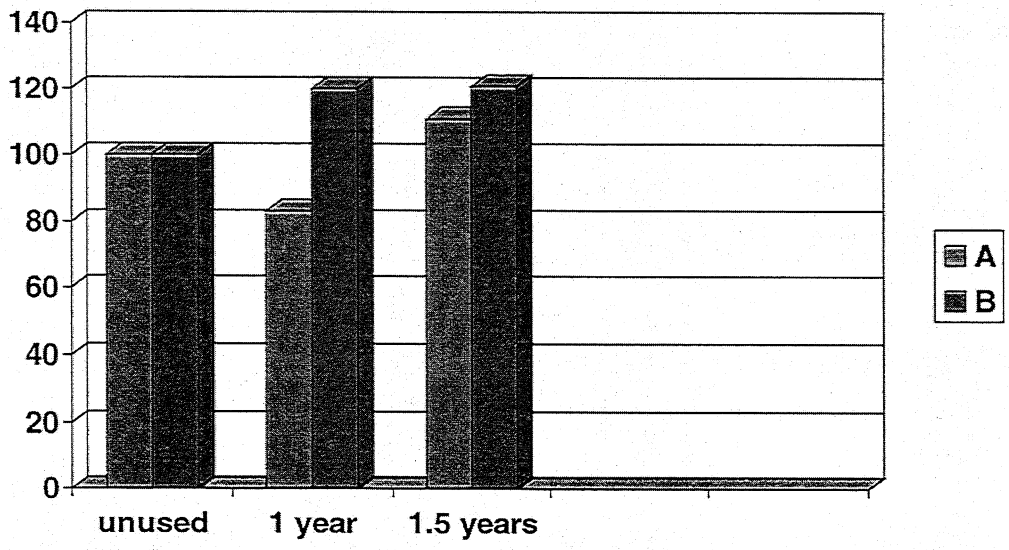
Figure 5. Flexural strength of marble E. A relative scale.

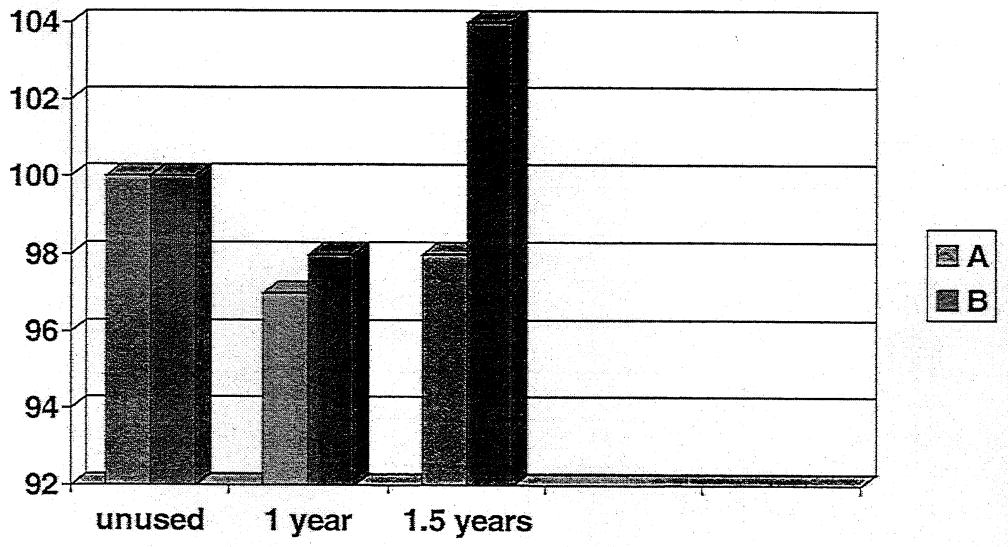
Figure 6. Flexural strength of marble K. A relative scale.

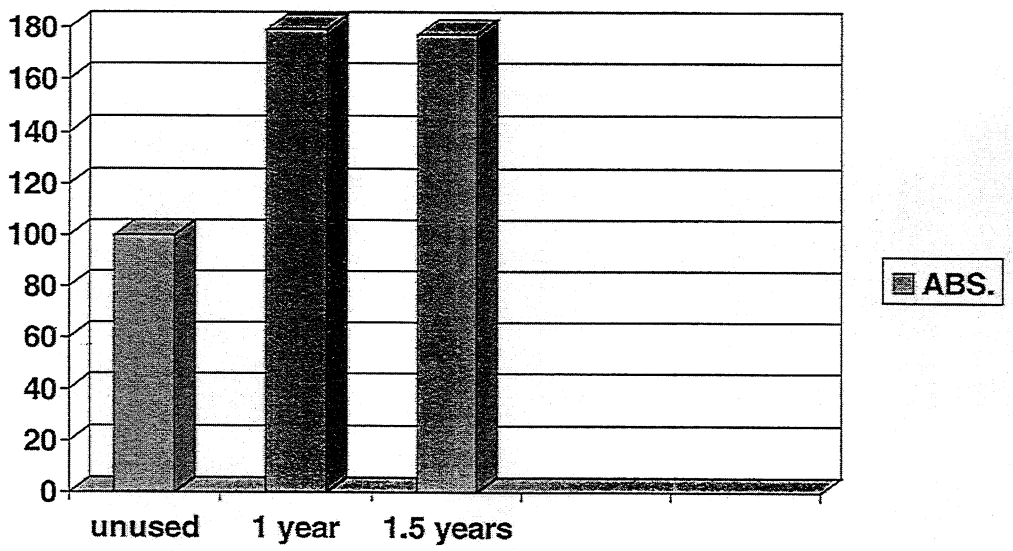
The increase of water absorption and porosity on the test wall is illustrated also in Figs. 9-12. In each case the water absorption (porosity) of unused marble has been given the value of 100.

Figure 9. Water absorption (porosity) of marble A. A relative scale.

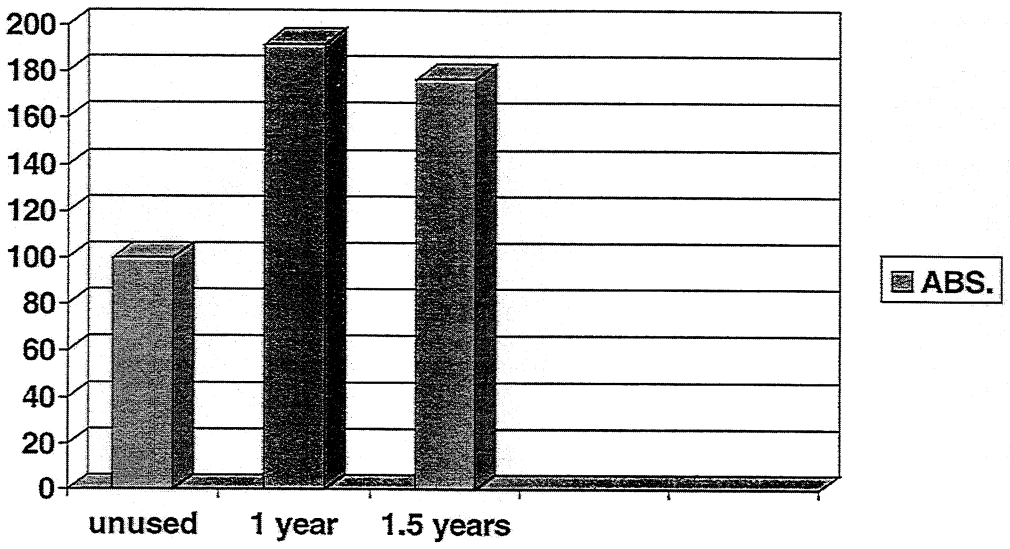
Figure 10. Water absorption (porosity) of marble D. A relative scale.

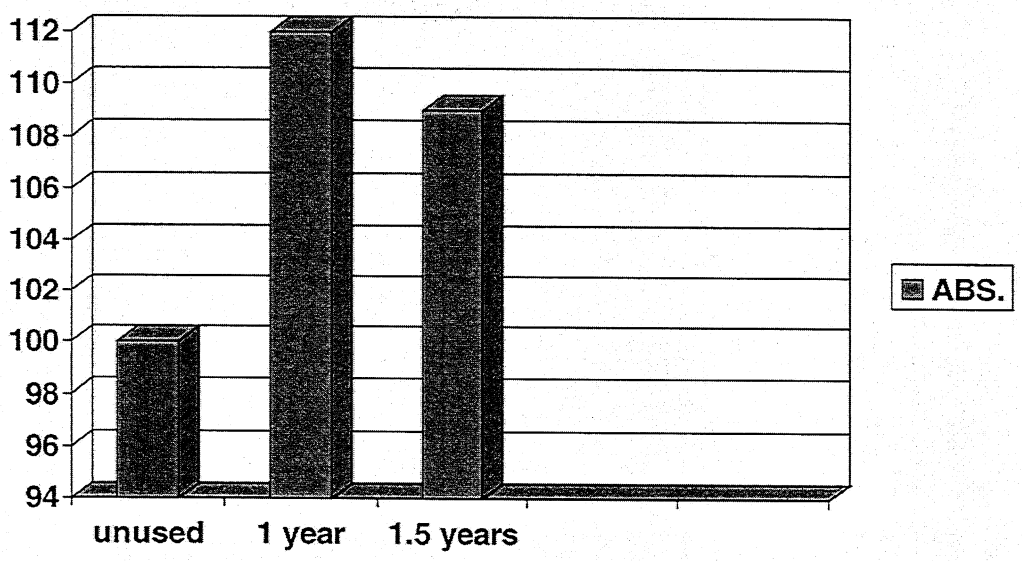
Figure 11. Water absorption (porosity) of marble E. A relative scale.

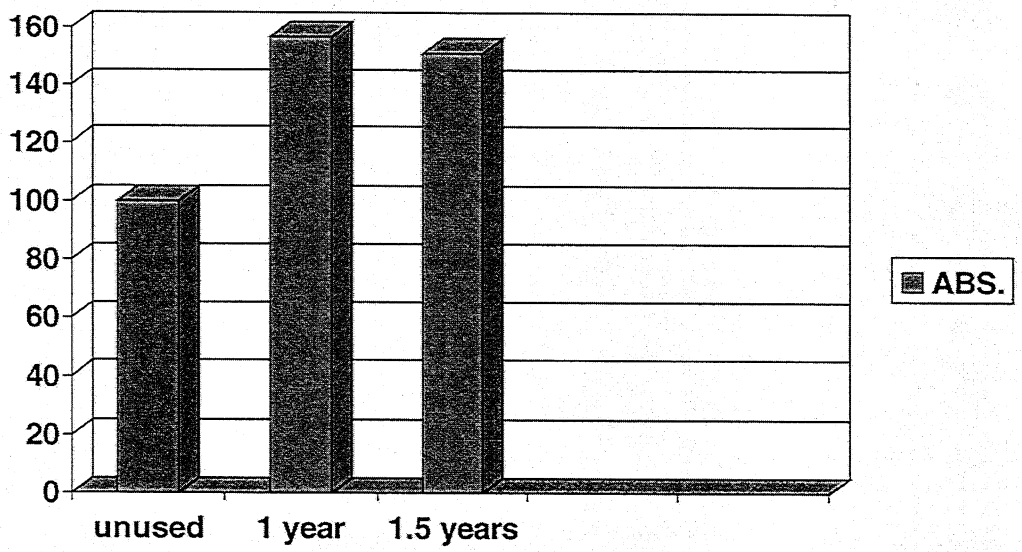
Figure 12. Water absorption (porosity) of marble K. A relative scale.

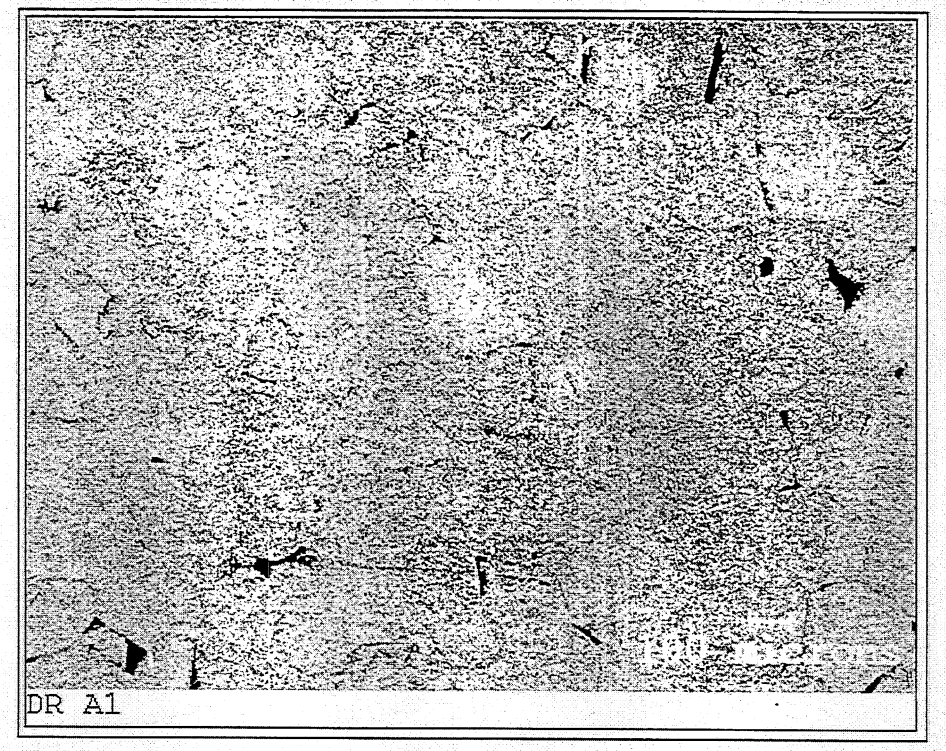
BSE- and SE-images of marble D, both unused and after 1 year on the test wall, are shown in Figs. 41-44. Grain boundaries can clearly be distinguished. Stresses caused by 1 year on the test wall seemed to affect the structure of the marble in such a way that the grain boundaries could be distinguished even more easily.

Figure 42. Marble D, 1 year on the test wall. BSE-image, 50x.

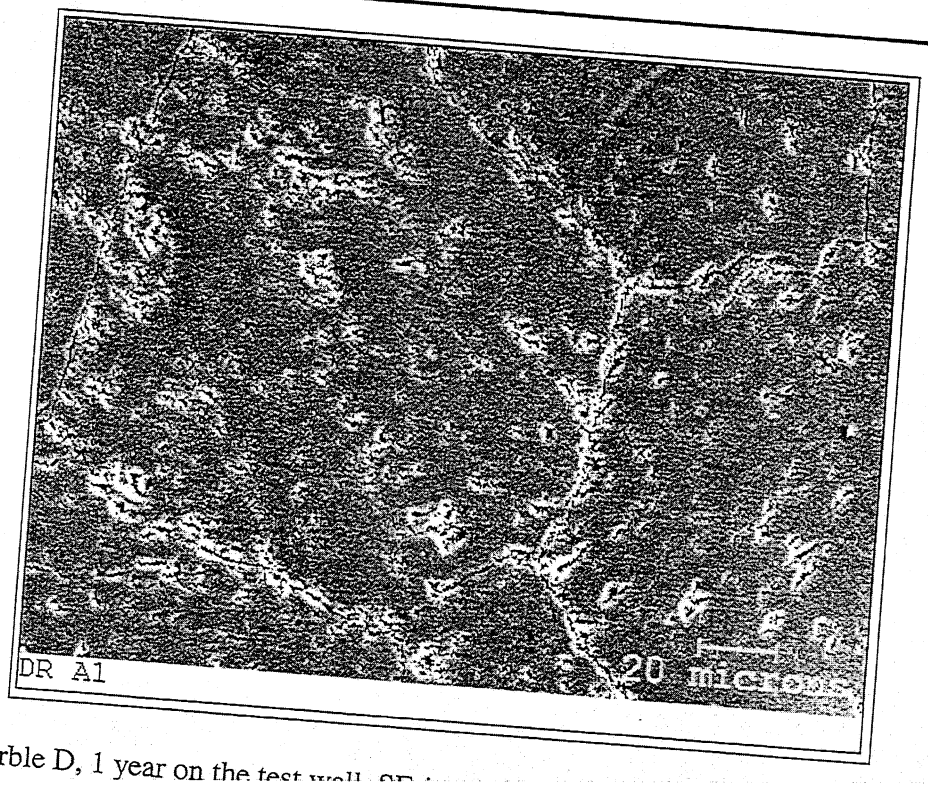
gure 44. Marble D, 1 year on the test wall, SE

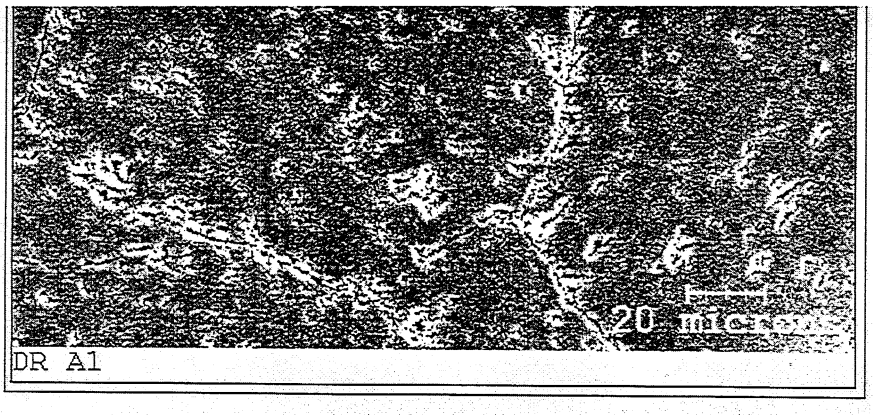
Figure 44. Marble D, 1 year on the test wall. SE-image, 500x.

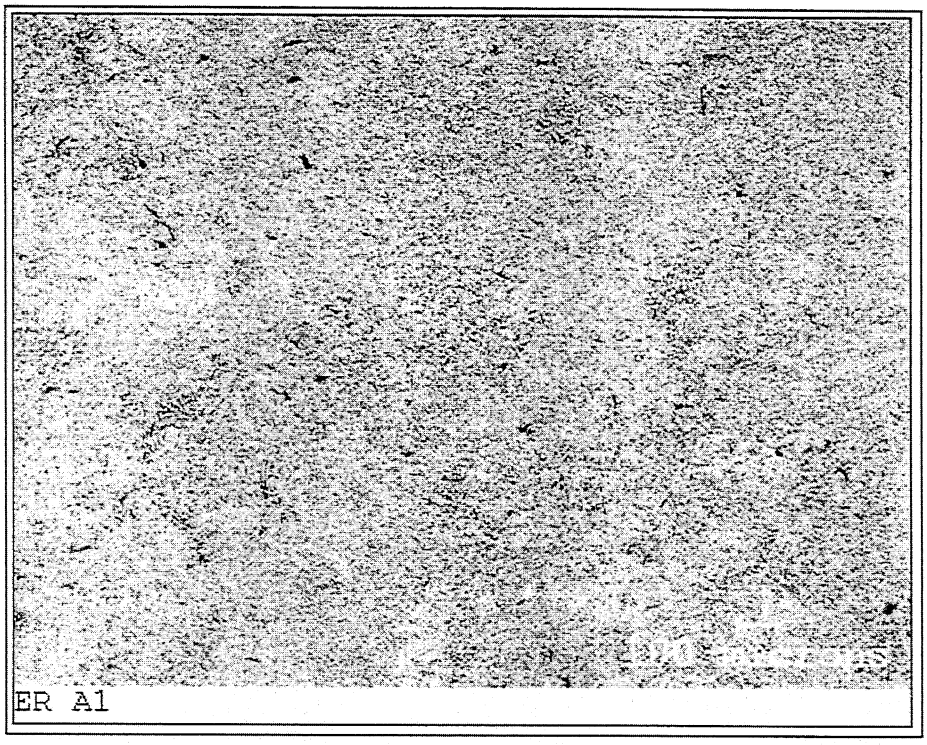
BSE- and SE-images of marble E, both unused and after 1 year on the test wall, are shown in Figs. 45-48. Grain boundaries can only partly and even then very vaguely be distinguished. No changes could be seen in the structure of the marble after 1 year on the test wall.

Figure 46. Marble E, 1 year on the test wall. BSE-image, 50x.

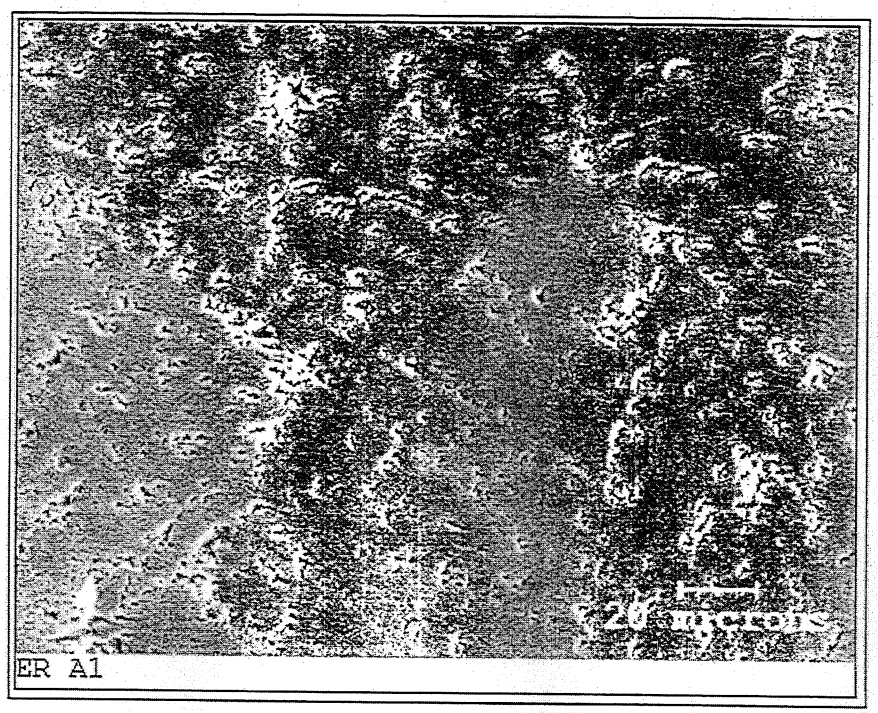
Figure 48. Marble E, 1 year on the test wall. SE-image, 500x.

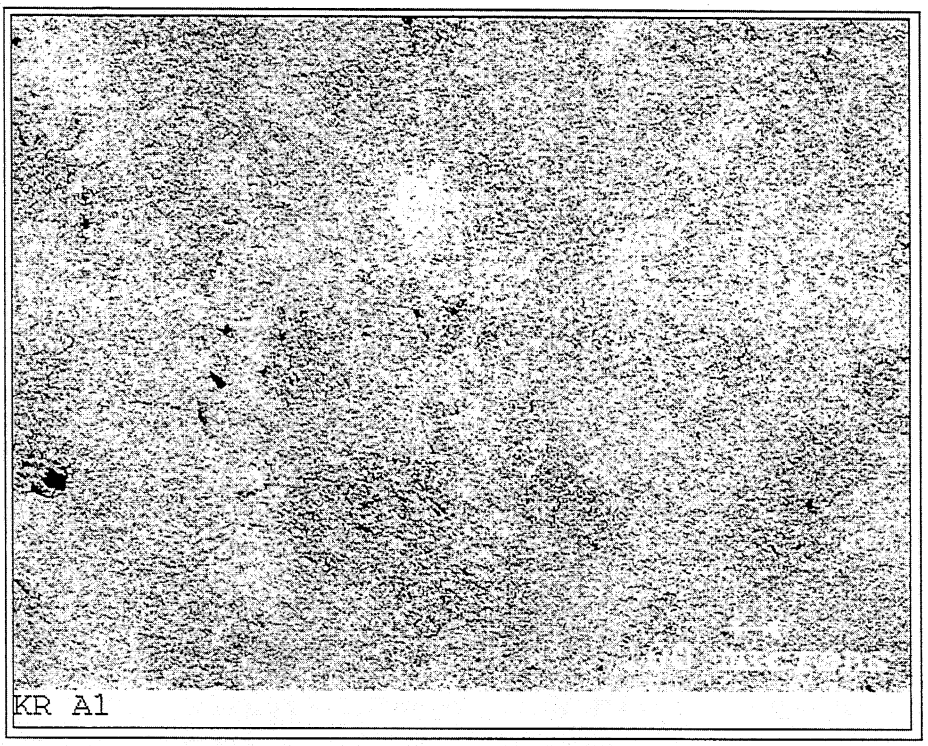
BSE- and SE-images of marble K, both unused and after 1 year on the test wall, are shown in Figs. 49-52. Grain boundaries can only partly and even then very vaguely be distinguished. No changes could be seen in the structure of the marble after 1 year on the test wall.

Figure 50. Marble K, 1 year on the test wall. BSE-image, 50x.

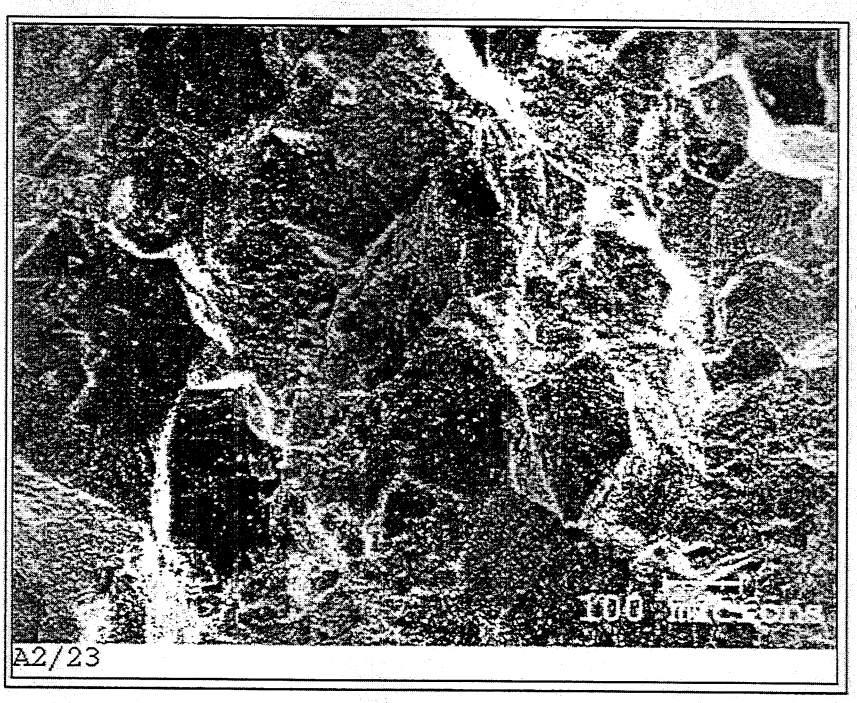
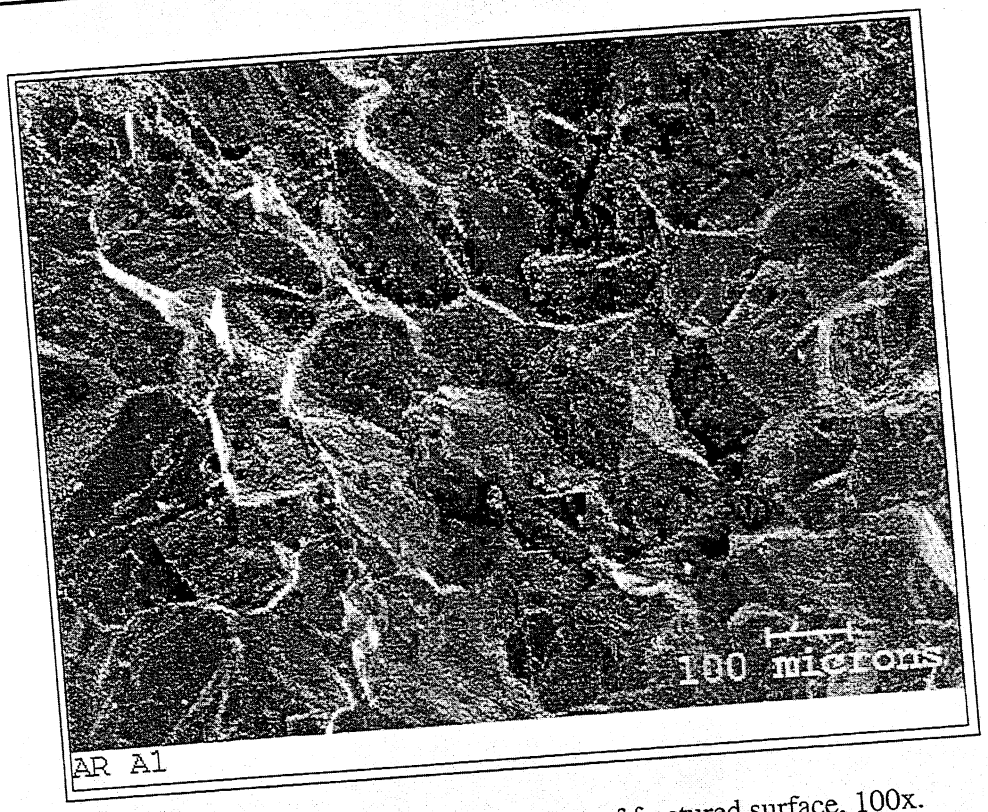
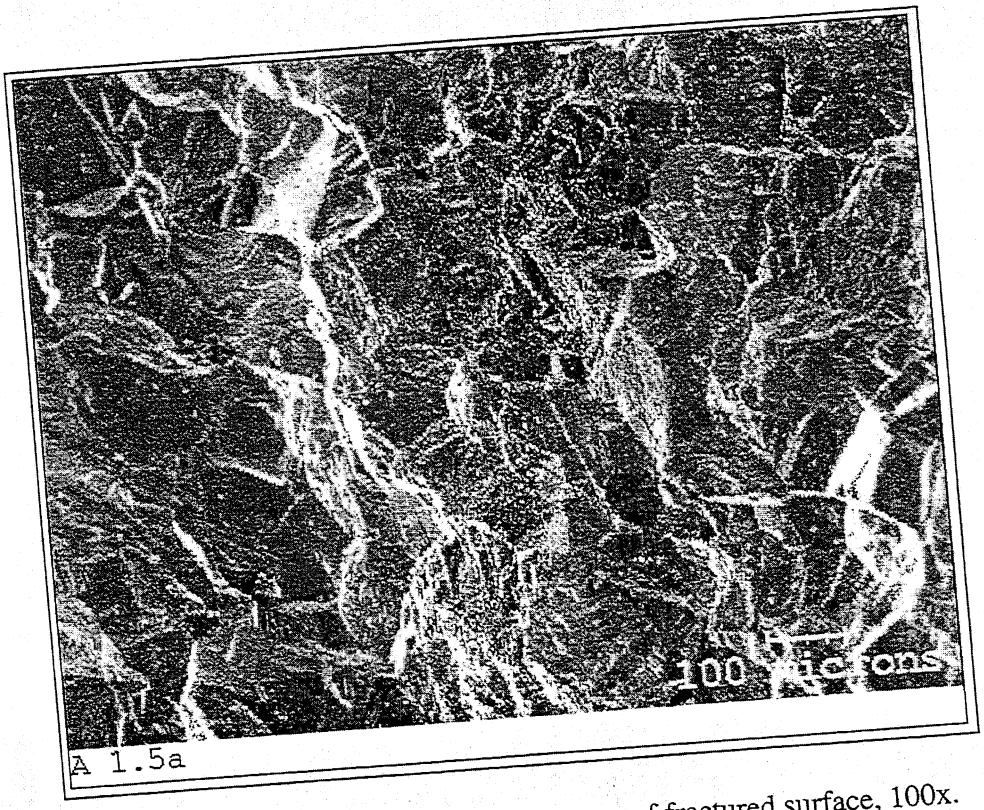
SEM-pictures of fractured surfaces of marble A, both unused and after 1 and 1.5 years on the test wall, are shown in Figs. 53-58. The individual grains can at least partly be distinguished from each other. Narrow cracks can also be noticed between some of the grains. More and wider cracks were detected when the marble had been exposed to the environmental stresses on the test wall. The maximum crack width after 1.5 years on the test wall is around 0.6-0.7 µm.

Figure 53. Marble A, unused. SE-image of fractured surface, 100x.

Figure 54. Marble A, 1 year on the test wall. SE-image of fractured surface, 100x.

Figure 55. Marble A, 1.5 years on the test wall. SE-image of fractured surface, 100x.

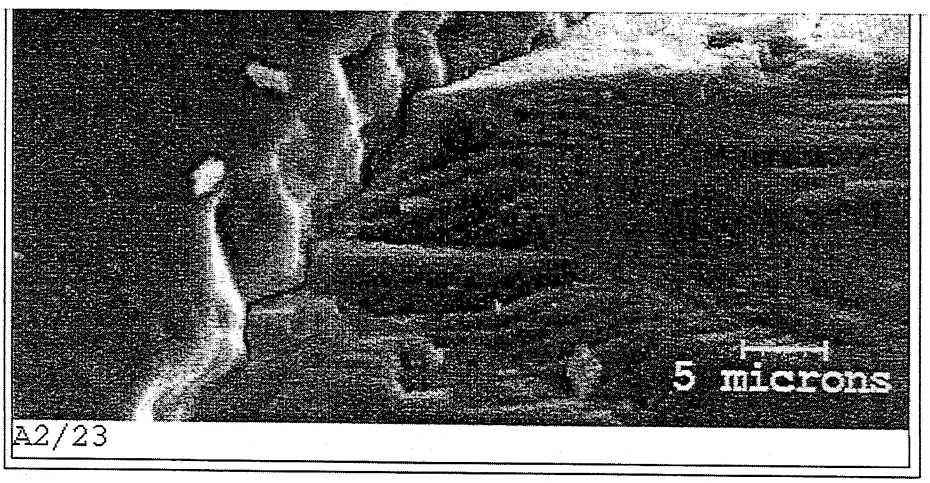
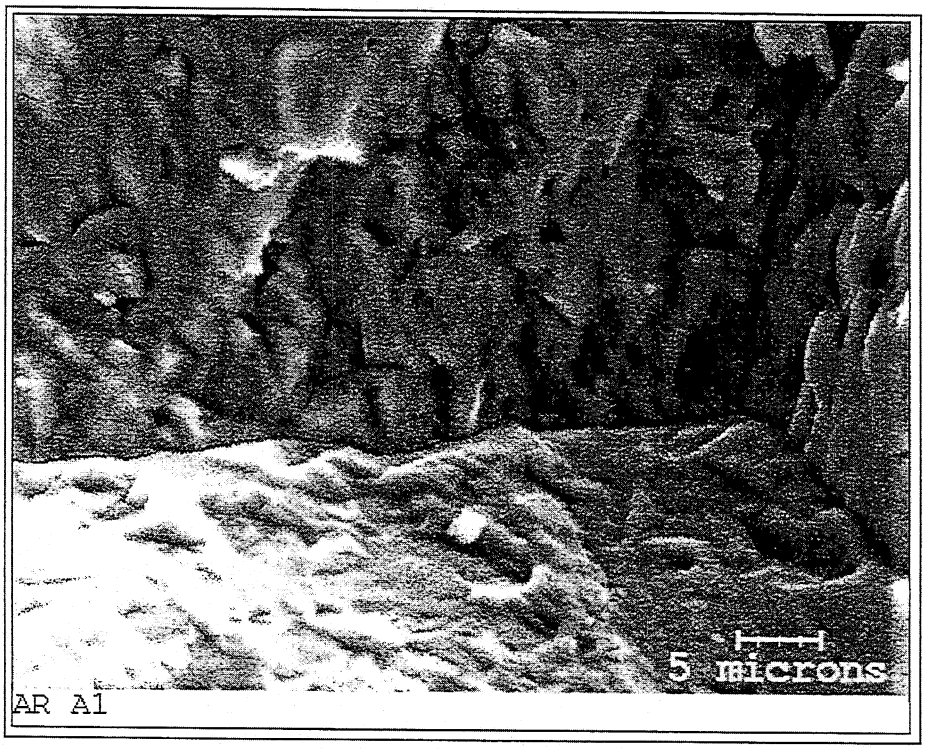
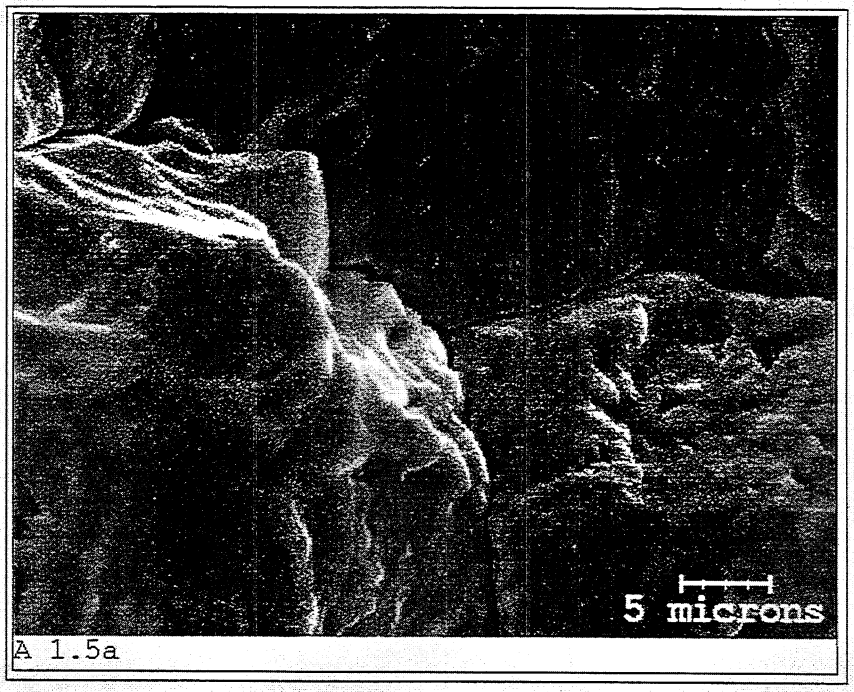
Figure 56. Marble A, unused. SE-image of fractured surface, 2500x.

Figure 57. Marble A, 1 year on the test wall. SE-image of fractured surface, 2500x.

Figure 58. Marble A, 1.5 years on the test wall. SE-image of fractured surface, 2500x.

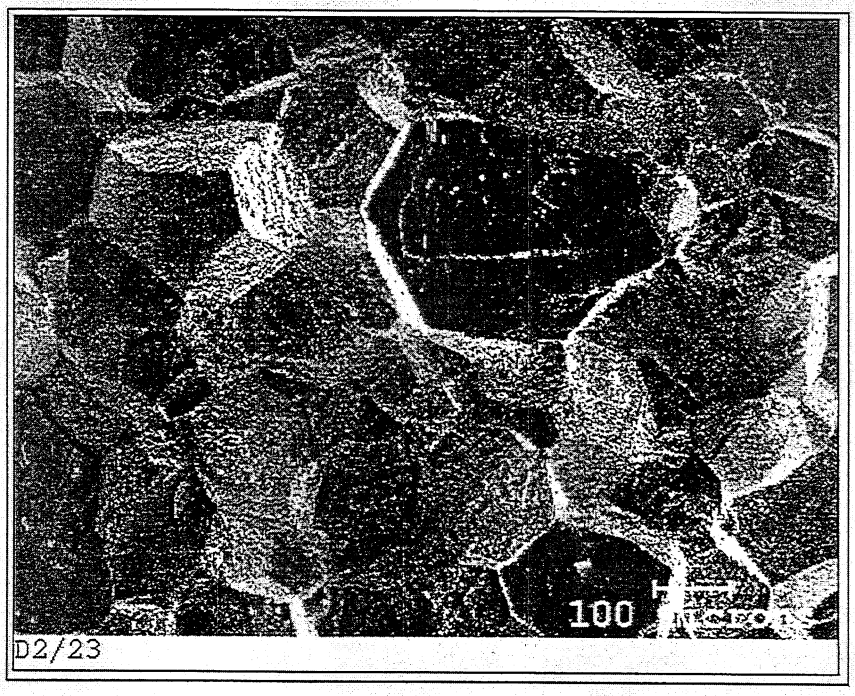
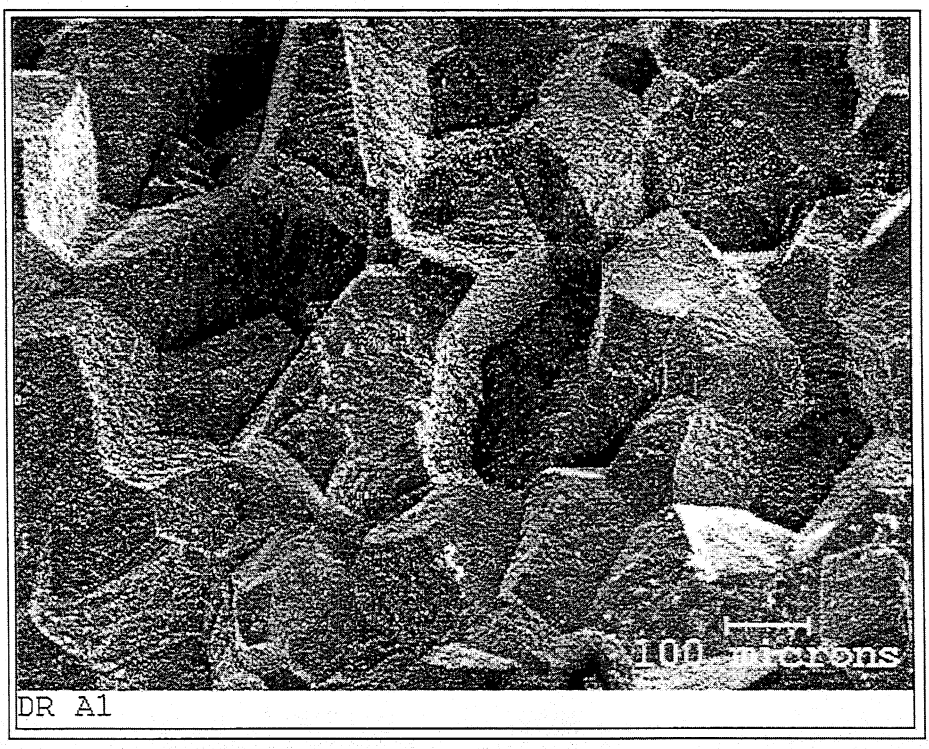
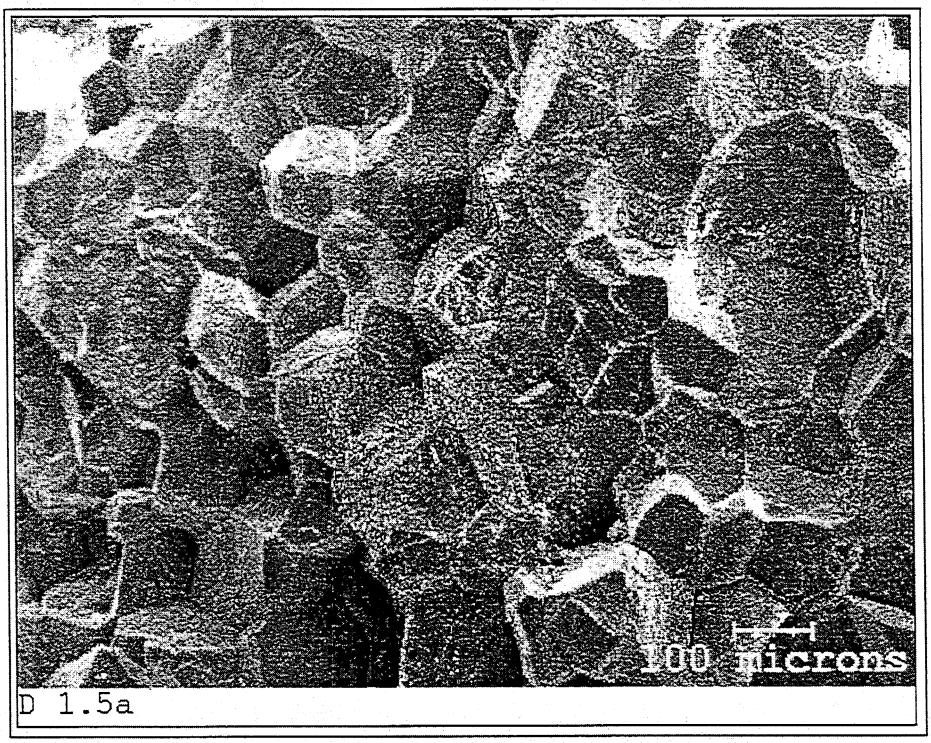
SEM-pictures of fractured surfaces of marble D, both unused and after 1 and 1.5 years on the test wall, are shown in Figs. 59-64. The individual grains can easily be distinguished from each other. Clear cracks can also be noticed between all the grains. These cracks were wider when the marble had been exposed to the environmental stresses on the test wall. The maximum crack width after 1.5 years on the test wall is around 1 µm.

Figure 59. Marble D, unused. SE-image of fractured surface, 100x.

Figure 60. Marble D, 1 year on the test wall. SE-image of fractured surface, 100x.

Figure 61. Marble D, 1.5 years on the test wall. SE-image of fractured surface, 100x.

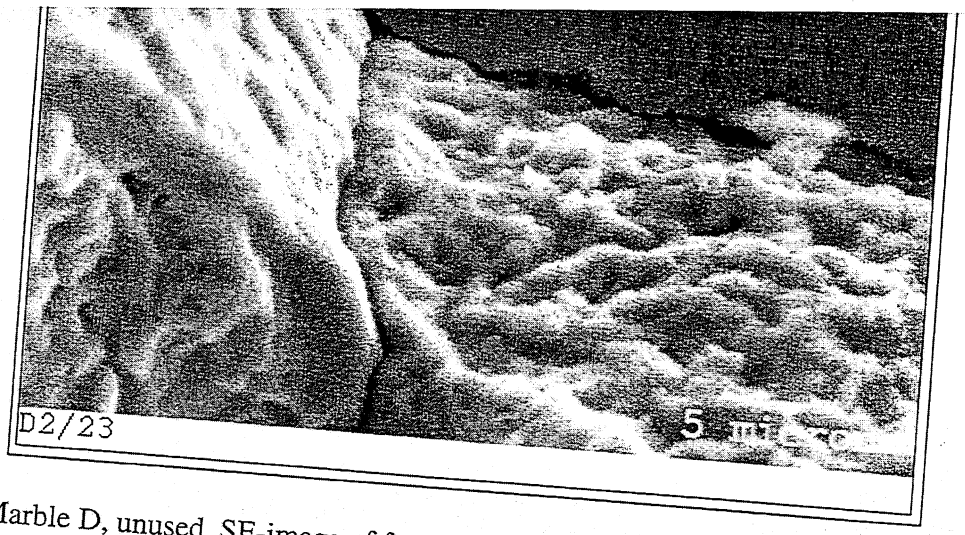
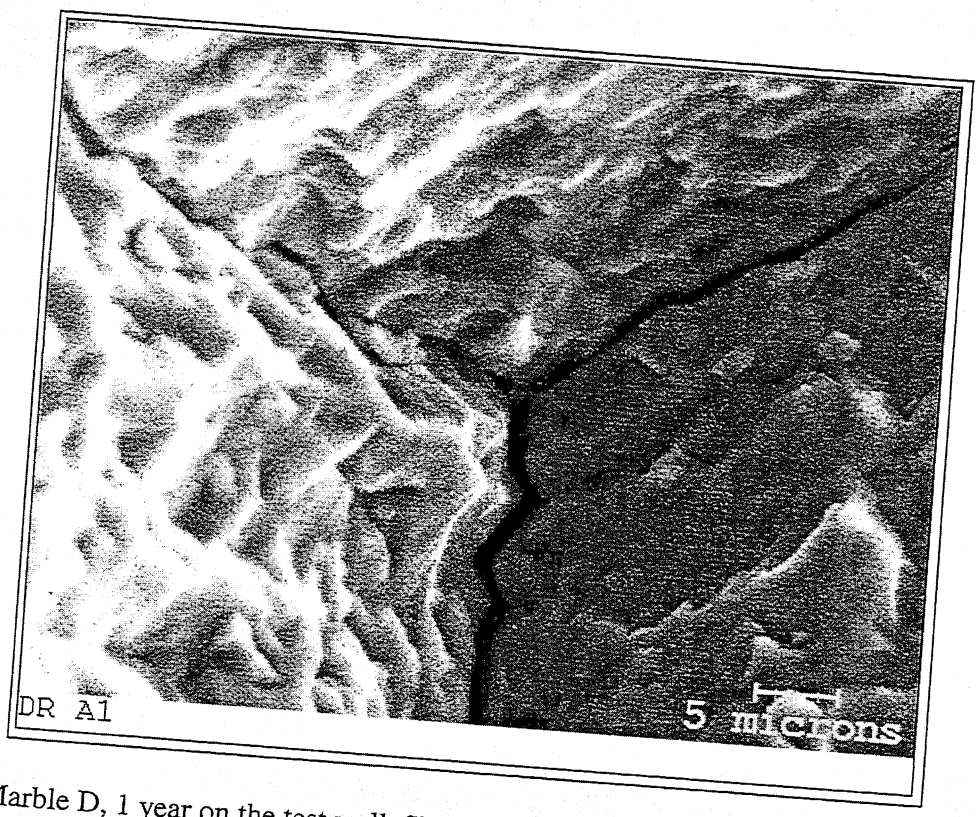
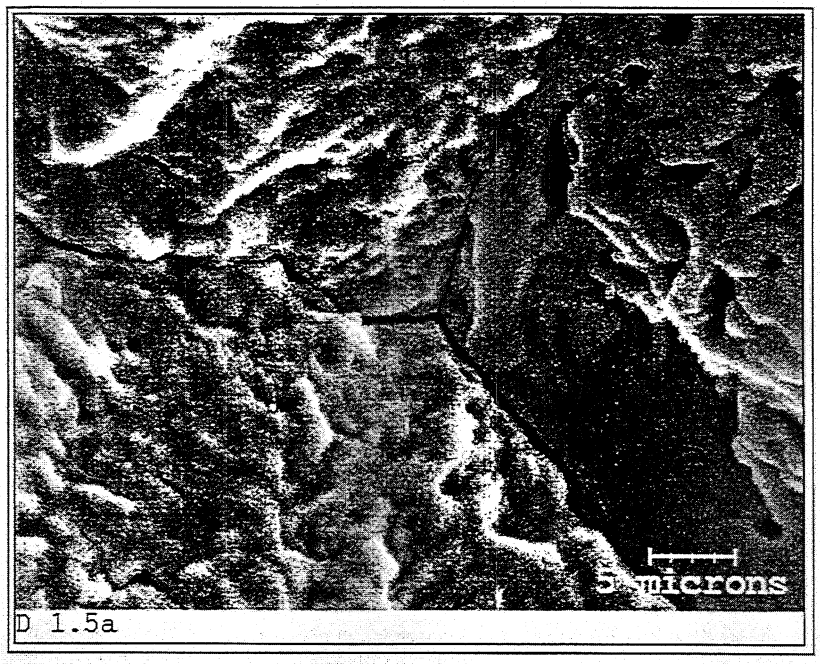
Figure 62. Marble D, unused. SE-image of fractured surface, 2500x.

Figure 63. Marble D, 1 year on the test wall. SE-image of fractured surface, 2500x.

Figure 64. Marble D, 1.5 years on the test wall. SE-image of fractured surface, 2500x.

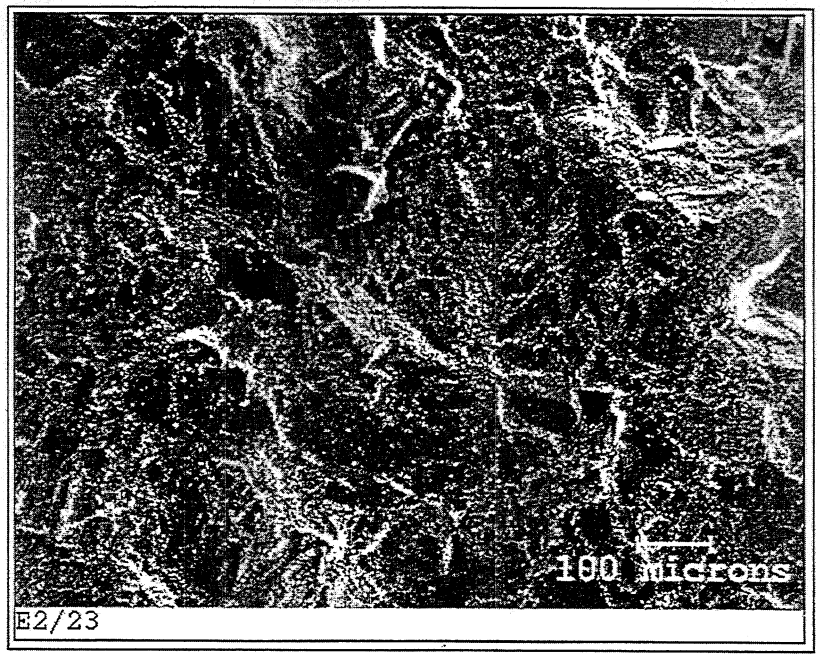
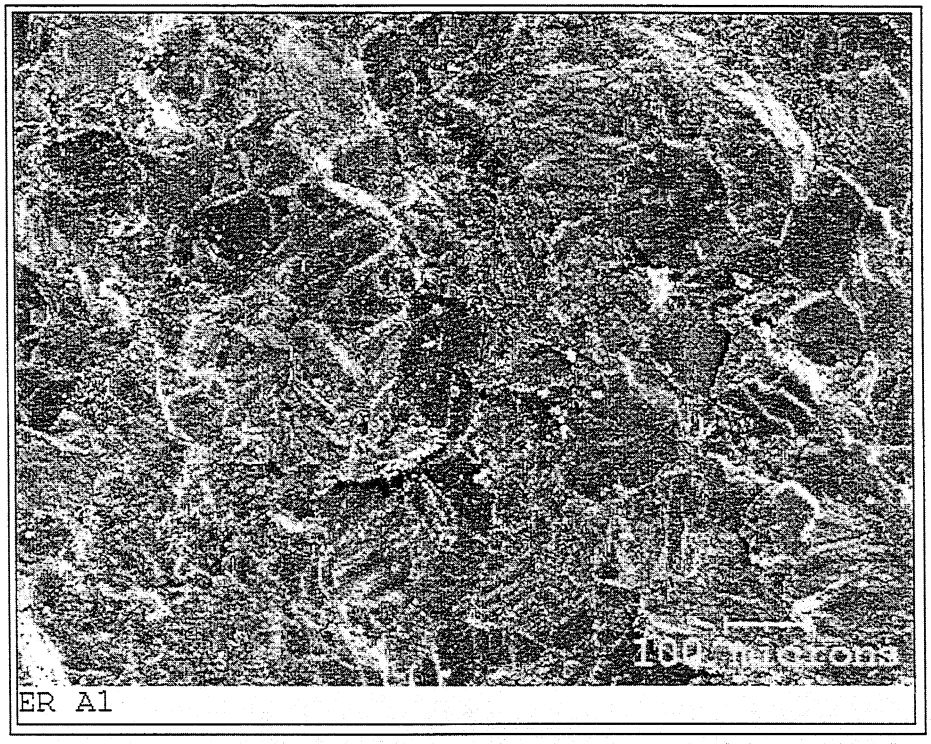
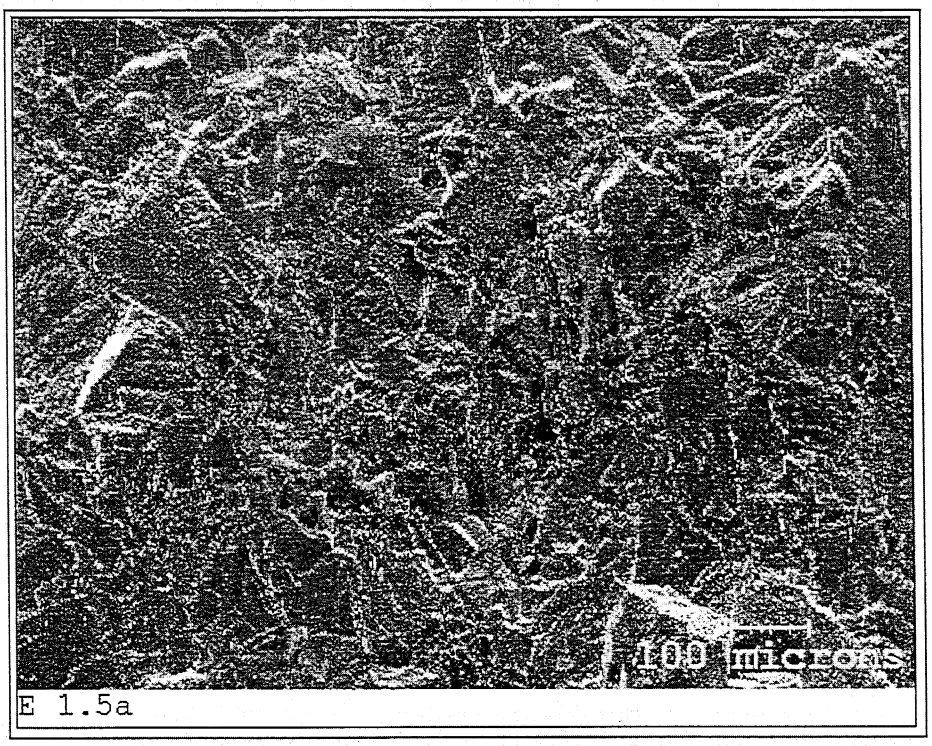
SEM-pictures of fractured surfaces of marble E, both unused and after 1 and 1.5 years on the test wall, are shown in Figs. 65-70. The grain boundaries can be seen only in some places. Thus, it is impossible to distinguish the grains from each other. Some very narrow cracks can be noticed between some of the grains. Some more and a little wider cracks were detected when the marble had been exposed to the environmental stresses on the test wall. The maximum crack width after 1.5 years on the test wall is around 0.3 µm.

Figure 65. Marble E, unused. SE-image of fractured surface, 100x.

Figure 66. Marble E, 1 year on the test wall. SE-image of fractured surface, 100x.

Figure 67. Marble E, 1.5 years on the test wall. SE-image of fractured surface, 100x.

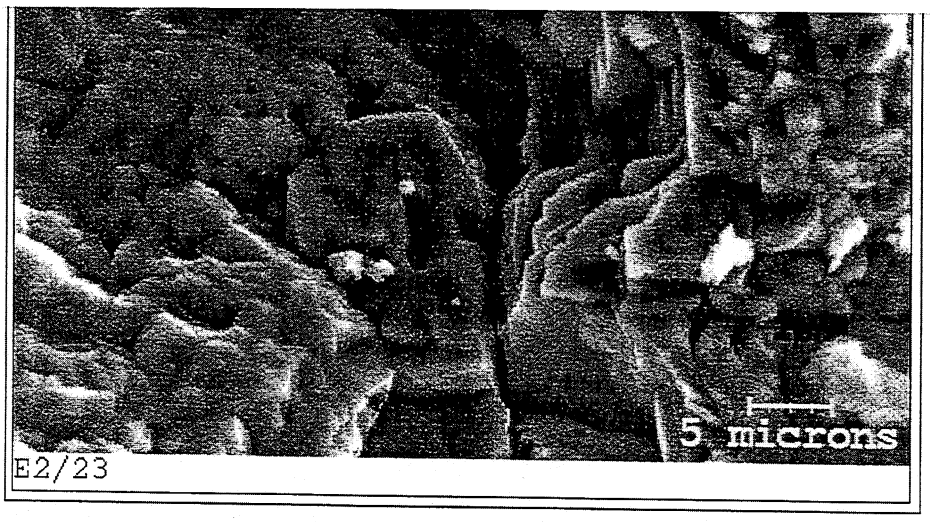
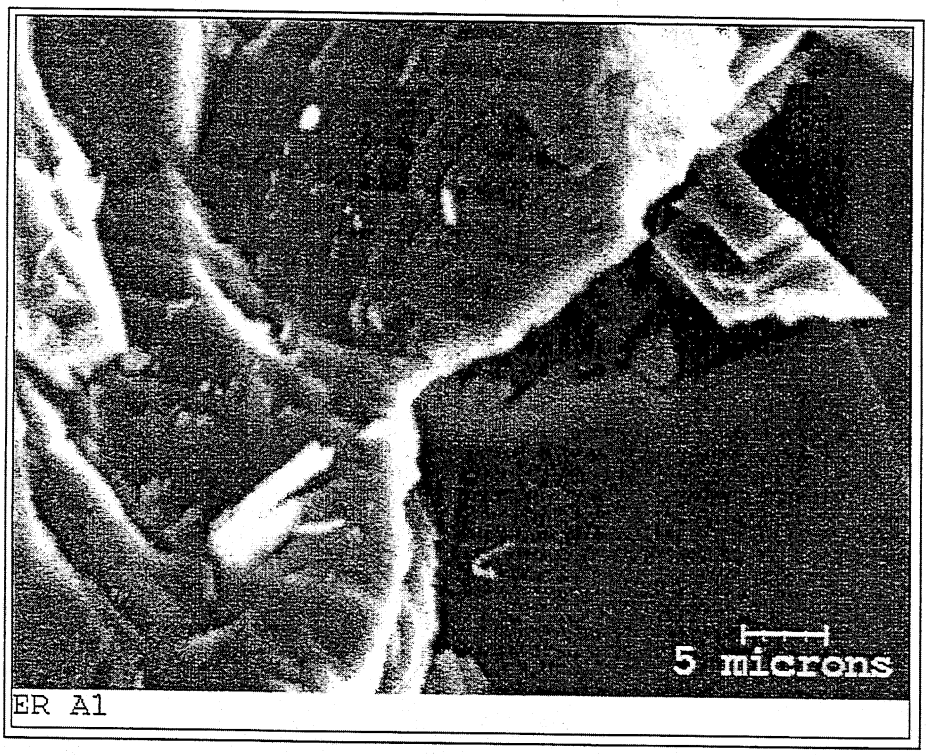
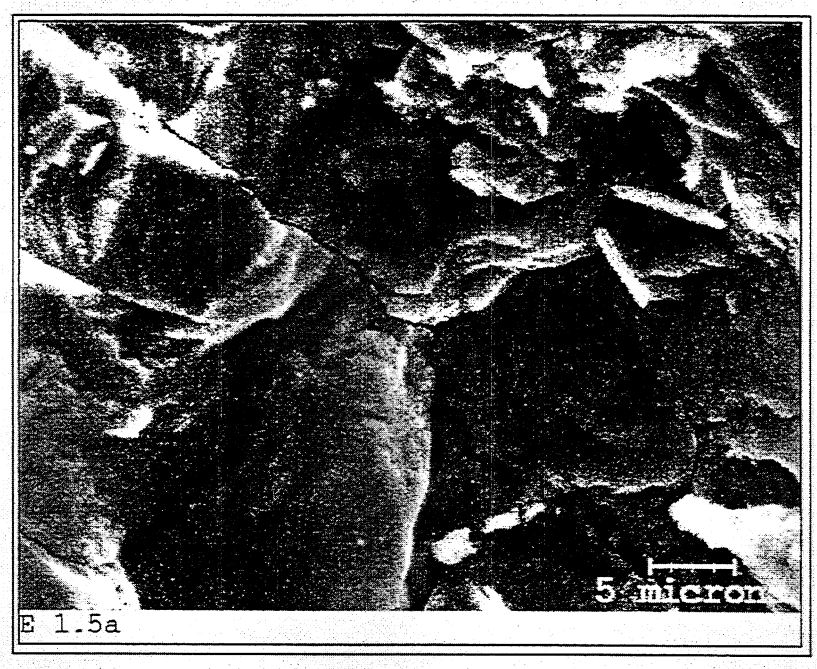
Figure 68. Marble E, unused. SE-image of fractured surface, 2500x.

Figure 69. Marble E, 1 year on the test wall. SE-image of fractured surface, 2500x.

Figure 70. Marble E, 1.5 years on the test wall. SE-image of fractured surface, 2500x.
