RESEARCH REPORT

Developing long term durability of marble facades

Subproject "Test wall"

Espoo, April 20, 2001

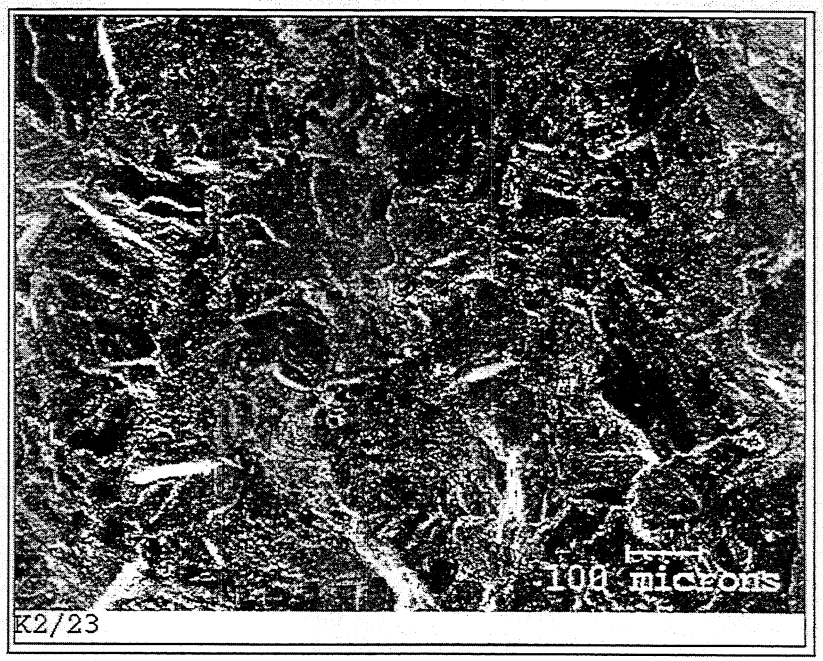
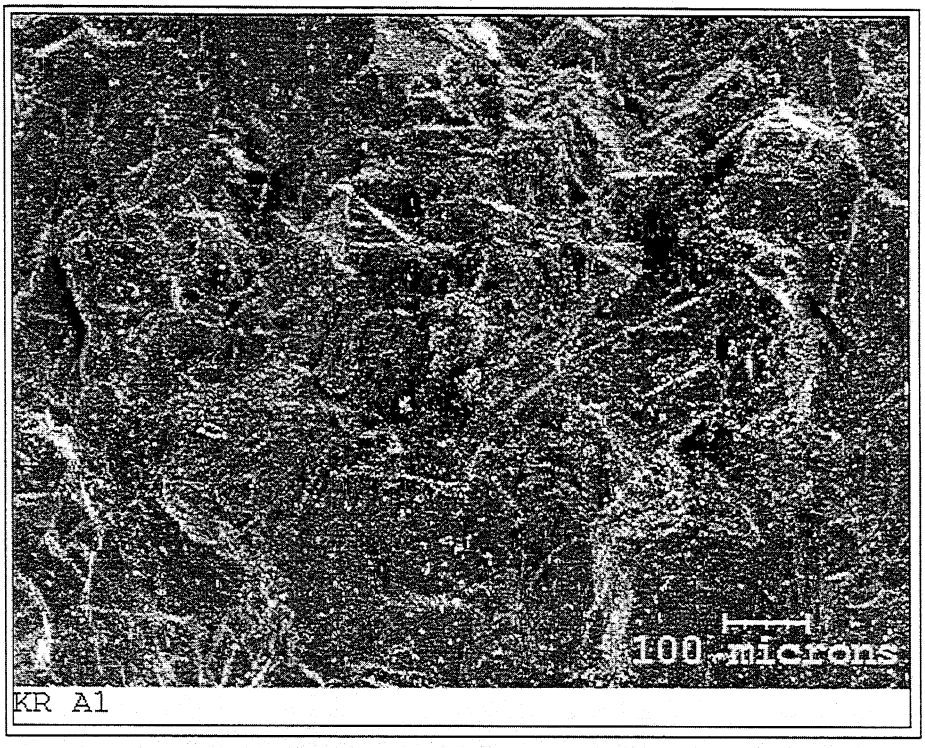
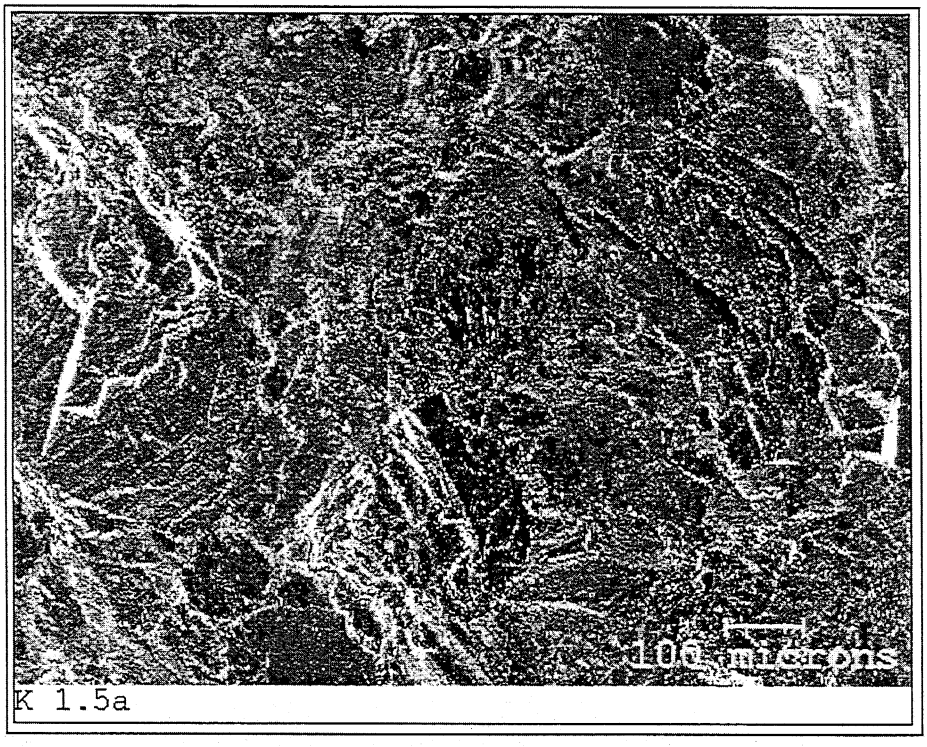
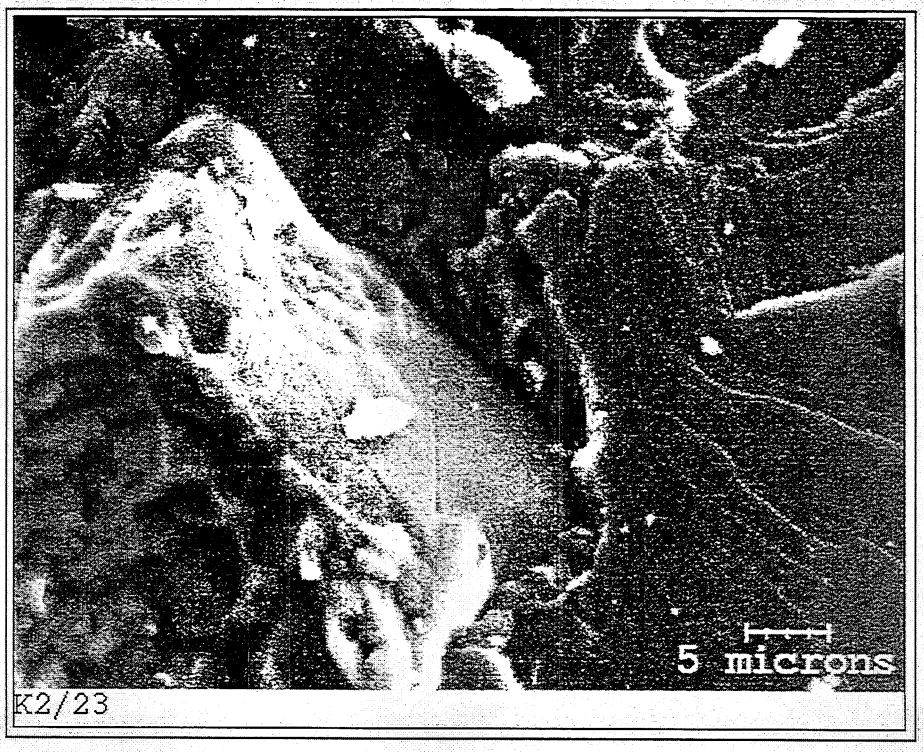
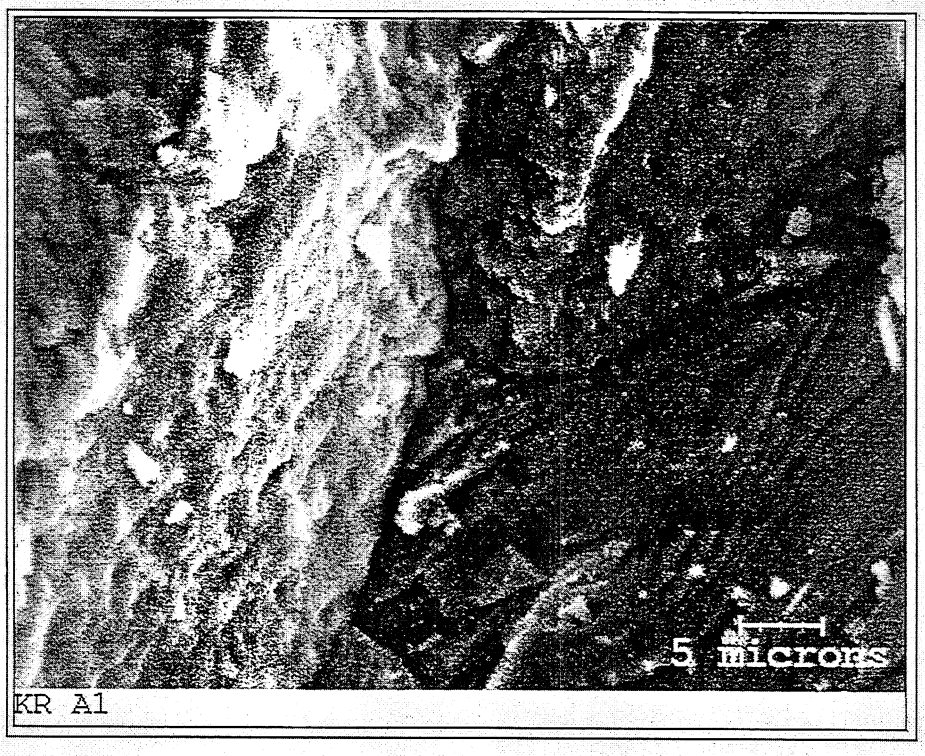
SEM-pictures of fractured surfaces of marble K, both unused and after 1 and 1.5 years on the test wall, are shown in Figs. 71-76. The grain boundaries can be seen only in some places. Thus, it is impossible to distinguish the grains from each other. Some very narrow cracks can be noticed between some of the grains. Some more and a little wider cracks were detected when the marble had been exposed to the environmental stresses on the test wall. The maximum crack width after 1.5 years on the test wall is around 0.3 µm.

Figure 71. Marble K, unused. SE-image of fractured surface, 100x.

Figure 72. Marble K, 1 year on the test wall. SE-image of fractured surface, 100x.

Figure 73. Marble K, 1.5 years on the test wall. SE-image of fractured surface, 100x.

Figure 74. Marble K, unused. SE-image of fractured surface, 2500x.

Figure 75. Marble K, 1 year on the test wall. SE-image of fractured surface, 2500x.

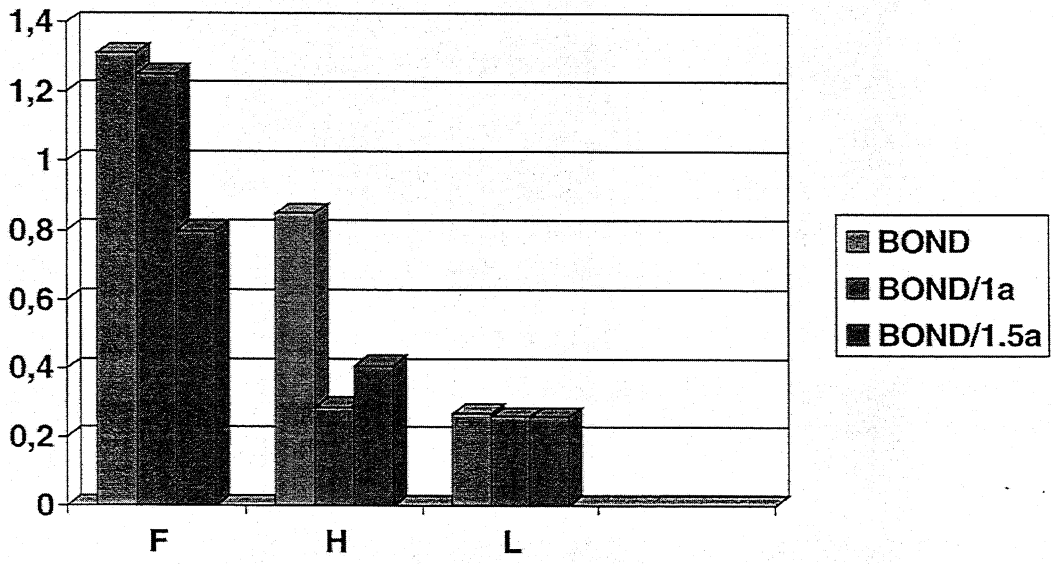
Figure 77. Bond strength of marble in marble clad elements (MPa).

In the element type F the breaking point was usually the interface between marble and concrete. Only in a couple of cases the loosening took place, at least partly, deeper inside concrete.

In the element type L the breaking point was always the interface between marble and the rest of the structure. Thus, the loosening of marble took place from the top of the glue layer.

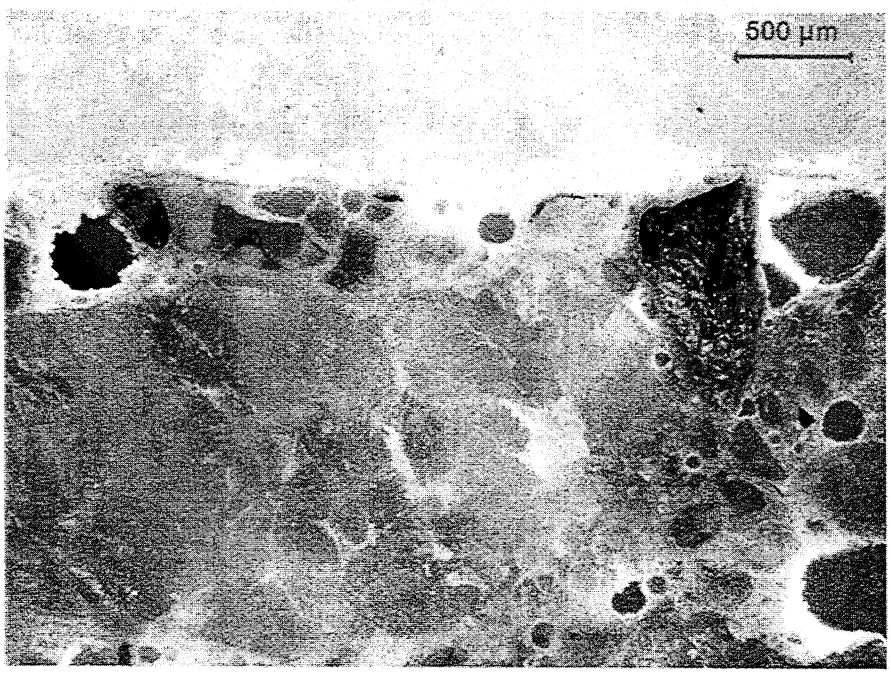
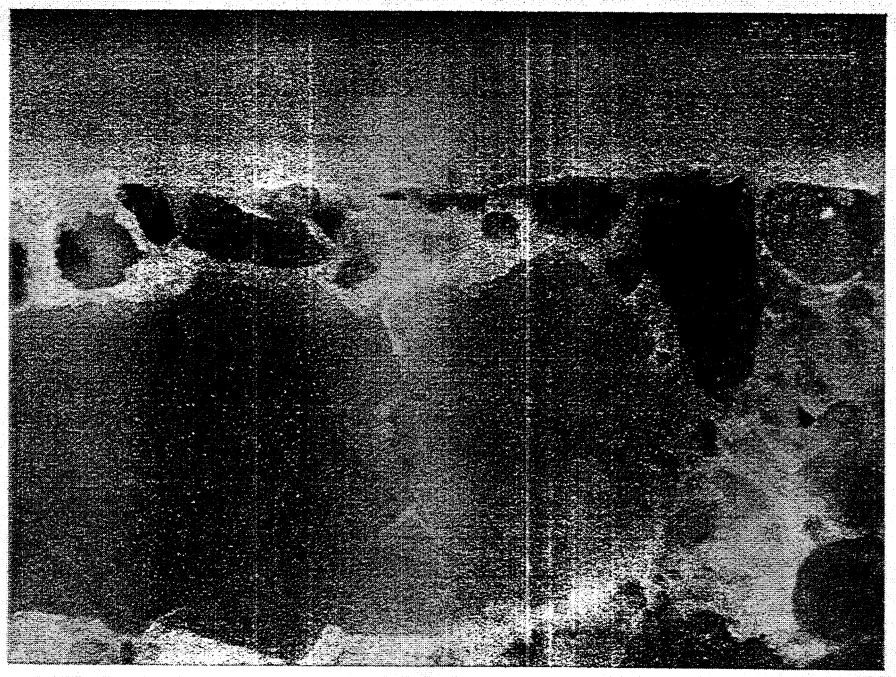
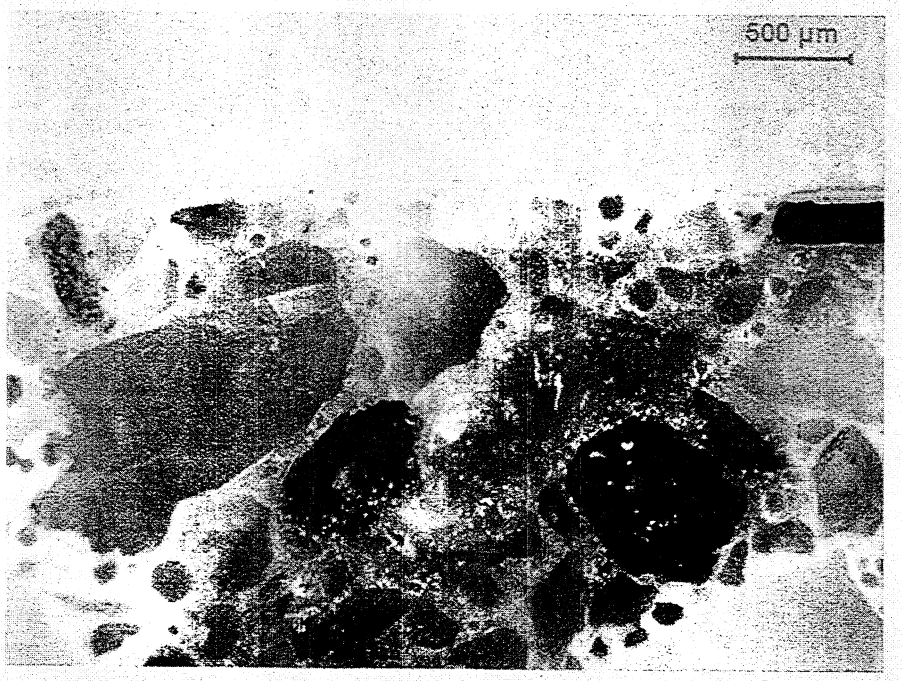
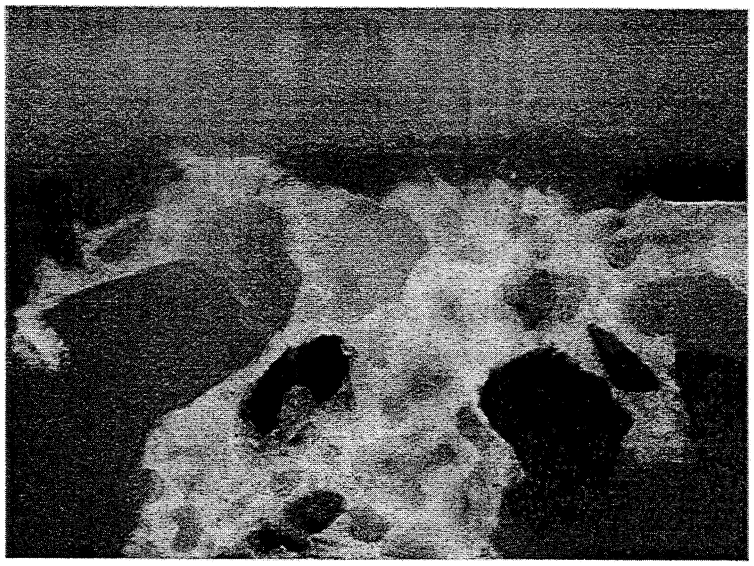
- contact between marble and concrete tight and cohesive
- a thin layer of third material, probably primer, between marble and concrete
- material (primer) layer rather continuous, though pores are common; thickness of the layer generally 20-30 µm, in places even 60 µm
- in the unused element only a few very tiny cracks along the marble/concrete contact zone
- in the element stressed for 1.5 years on the test wall some slight and narrow cracking at the marble/concrete contact zone

Figure 78. Microstructure of marble clad element F. Unused. Objective 2.5x, oblique illumination.

Figure 79. Microstructure of marble clad element F. Unused. Objective 2.5x, fluorescent light.

Figure 80. Microstructure of marble clad element F. 1.5 years on the test wall. Objective 2.5x, oblique illumination.

Figure 81. Microstructure of marble clad element F. 1.5 years on the test wall. Objective 2.5x, fluorescent light.

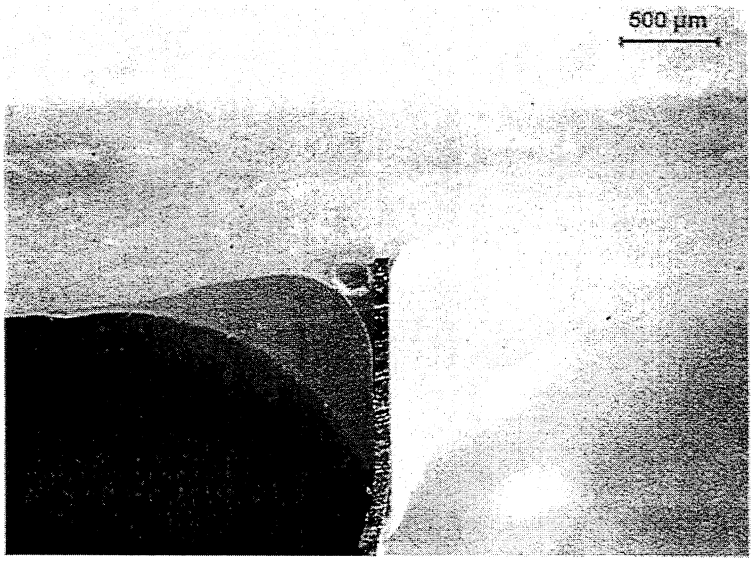
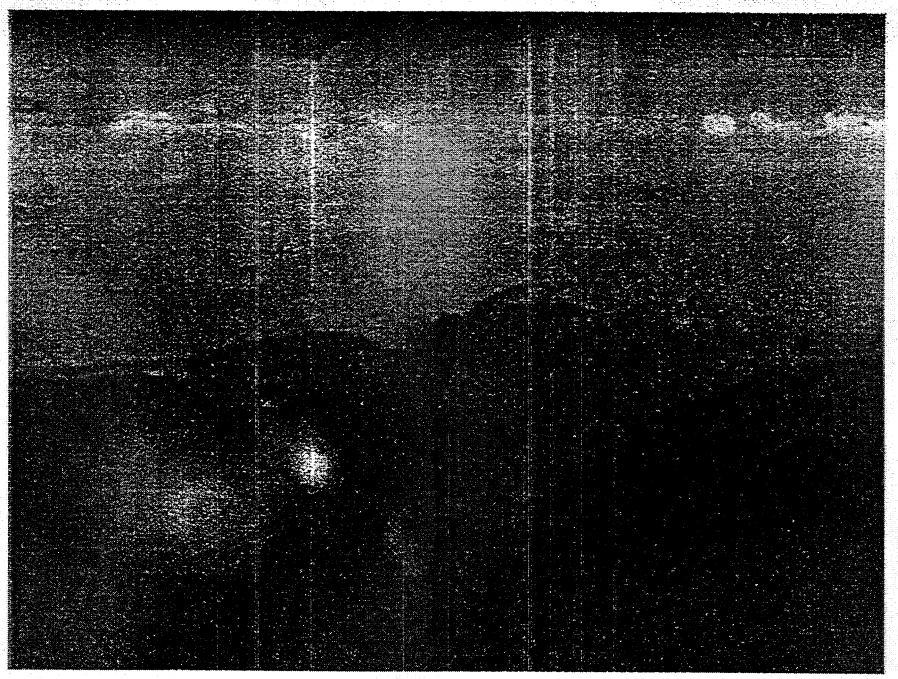
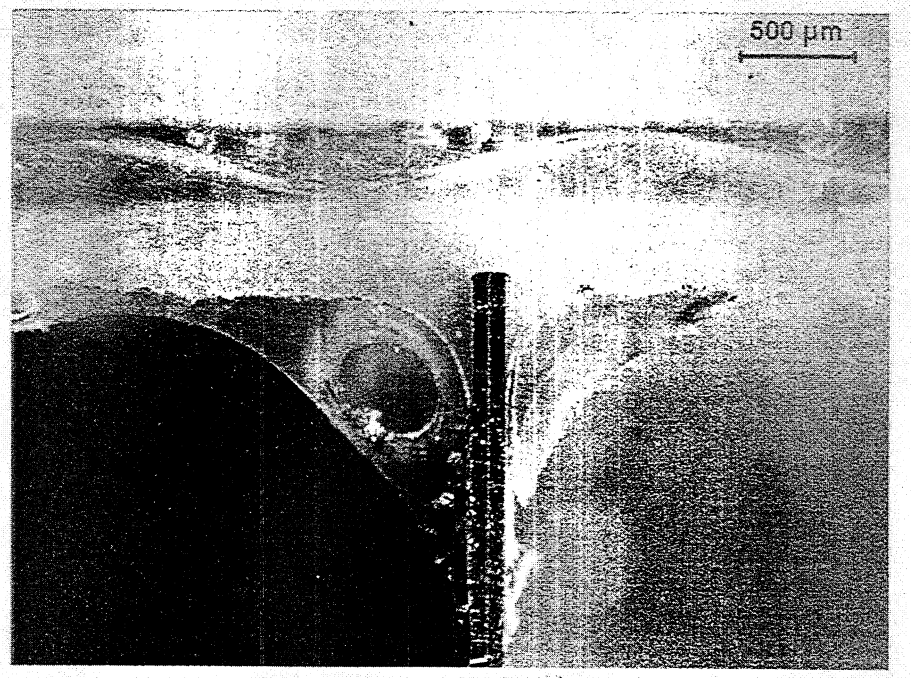
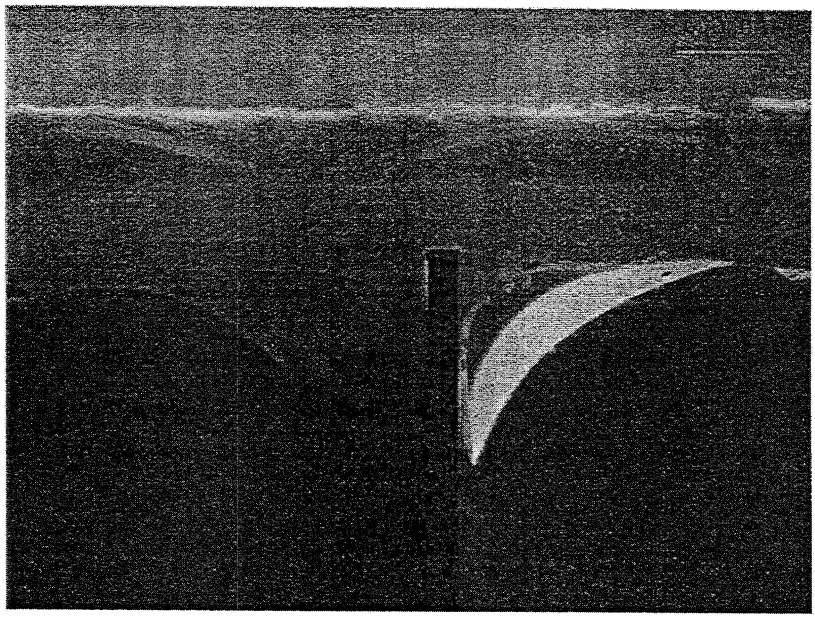
- a layer of glue between marble and metal structure, thickness of the layer approximately 1 mm
- structure of the unused element partly cracked along the contact zone marble/glue
- in the unused element the upper half of the glue layer tinted yellowish
- in the element stressed for 1.5 years on the test wall the upper half of the glue layer tinted brownish
- in the element stressed for 1.5 years on the test wall open crack on about 60% of the contact zone marble/glue

Figure 82. Microstructure of marble clad element H. Unused. Objective 2.5x, oblique illumination.

Figure 83. Microstructure of marble clad element H. Unused. Objective 2.5x, fluorescent light.

Figure 84. Microstructure of marble clad element H. 1.5 years on the test wall. Objective 2.5x, oblique illumination.

Figure 85. Microstructure of marble clad element H. 1.5 years on the test wall. Objective 2.5x, fluorescent light.

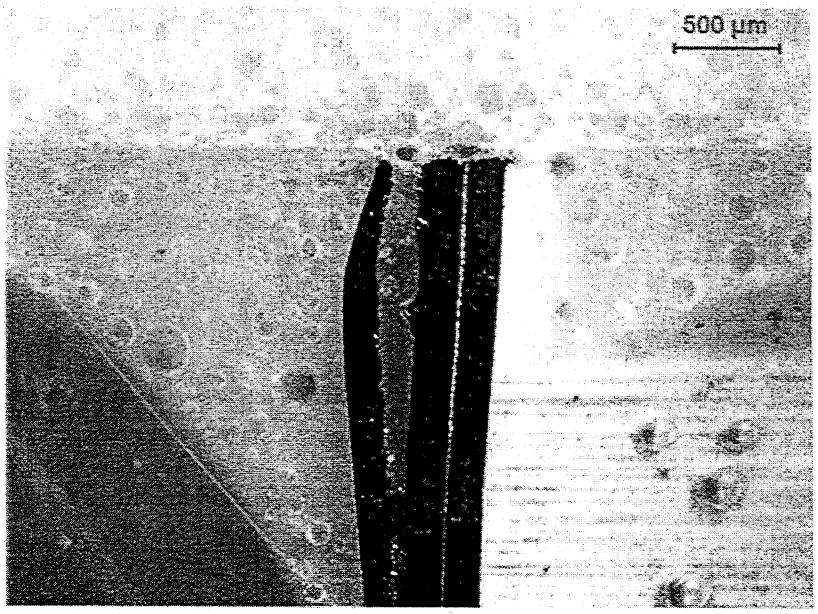
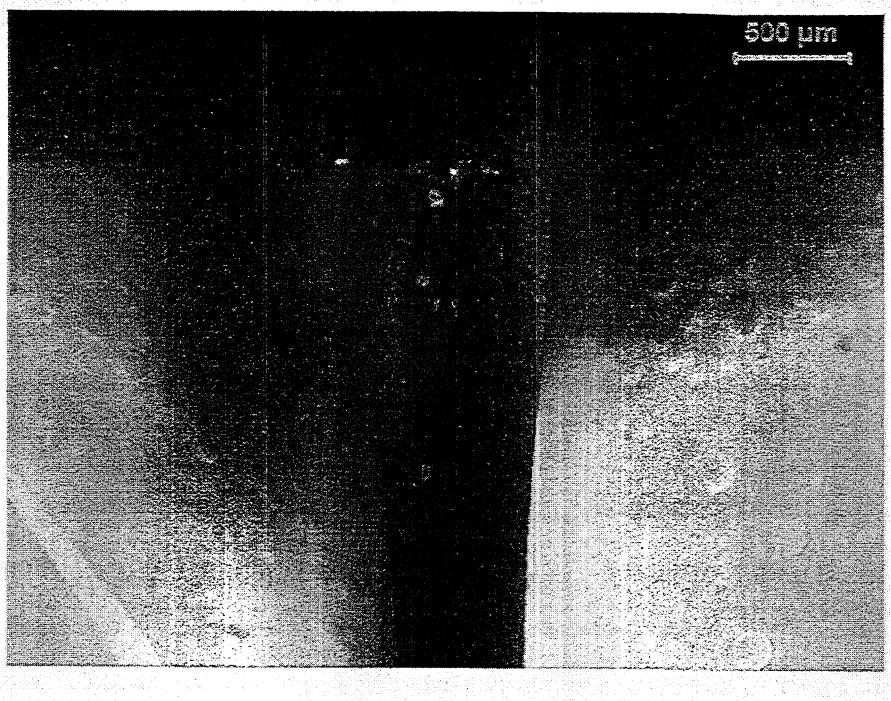
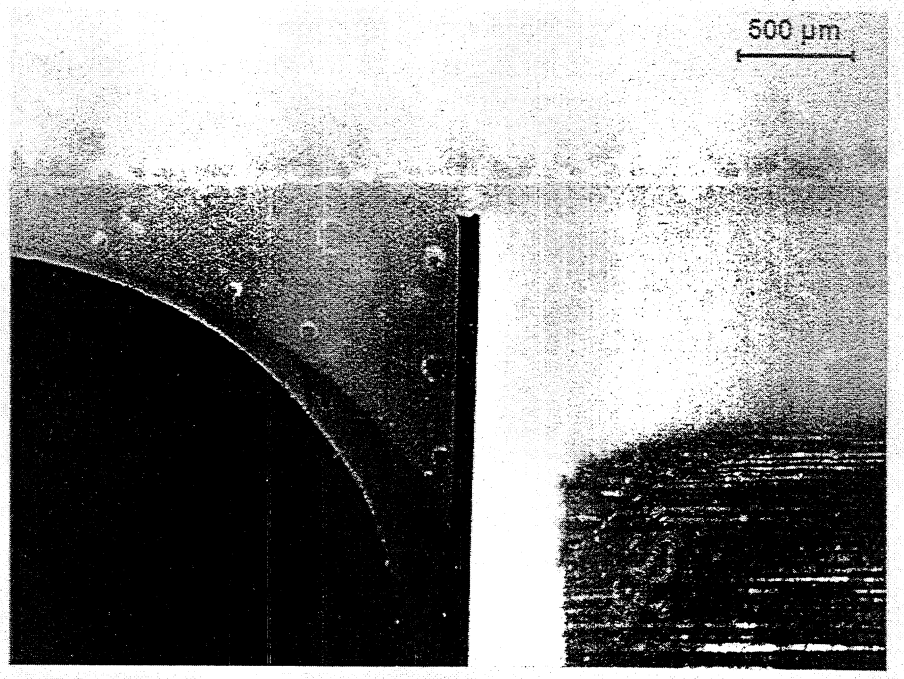
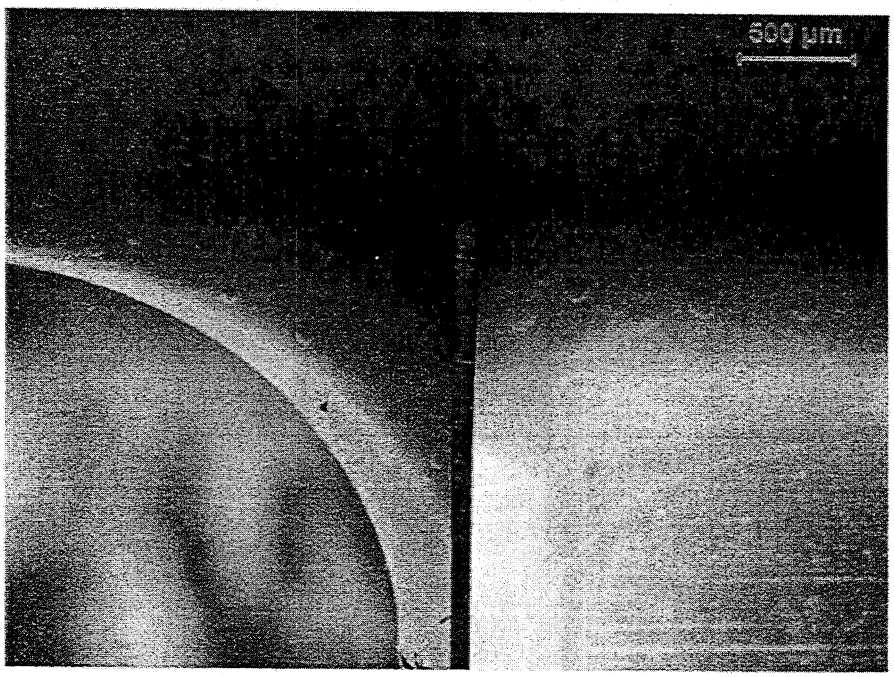
- a layer of glue between marble and metal structure, thickness of the layer approximately 0.5 mm
- the glue contains a lot of porosity
- in the unused element the glue layer partly detached from marble
- in the element stressed for 1.5 years on the test wall the glue layer rather tightly attached to marble, only minor cracking in some parts of the contact zone

Figure 86. Microstructure of marble clad element L. Unused. Objective 2.5x, oblique illumination.

Figure 87. Microstructure of marble clad element L. Unused. Objective 2.5x, fluorescent light.

Figure 88. Microstructure of marble clad element L. 1.5 years on the test wall. Objective 2.5x, oblique illumination.

Figure 89. Microstructure of marble clad element L. 1.5 years on the test wall. Objective 2.5x, fluorescent light.

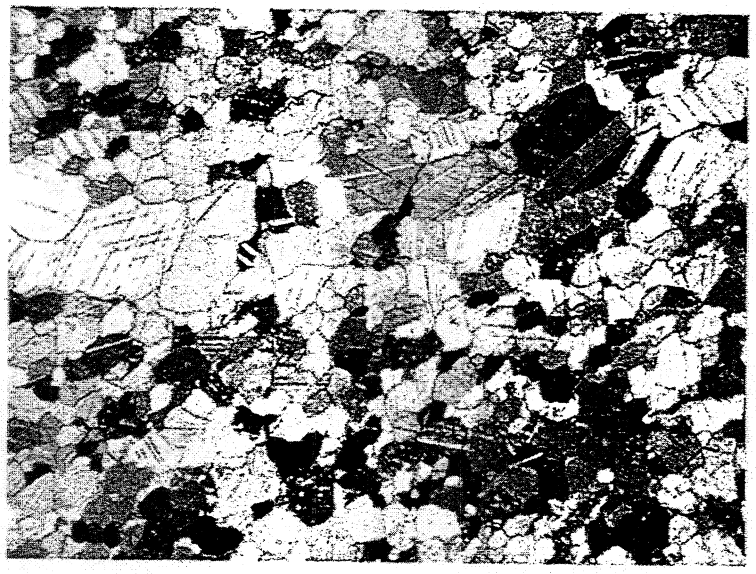
- fine-grained ground mass, slightly oriented, average grain size 0.1-0.2 mm
- in places more coarse-grained veinlets with a thickness of about 1 mm, veinlets show the same orientation as the ground mass
- grain boundaries clear, often straight, grains easily distinguished
- nearly pure carbonate rock, only a little quartz and opaque minerals, possibly feldspar

Figure 113. Microstructure of marble from case 1. Cross-polarized light.

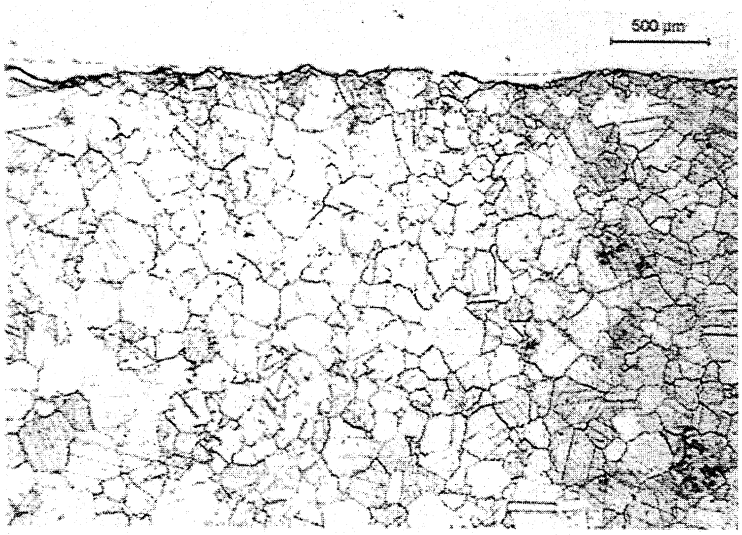
- ground mass fine-grained, even-grained, not oriented
- grain boundaries easily distinguished
- a few very fine-grained cryptocrystalline lenses, max. length about 10 mm, inside the ground mass
- no heavy cracking
- outer surface dirty and uneven

Figure 114. Microstructure of older marble from case 2. Plane-polarized light.

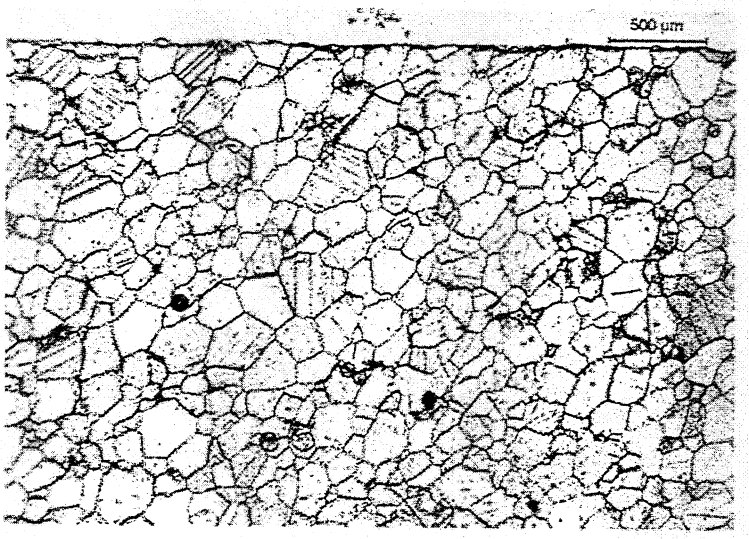
- ground mass fine-grained, fairly even-grained, not oriented
- grain boundaries easily distinguished
- a few very fine-grained cryptocrystalline lenses, max. length about 2-3 mm, inside the ground mass
- cracks between the grains extending to a depth of about 2-3 mm from the outer surface and to a depth of about 1-2 mm from the inner surface, some cracks cut the surface
- outer surface dirty

Figure 116. Microstructure of younger marble from case 2. Plane-polarized light.

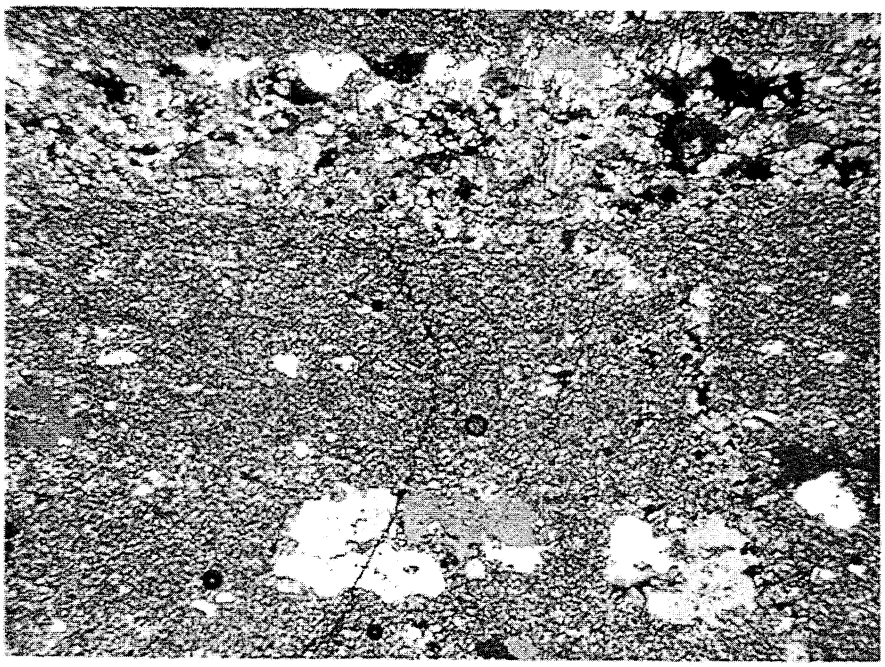
- ground mass very fine-grained, microcrystalline, dense
- clearly oriented, layered
- in places more coarse-grained veinlets with a thickness of about 1 mm, mostly oriented parallel to layering, a few also cross the layering
- some separate fine- to medium-grained quartz grains in rows, parallel to layering
- mainly carbonate rock, moderate content of quartz, other minerals include feldspar (probably plagioclase), mica (probably muscovite) and opaque minerals
- in places mica forms veinlets, partly with opaque minerals

Figure 118. Microstructure of dolomite from case 3. Cross-polarized light.

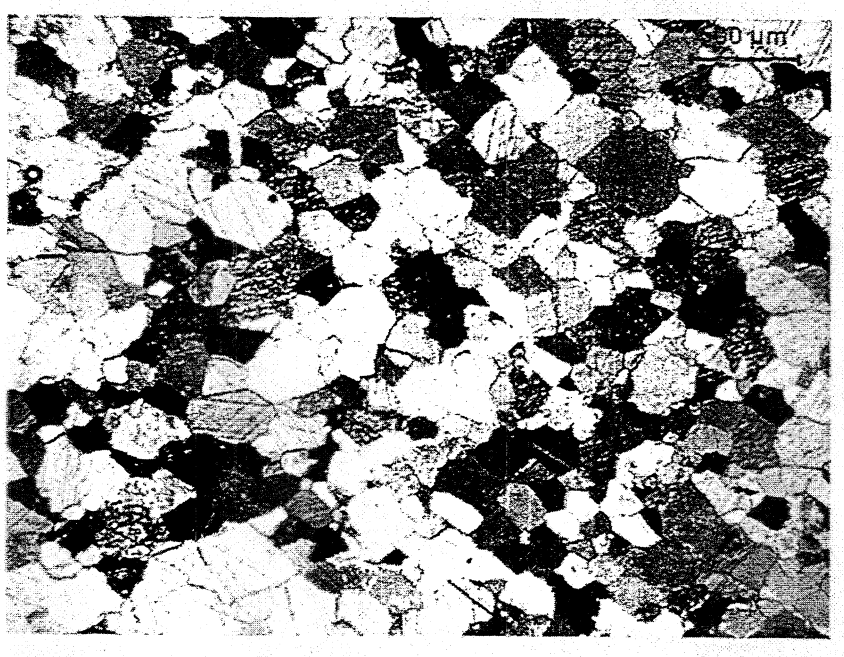
- fine-grained, fairly even-grained, slightly oriented
- average grain size 0.2-0.3 mm
- grain boundaries clear, straight, grains easily distinguished
- nearly pure carbonate rock, a little quartz and opaque minerals

Figure 119. Microstructure of marble from Finlandia Hall. Cross-polarized light.

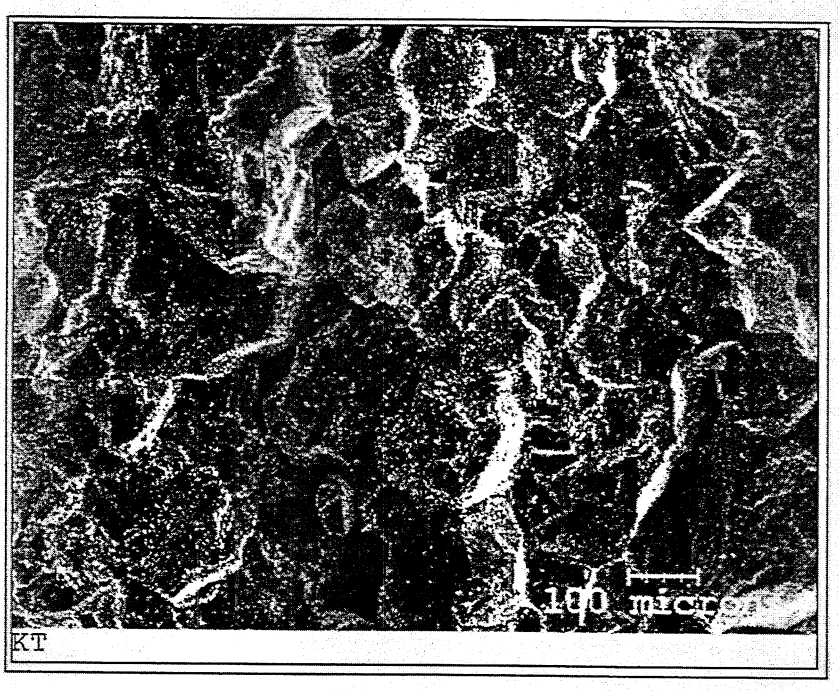
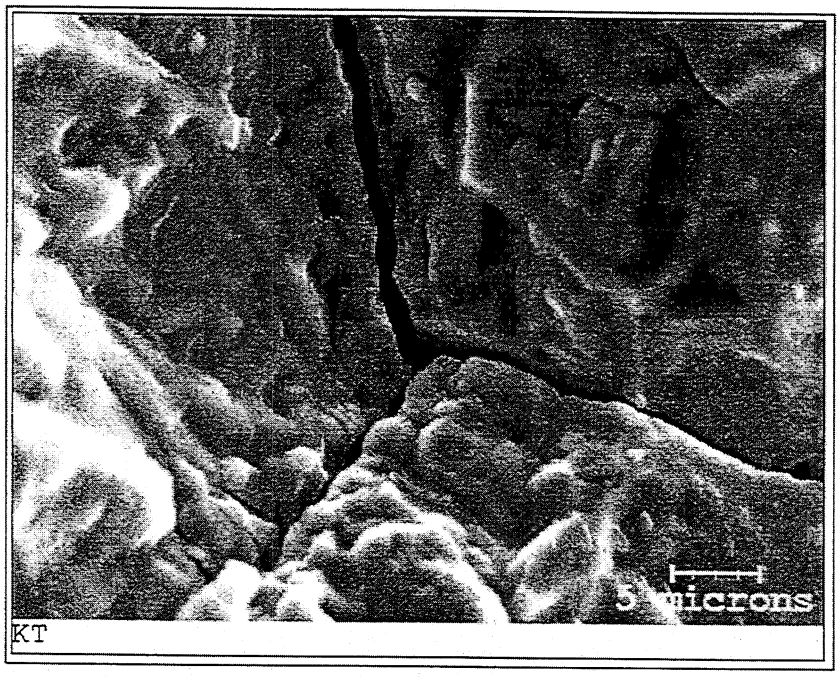
SEM-pictures of fractured surfaces of marble from the case 1 are shown in Figs. 120 and 121. The individual grains can at least for the most part be distinguished from each other. Cracks can be noticed practically between all the grains. The maximum crack width is around 2 µm. The average grain size of marble is about 200 µm.

Figure 120. Marble from case 1. SE-image of fractured surface, 100x.

Figure 121. Marble from case 1. SE-image of fractured surface, 2500x.

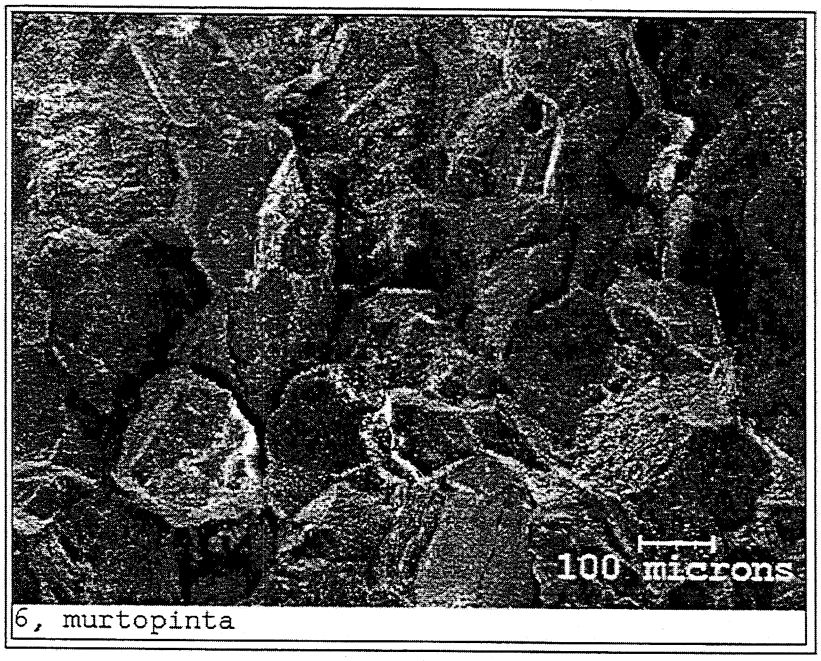
Figure 122. Marble from case 2, older part. SE-image of fractured surface, 100x.

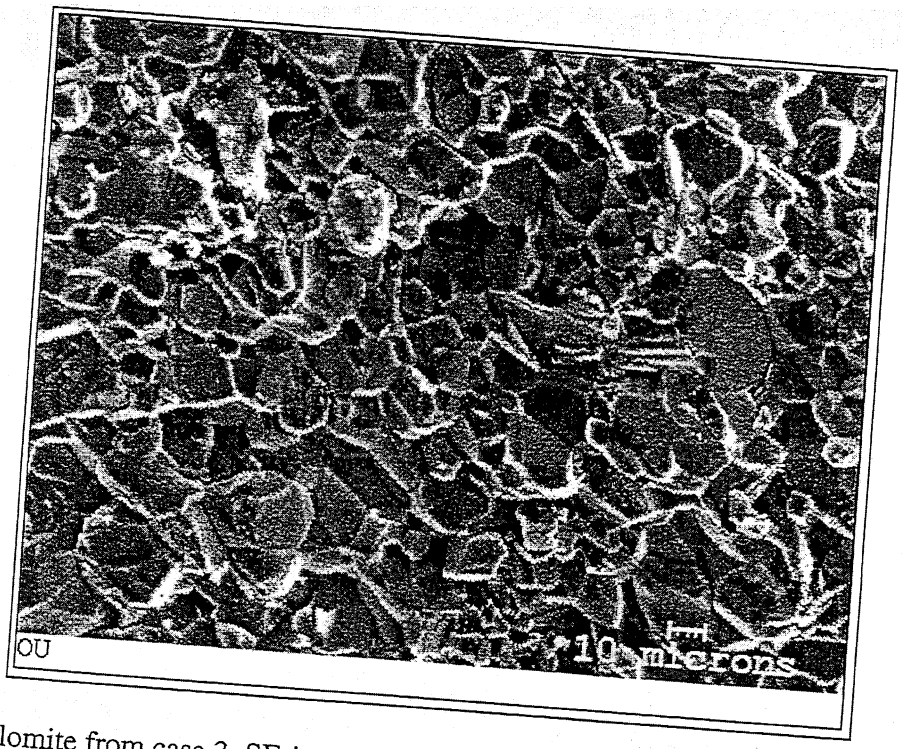
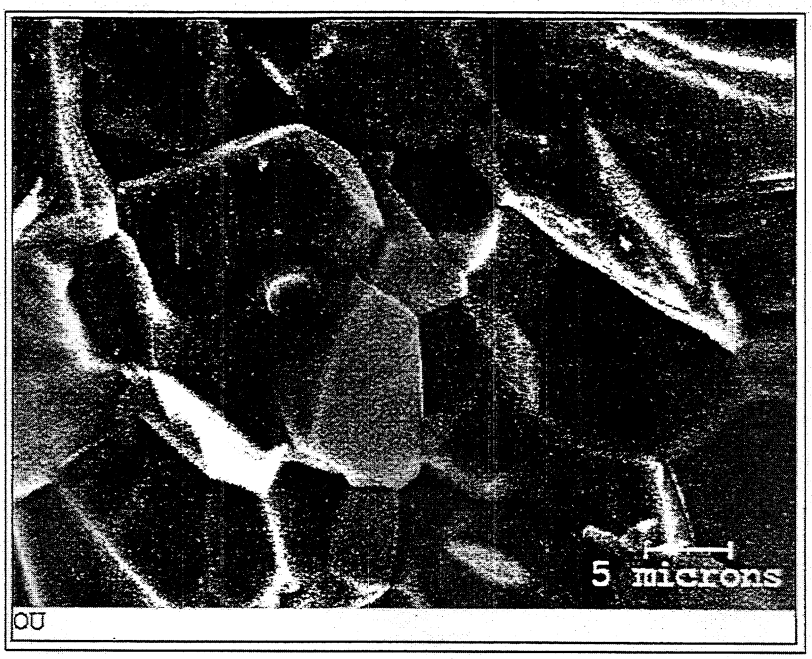
Figure 124. Dolomite from case 3. SE-image of fractured surface, 500x.

Figure 125. Dolomite from case 3. SE-image of fractured surface, 2500x.

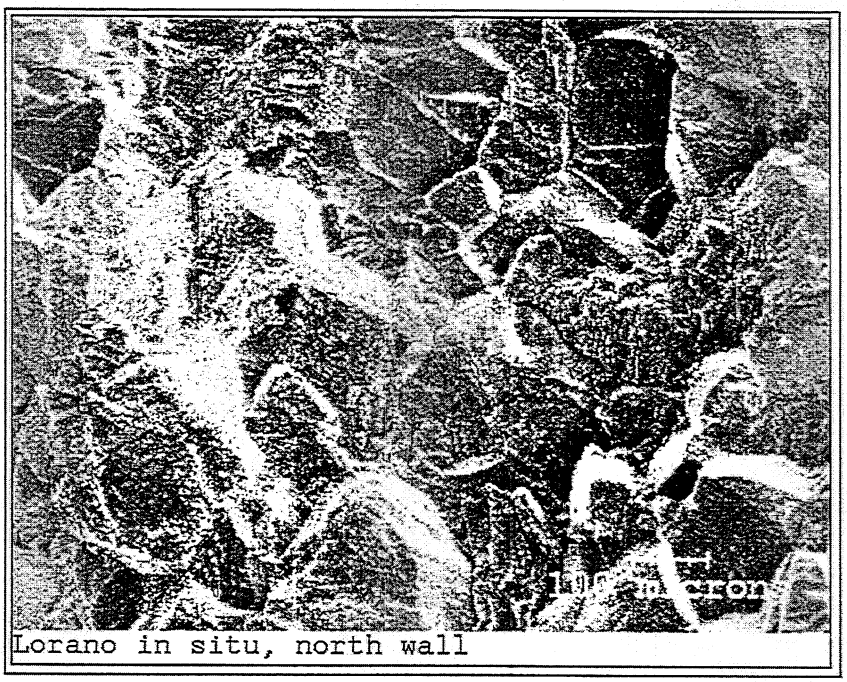
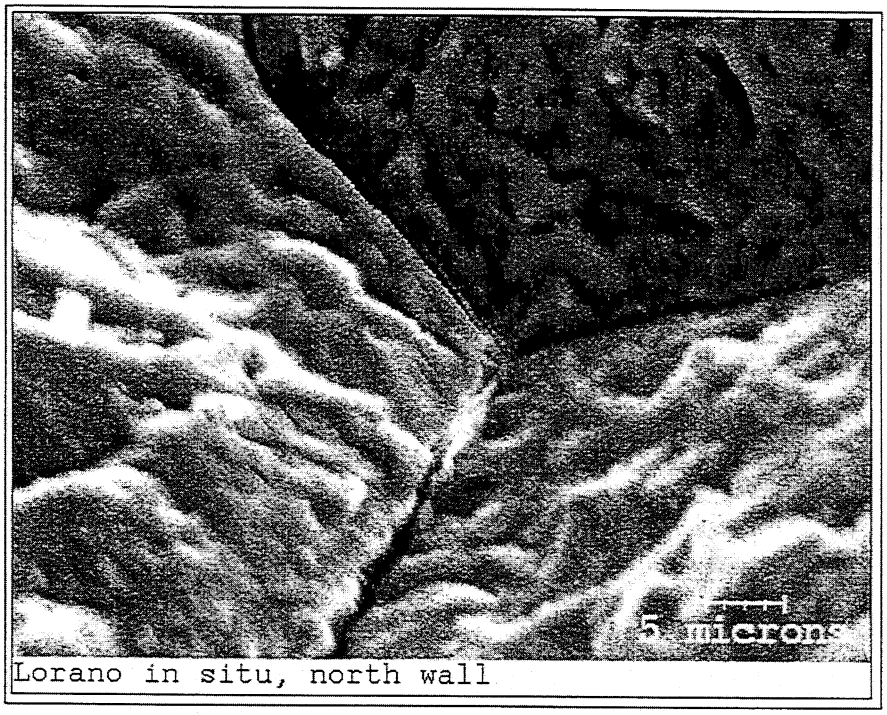
Figure 126. Marble from Finlandia Hall, north wall. SE-image of fractured surface, 100x.

Figure 127. Marble from Finlandia Hall, north wall. SE-image of fractured surface, 2500x.

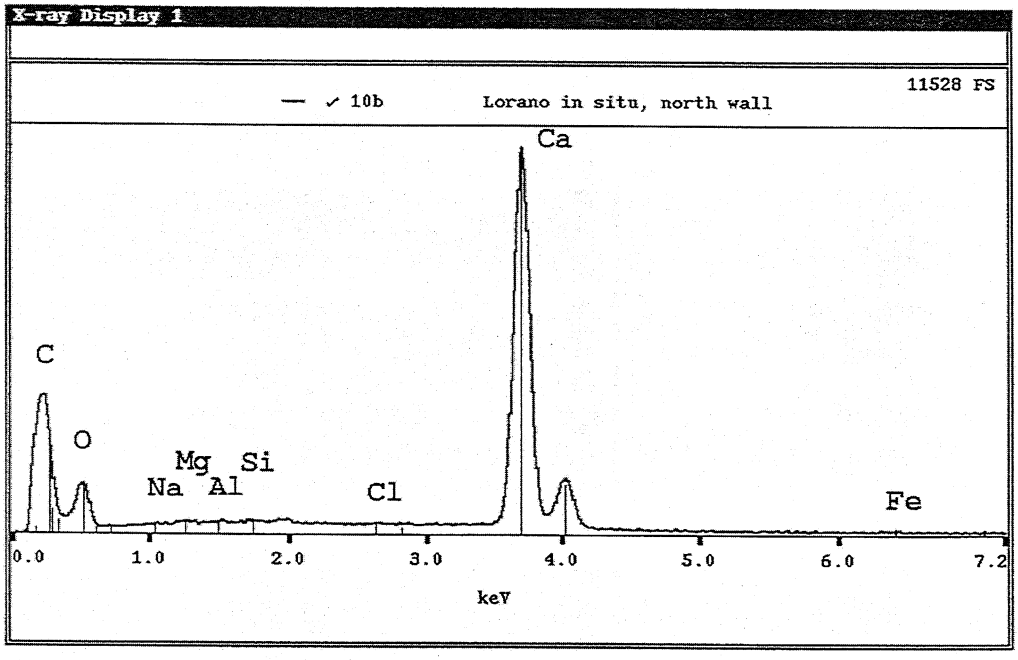
In connection with the SEM-study also the chemical composition of marble from the northern wall of Finlandia Hall was surveyed by using an energy dispersive PGT Imix spectrometer (EDS). The analysis was made from the fractured surface very close to the outer surface of the slab. The composition observed was practically that of the unused marble, only a little chlorine was detected. The EDS-spectra of marble are shown in Figs. 128 and 129.

Figure 128. EDS-spectrum of marble from Finlandia Hall, north wall.

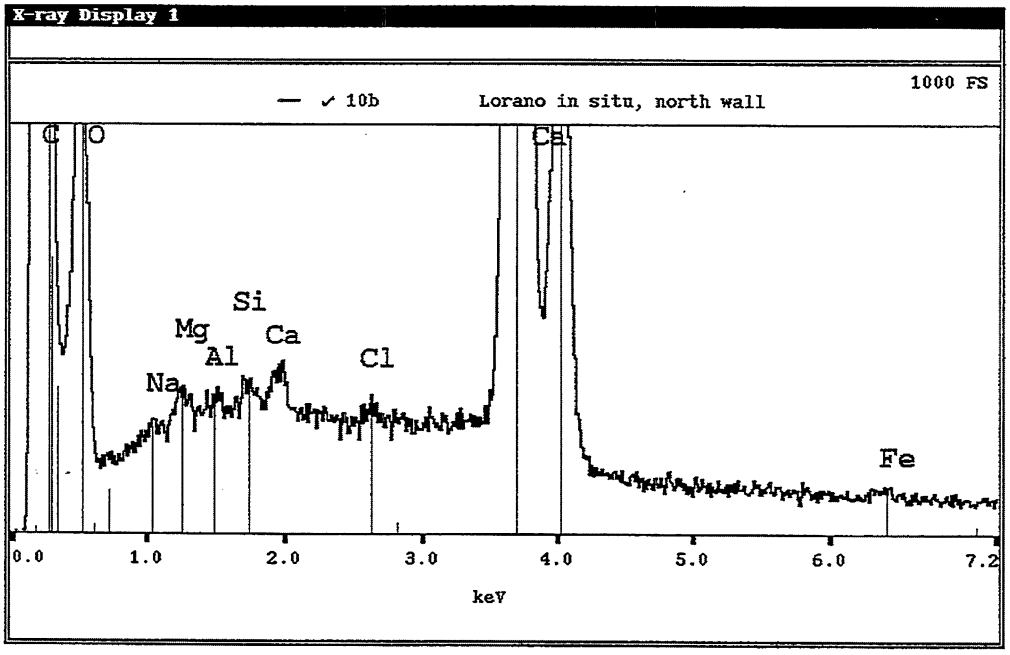
Figure 129. EDS-spectrum of marble from Finlandia Hall, north wall. Small peaks.
