FINAL TECHNICAL REPORT

ACRONYM : TEAM

TITLE : Testing and Assessment of Marble and Limestone

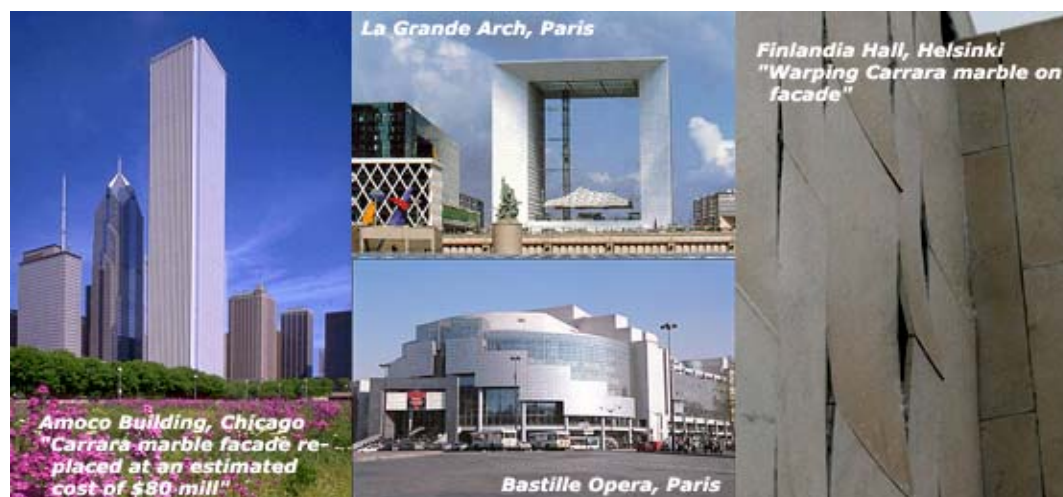
Figure A. Examples of some famous buildings clad with marble or limestone with durability problems.

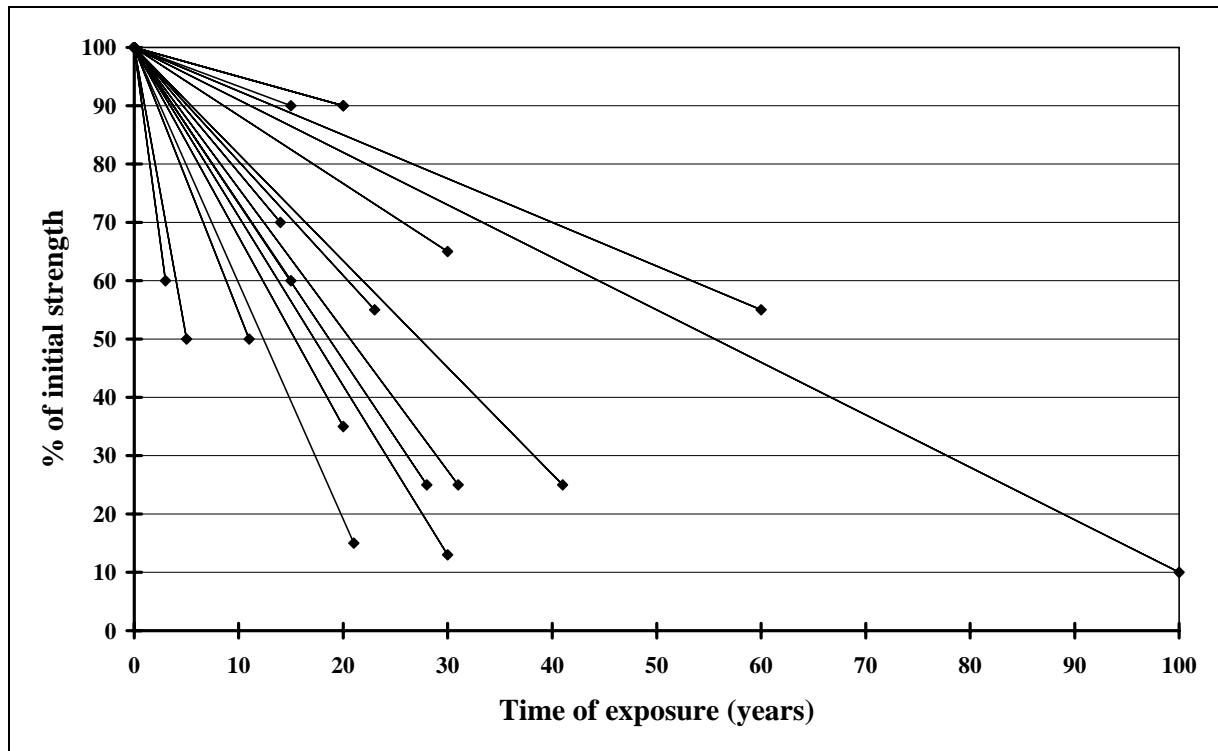
Case studies made by TEAM also show large strength loss as shown in figure 1.4; in the order of 80 % after 35 years for one calcitic marble and 40 % for one dolomitic marble. Laboratory studies performed by the authors (Schouenborg et al. 2000 and TEAM, 2001b) clearly indicate that there is no correlation between the amount of bowing and the loss of strength. This is especially worrying since there is a potential risk of severe strength loss without any evident bowing of claddings.

Figure 1.4. The relative loss of flexural strength of marble panels exposed to outside climates.

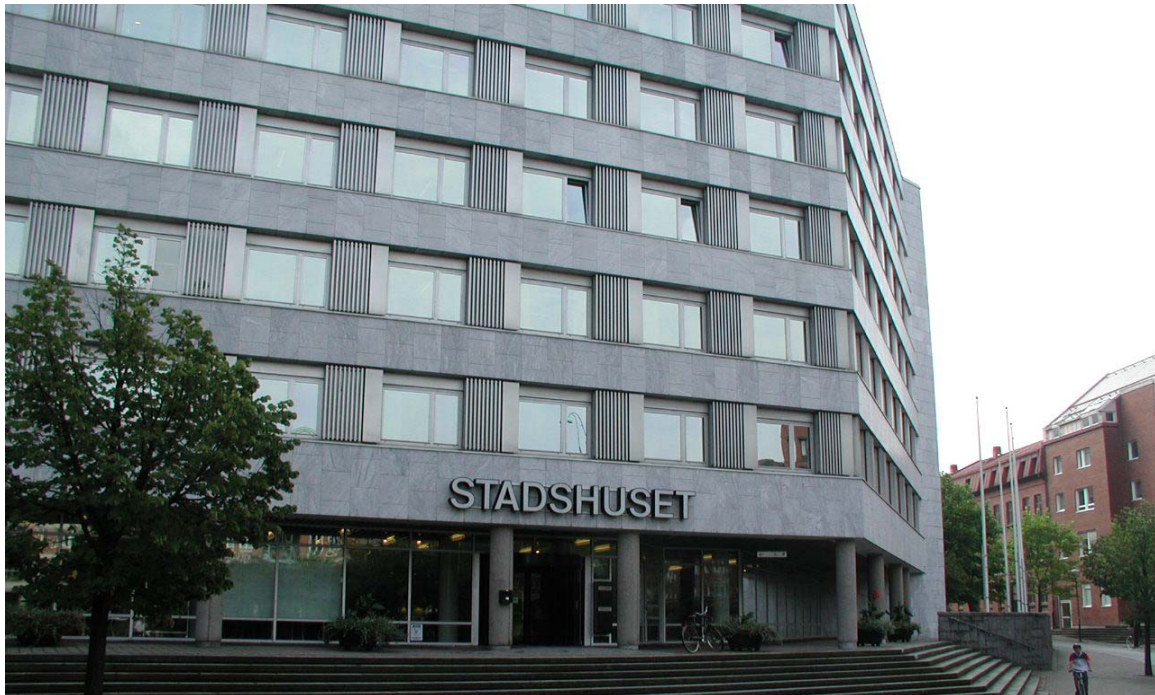
It is also equally important to draw the attention to the fact that many marble and limestone claddings and pavements tend to be durable and robust, provided that the correct quality has been use (e.g. as seen in figure 1.7).

Figure 1.7. The Malmö Stadshuset (City hall), S. Sweden; An example of a 30 year old marble facade with no signs of deterioration or damages.

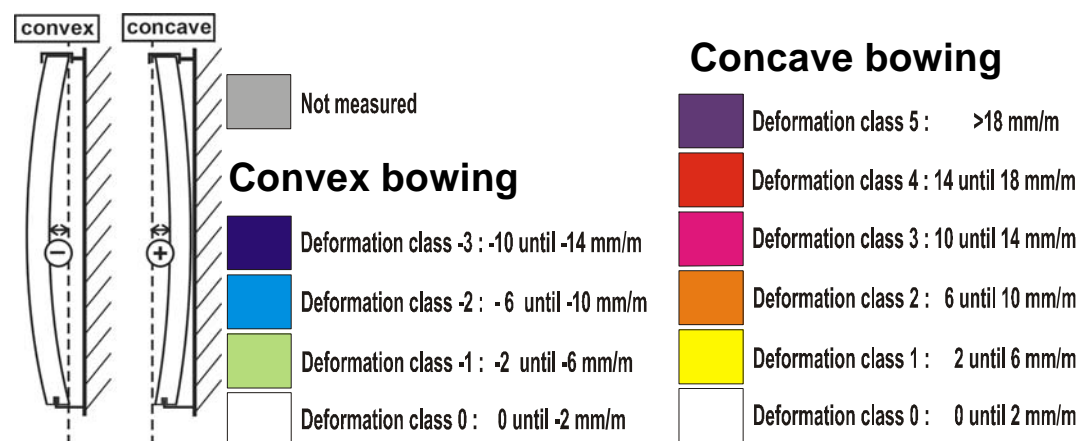
Figure 2.5. Definition of bowing value, deformation classes and colour codes.

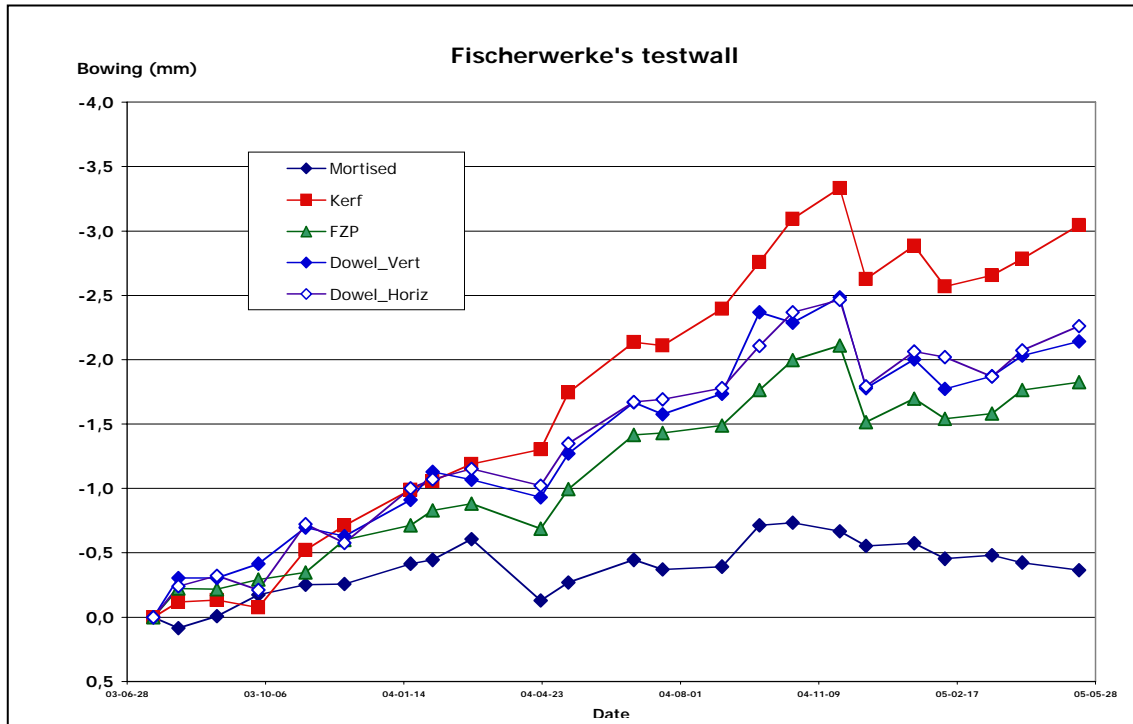
1. Panels installed mortised are bowing significantly less than the other types. Panels installed on continuous rails have the most significant bowing and the three remaining types show roughly identical bowing behaviour (figure 2.13).
2. All slabs located in bottom row bow less than all slabs in top row. Slabs in middle row in most cases have shown amplitudes between those of the top row and the bottom row. See curve diagrams figure 2.14 below.
3. The type of application has an obvious impact on the extent of bowing but is not a method to avoid bowing. Pending on the "rigidity" of the application, the bowing will be more or less significant.

Figure 2.13. Mean values for bowing (always convex, i.e. bowing outwards) for each type of application.

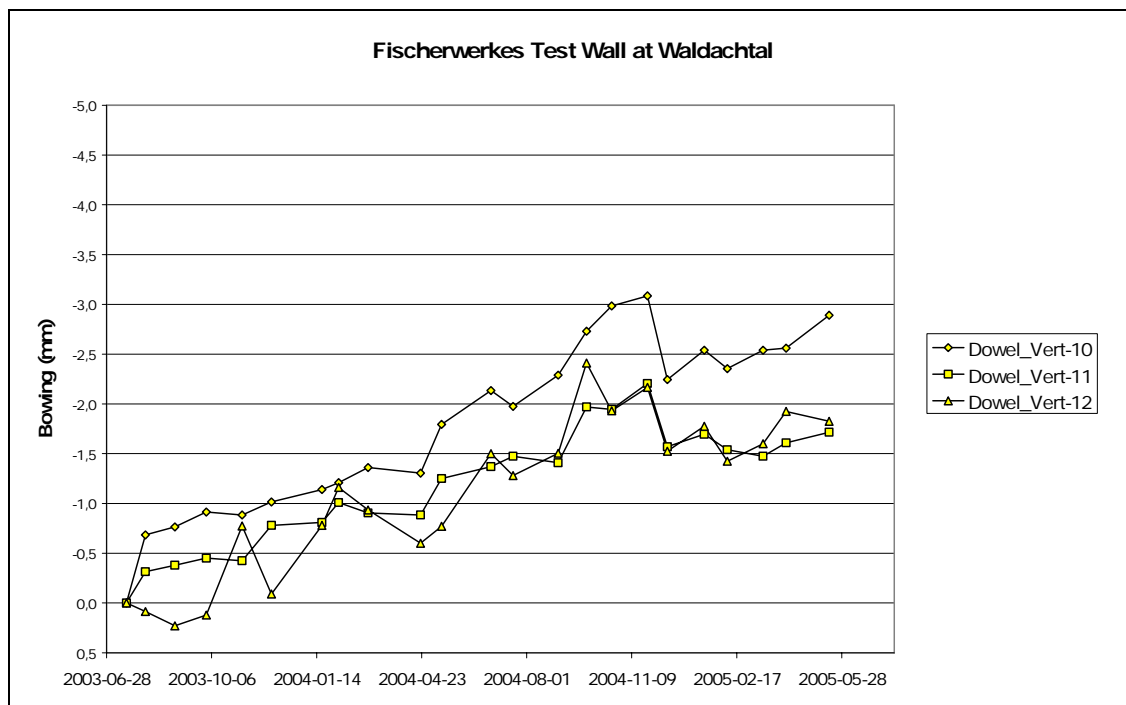
Figure 2.14. Bowing amplitudes – Dowel vertically. Wall slabs bowing development for top, middle and bottom rows.

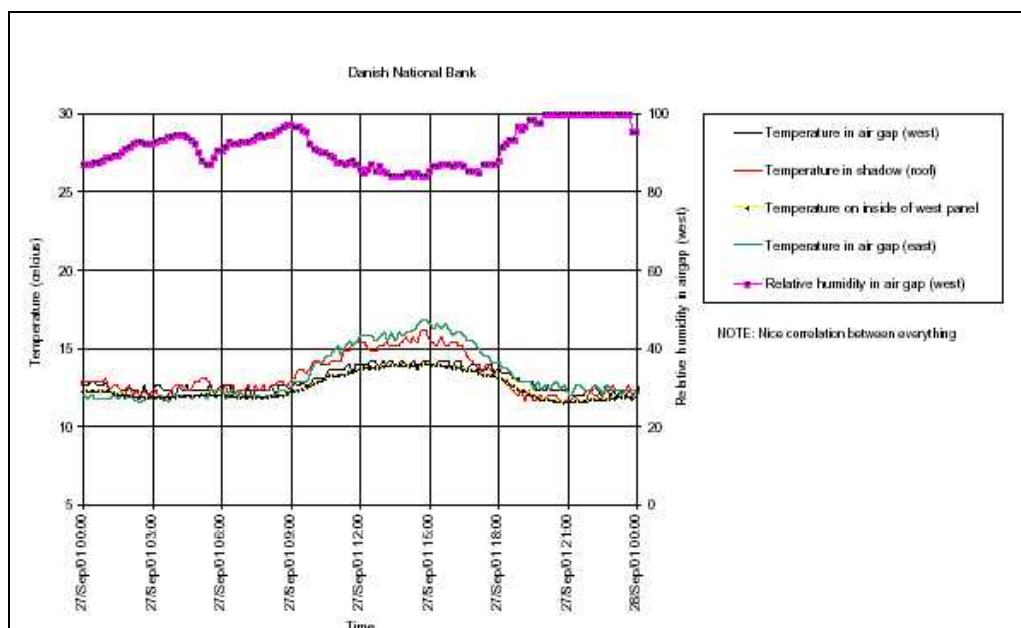
Amongst the most interesting results from the Danish National Bank in Copenhagen is the fact that there is very little difference between the temperatures on the front and back of the panels – only a few minutes ‘lag’ (figure 3.3). On the eastern side the front can be 4 °C warmer when the sun first shines on this face. The full temperature rise can take 6 hours but in more extreme cases the rate is around 0,3 °C per minute and this information has been used in the development of the bowing test.

Figure 3.3. Temperature and humidity data, Copenhagen

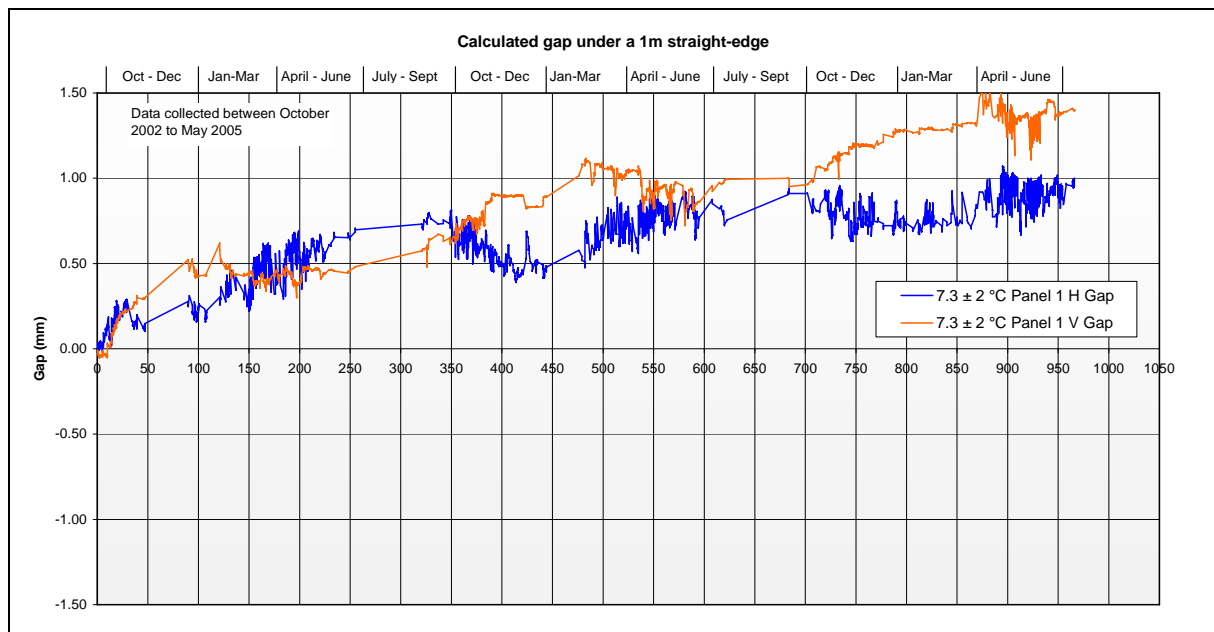
Figure 3.4 shows Panel 1 which was removed from the building in November 2002 and replaced on new fixings. The pattern of movement seems to show a fairly rapid bowing immediately after the panel was replaced – possibly as it moved back against the fixings- followed by a long period with very little movement.

Figure 3.4. Panel 1 at Nyköping – an existing panel of Carrara Marble removed and refixed.

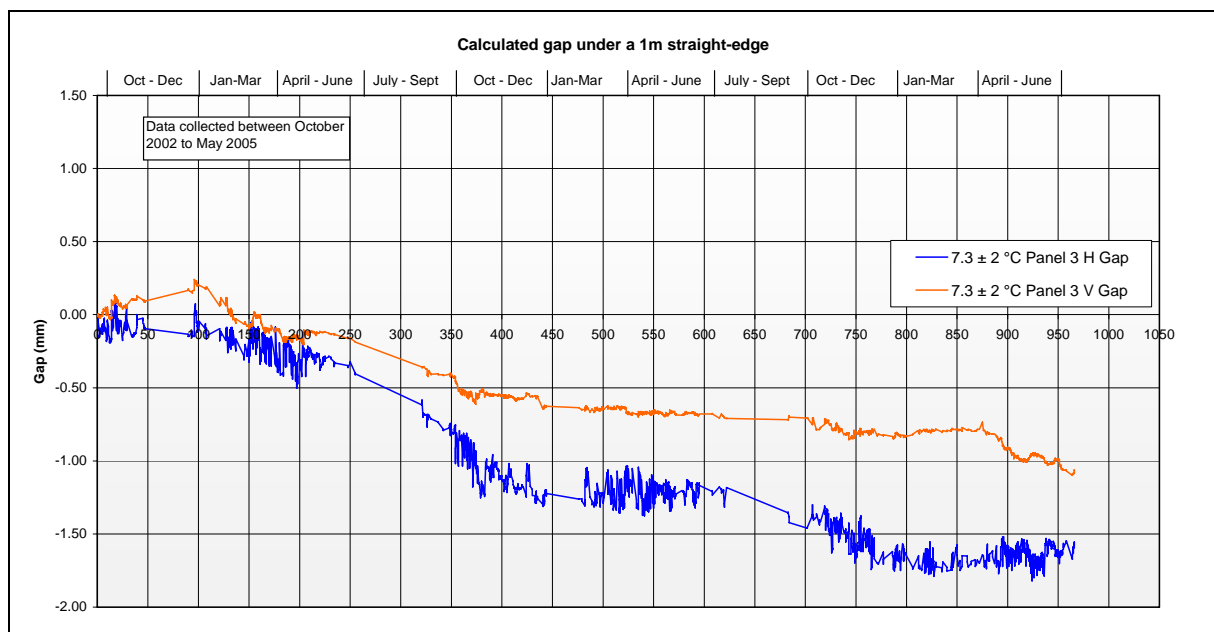
Figure 3.5 shows Panel 3 which was a panel of new Carrara marble. Note that the panel is bowing in the opposite direction to Panel 1 and that the magnitude of the bowing is also much greater.

Figure 3.5. Panel 3 at Nyköping – a new panel of Carrara Marble

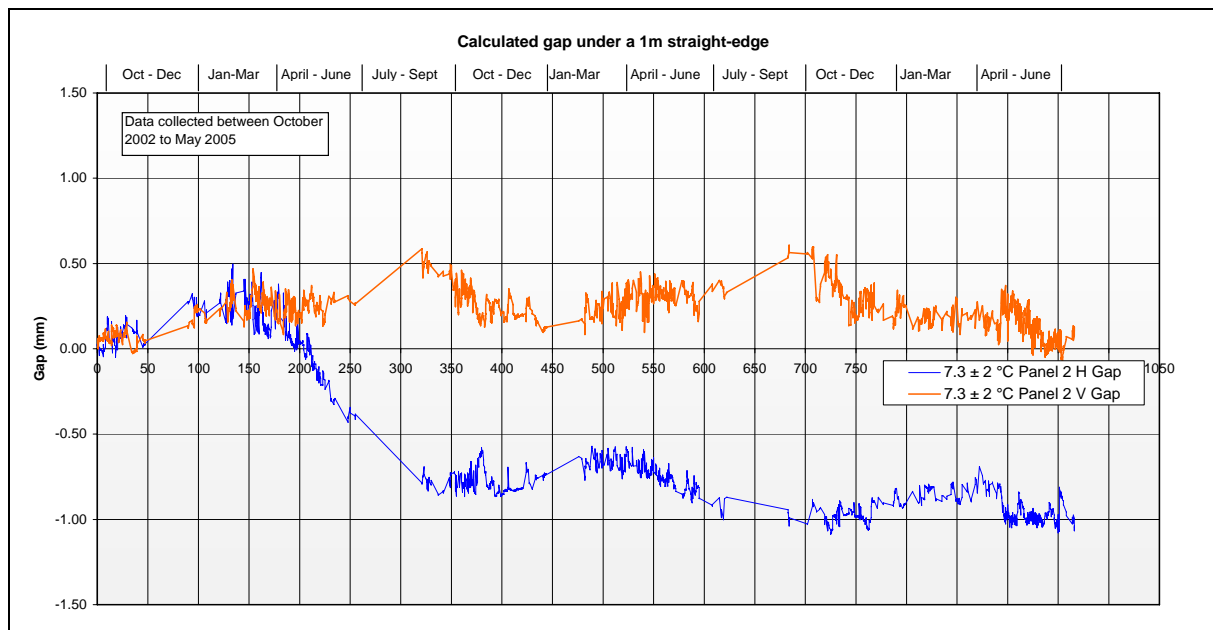
Figure 3.6 shows Panel 2 at Nyköping which was a panel of new Carrara marble that was treated with a hydrophobic coating. The treatment was intended to reduce the bowing. Initial the rate seemed to be reduced but it is not clear now quite what is happening except the panel seems to be move far more on the horizontal axis than on the vertical axis.

Figure 3.6. Panel 2 at Nyköping – a new panel of Carrara Marble treated with a hydrophobic coating.

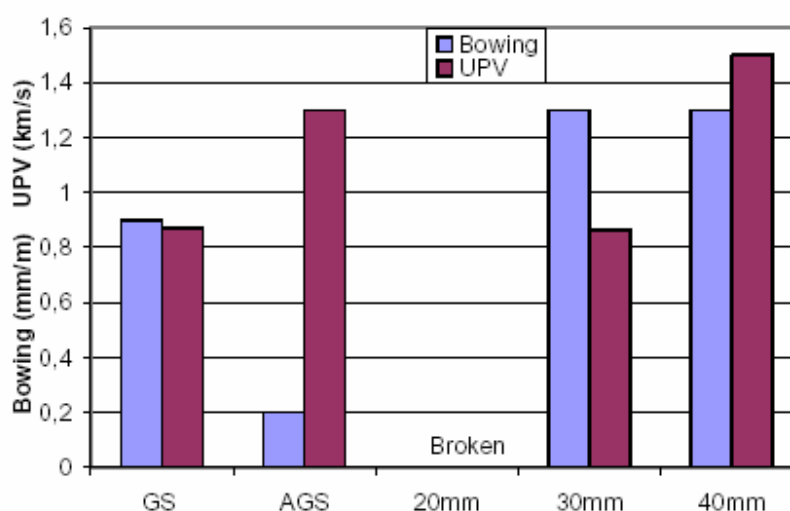
Figure 7.1. Absolute and permanent bowing for itq2 after three years exposure at Nyköping City Hall.

The panels were measured regularly to determine the permanent bowing using both strain gauges and the bow-meter. In addition, changes in UPV were also measured at regular intervals. Figure 7.1 (above) shows the results for the bow-meter and UPV measurements after three years of exposure. The AGS treatment appears to have inhibited the bowing of the panels with the same observations on both new and old panels. There is no apparent difference in the UPV values suggesting that the stones may still undergo some internal changes influencing the gradual disintegration.

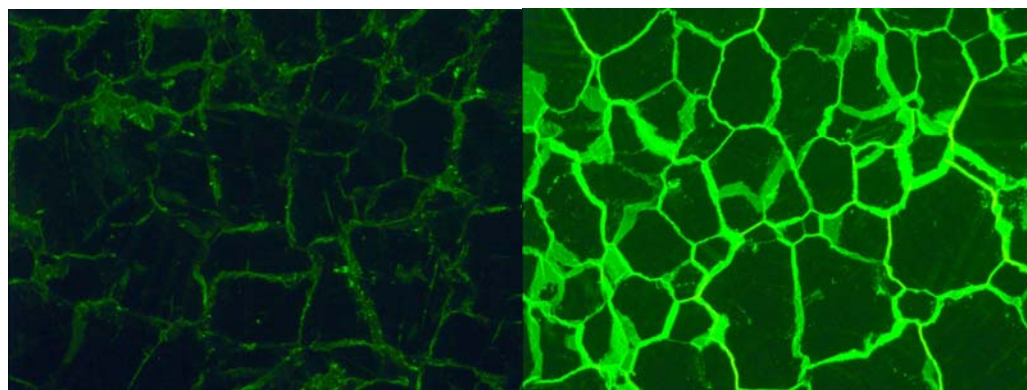
The influence of the water is also not totally clear but we know that stresses are built up both during wetting and drying processes and we know that most marble types with a bowing potential have more open grain boundary compared to the non-bowing types (figure 7.2). This enhances the ingress of water and larger capillary forces to act on the micro-scale for the unsuitable marble types. Furthermore, the energy needed for crack initiation and propagation is lower in a wet rock when compared to a dry one. The reason for this is that the energy increase is higher when a solid-solid contact is replaced with a solid-air contact compared to a solid water contact.

Figure 7.2. Fluorescent micro-photo of non-bowing marble to the left and a bowing one to the right. The marble to the right has a high proportion of cracks between the individual grains.
