# VTT BUILDING AND TRANSPORT

### Developing long term durability of marble facades

#### Subproject "Test wall"

Espoo, April 20, 2001

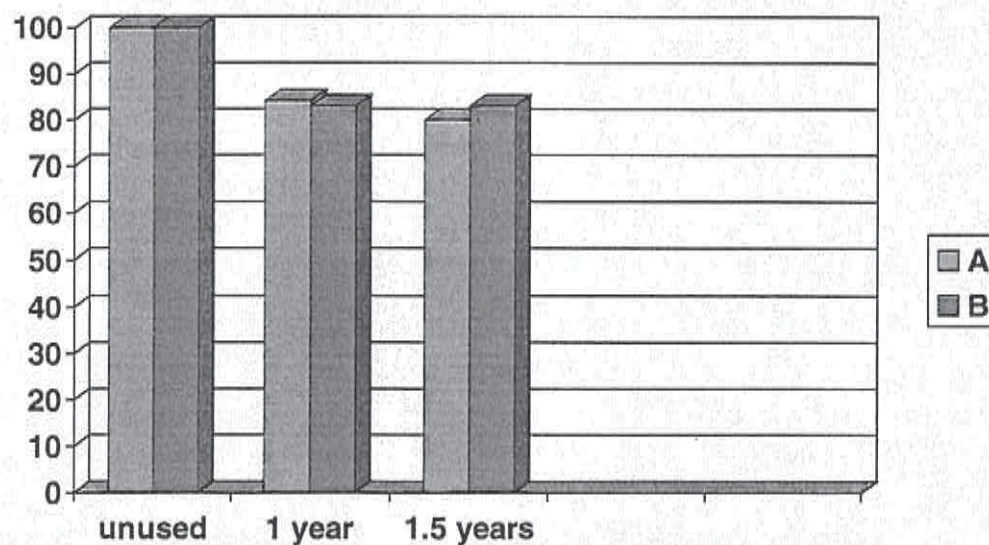
marble	$\Delta R_{rf}$	
	1 year %	1.5 years %
A		
direction A	-16	-20
direction B	-17	-17
D		
direction A	-35	-34
direction B	-48	-42
E		
direction A	-17	+11
direction B	+20	+21
K		
direction A	-3	-2
direction B	-2	+4

The loss of marble strength on the test wall is illustrated also in Figs. 3-6. In each case the flexural strength of unused marble has been given the value of 100.

**Figure 3.** Flexural strength of marble A. A relative scale.

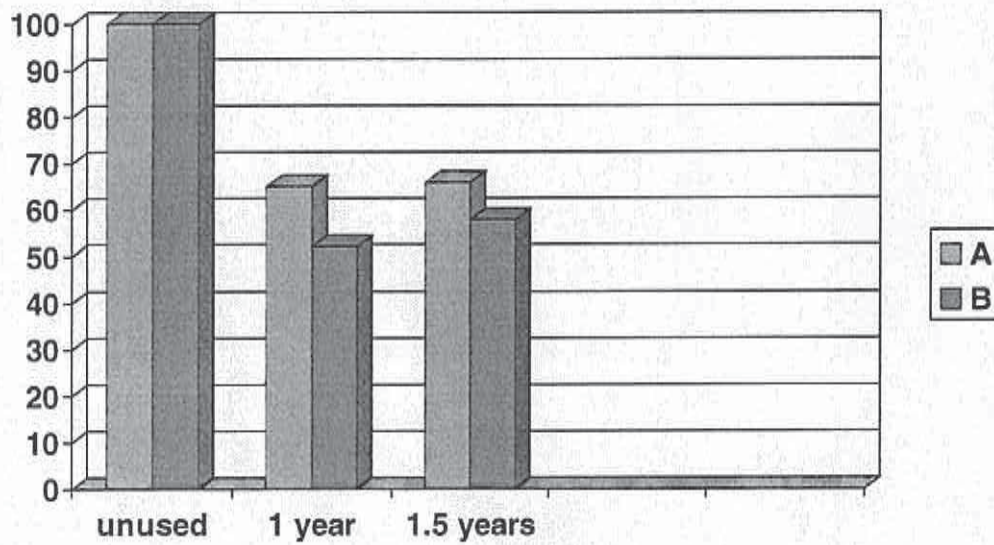
Figure 4. Flexural strength of marble D. A relative scale.

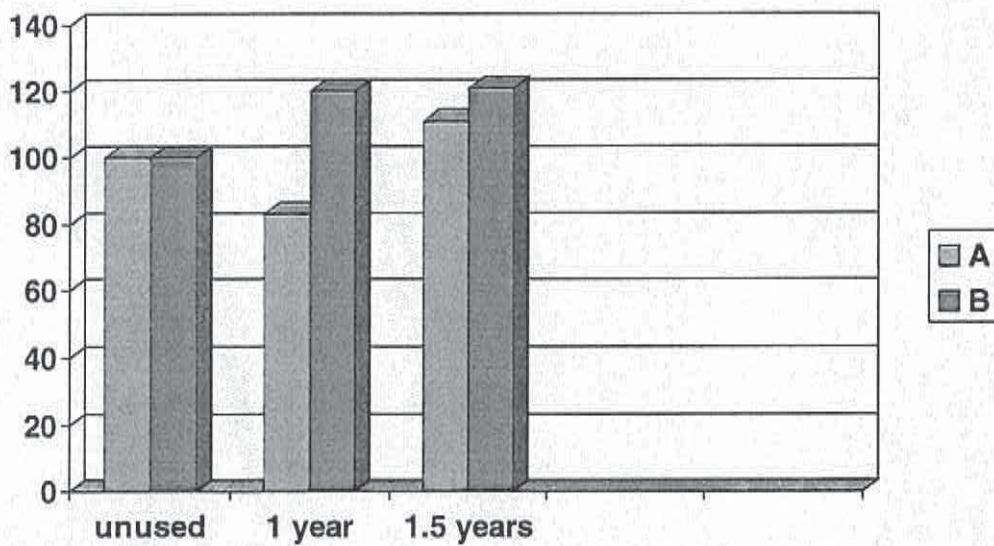
Figure 5. Flexural strength of marble E. A relative scale.

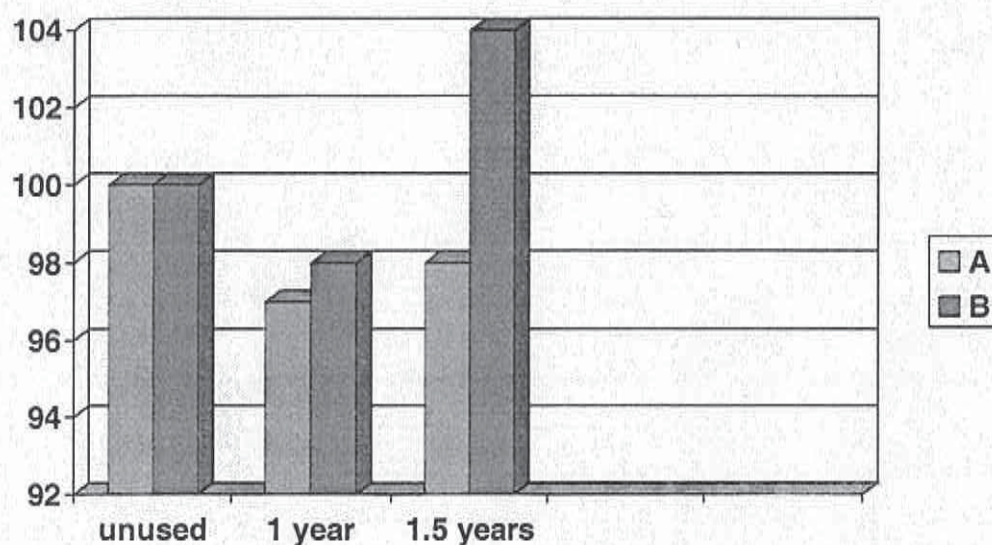
Figure 6. Flexural strength of marble K. A relative scale.

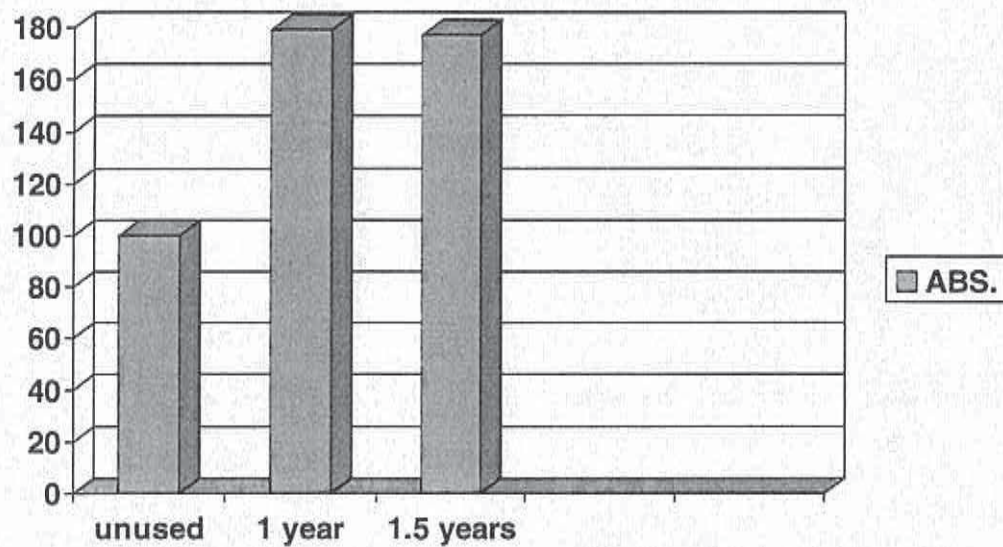
marble	$\Delta W$		$\Delta p_o$	
	1 year %	1.5 years %	1 year %	1.5 years %
A	+79	+77	+78	+76
D	+92	+77	+92	+76
E	+12	+9	+13	+9
K	+57	+51	+56	+50

The increase of water absorption and porosity on the test wall is illustrated also in Figs. 9-12. In each case the water absorption (porosity) of unused marble has been given the value of 100.

Figure 9. Water absorption (porosity) of marble A. A relative scale.

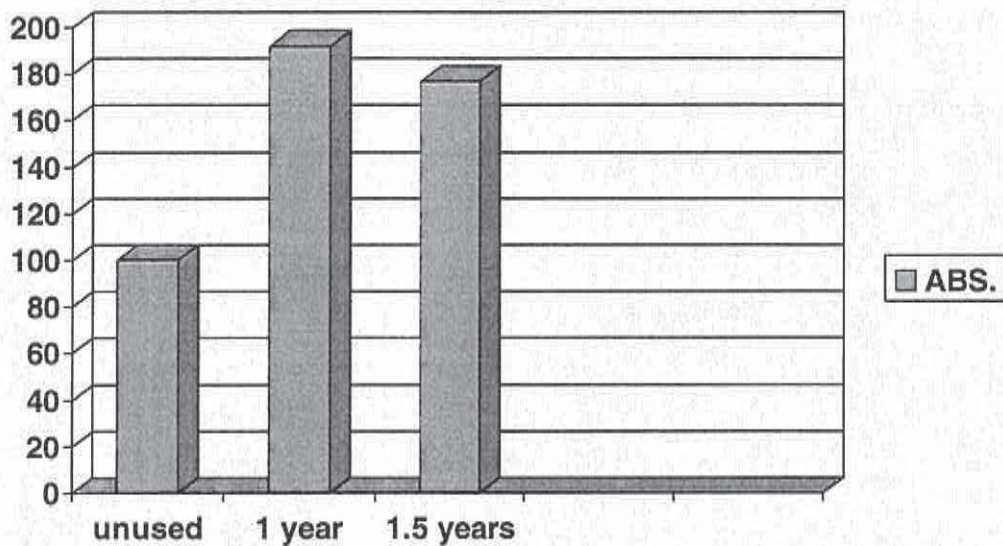
Figure 10. Water absorption (porosity) of marble D. A relative scale.

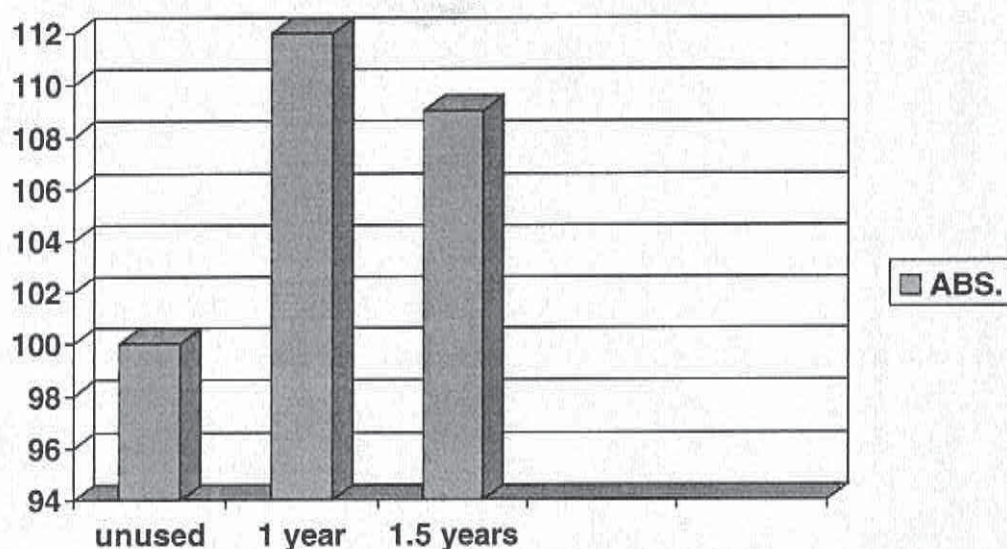
Figure 11. Water absorption (porosity) of marble E. A relative scale.

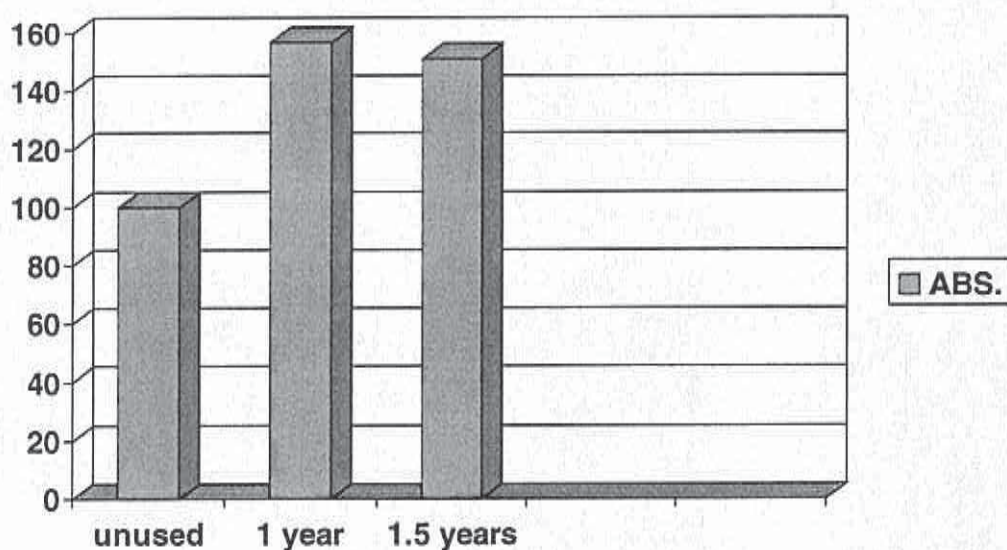
Figure 12. Water absorption (porosity) of marble K. A relative scale.

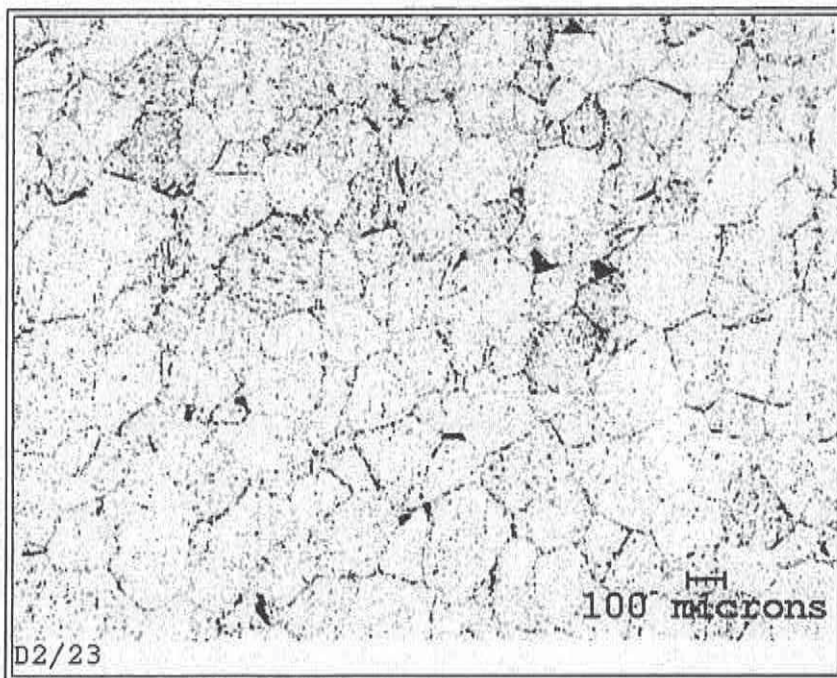
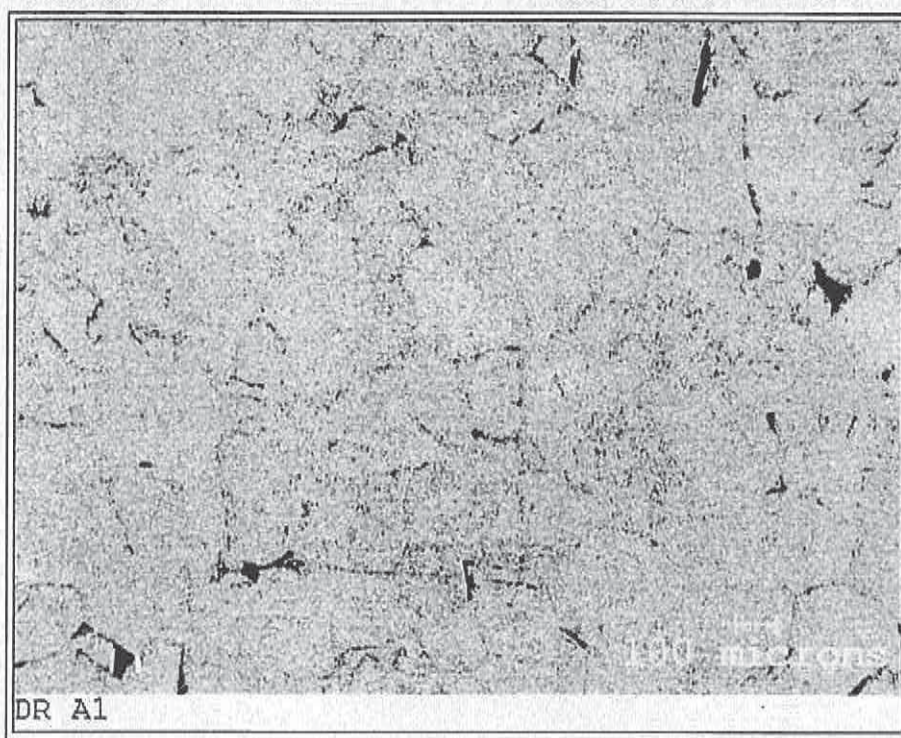
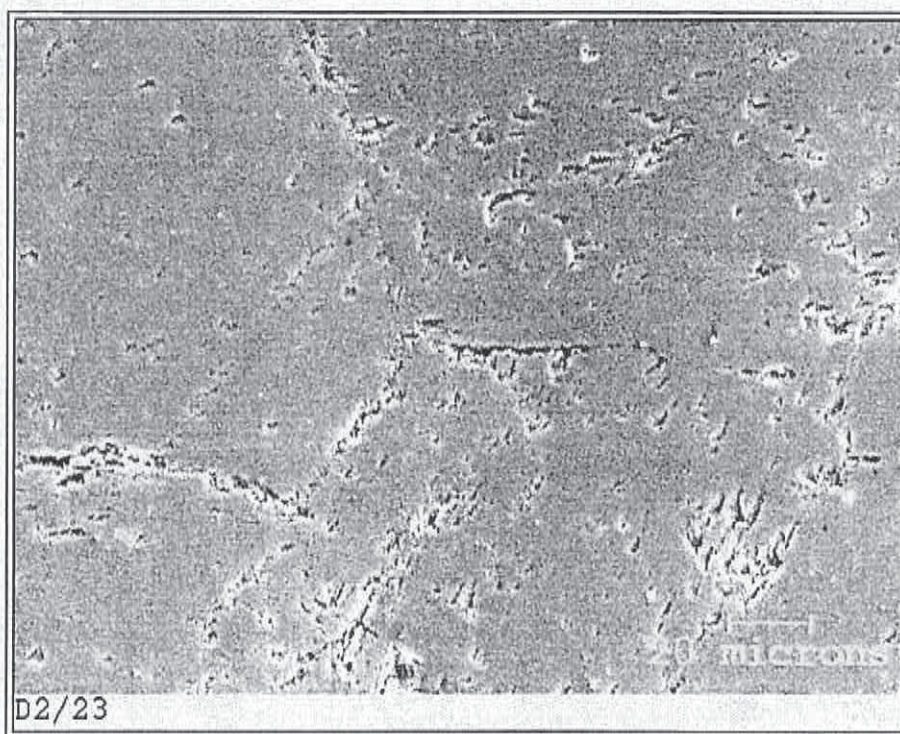
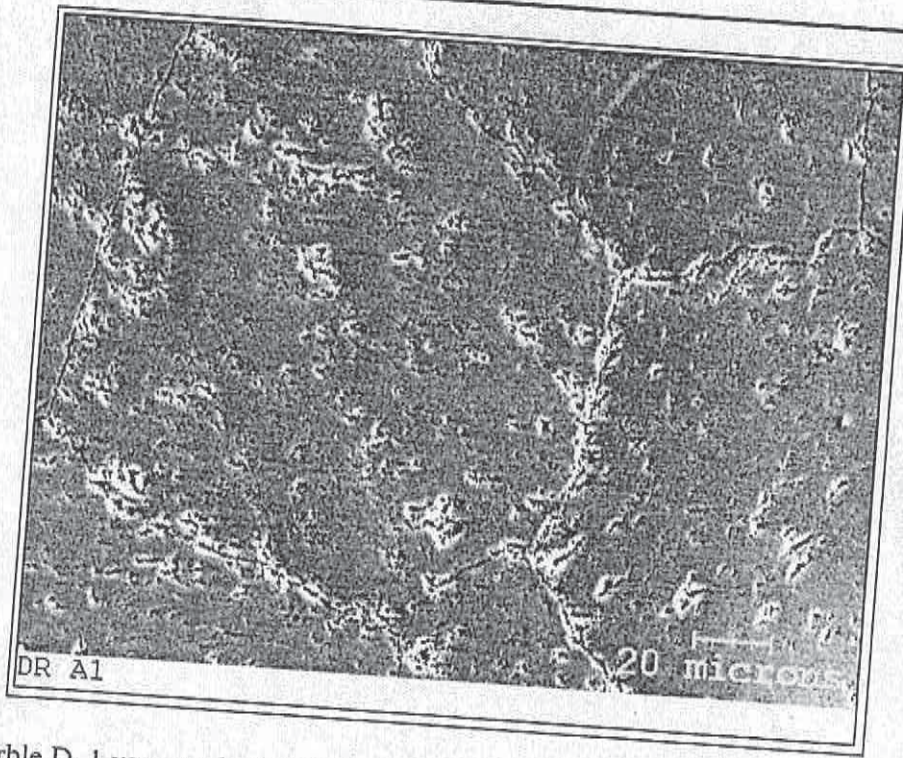
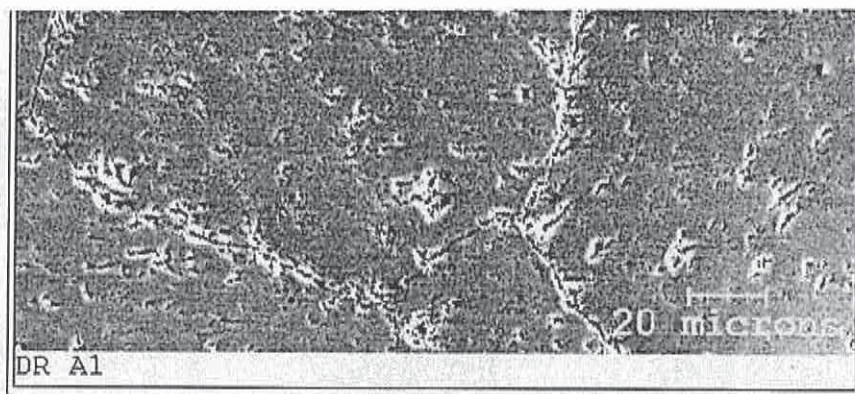
BSE- and SE-images of marble D, both unused and after 1 year on the test wall, are shown in Figs. 41-44. Grain boundaries can clearly be distinguished. Stresses caused by 1 year on the test wall seemed to affect the structure of the marble in such a way that the grain boundaries could be distinguished even more easily.

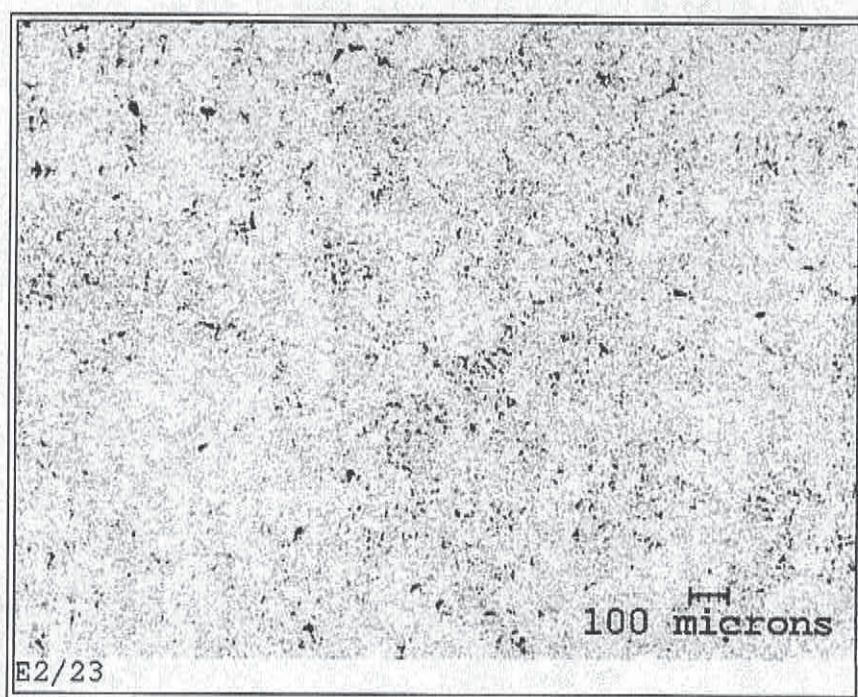
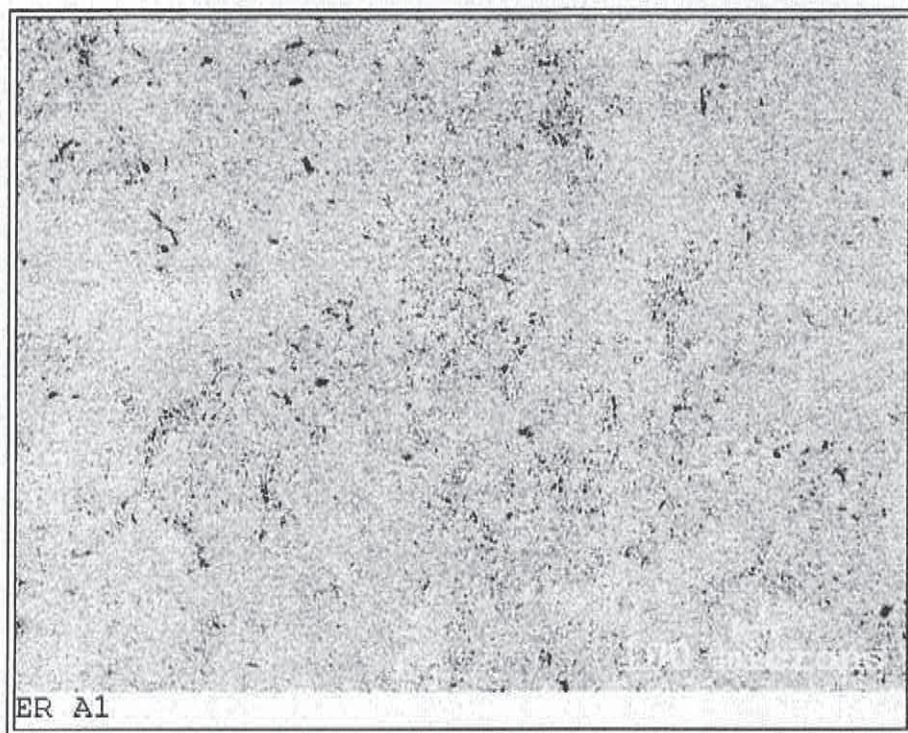
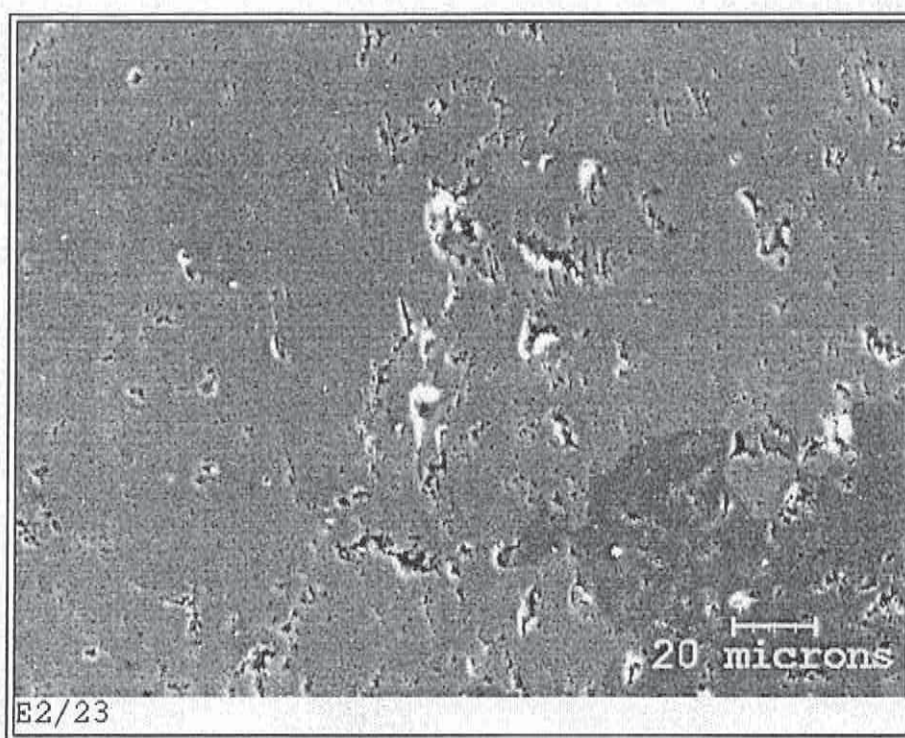
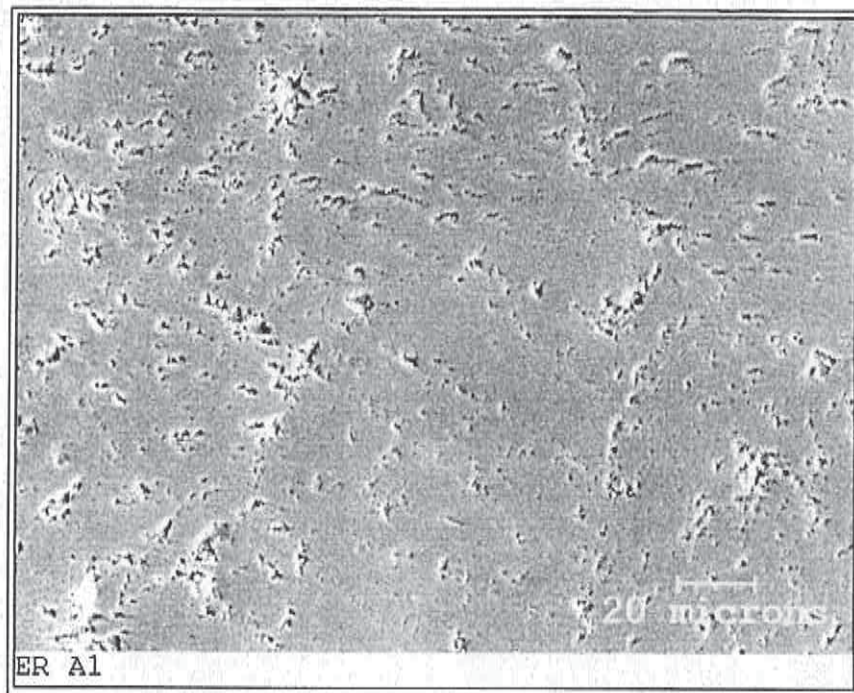
BSE- and SE-images of marble E, both unused and after 1 year on the test wall, are shown in Figs. 45-48. Grain boundaries can only partly and even then very vaguely be distinguished. No changes could be seen in the structure of the marble after 1 year on the test wall.

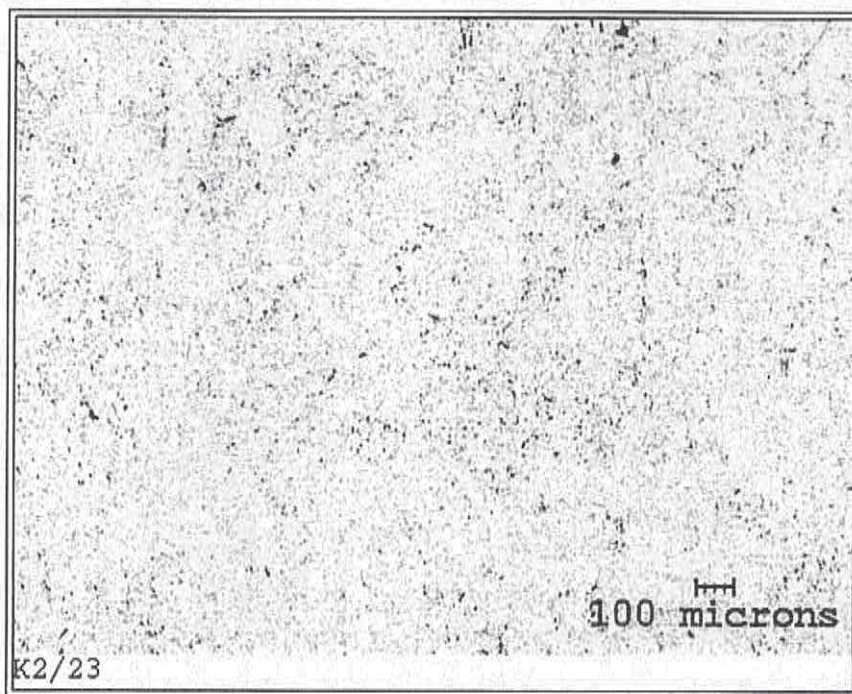
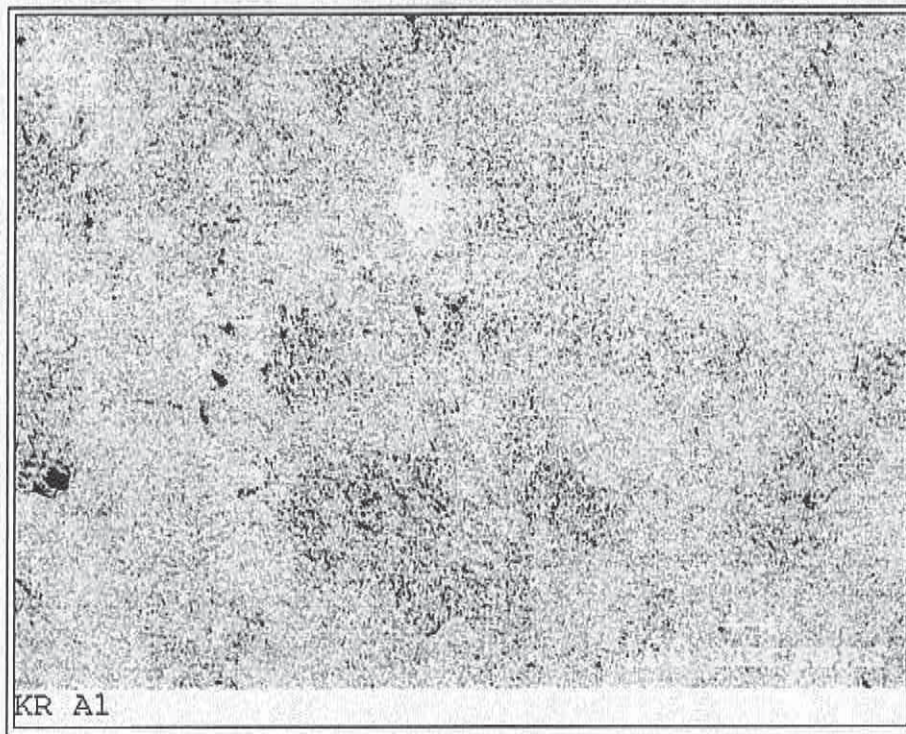
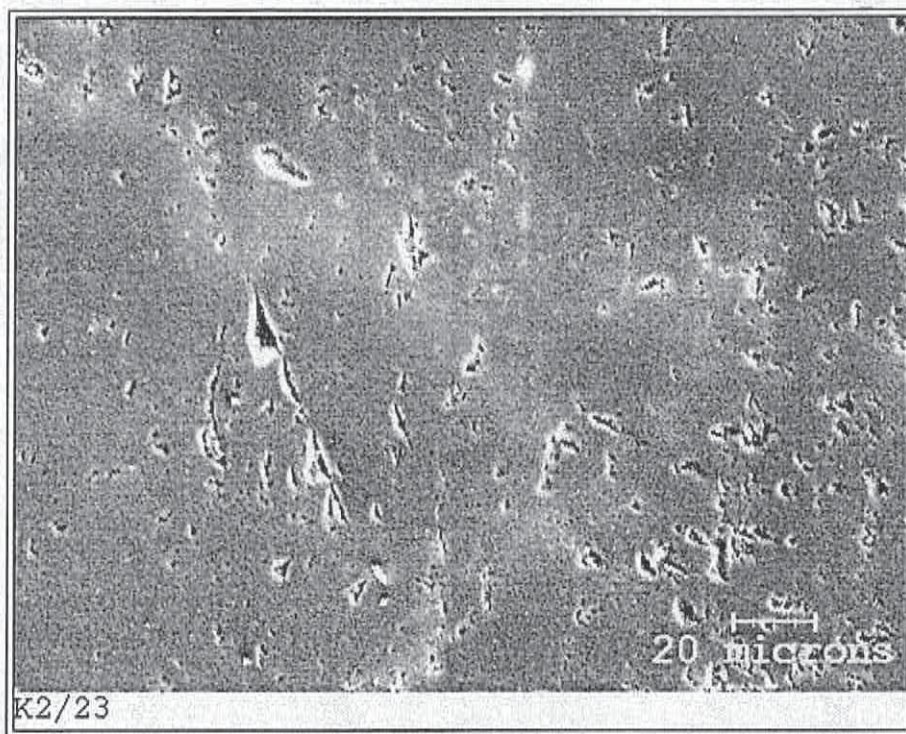
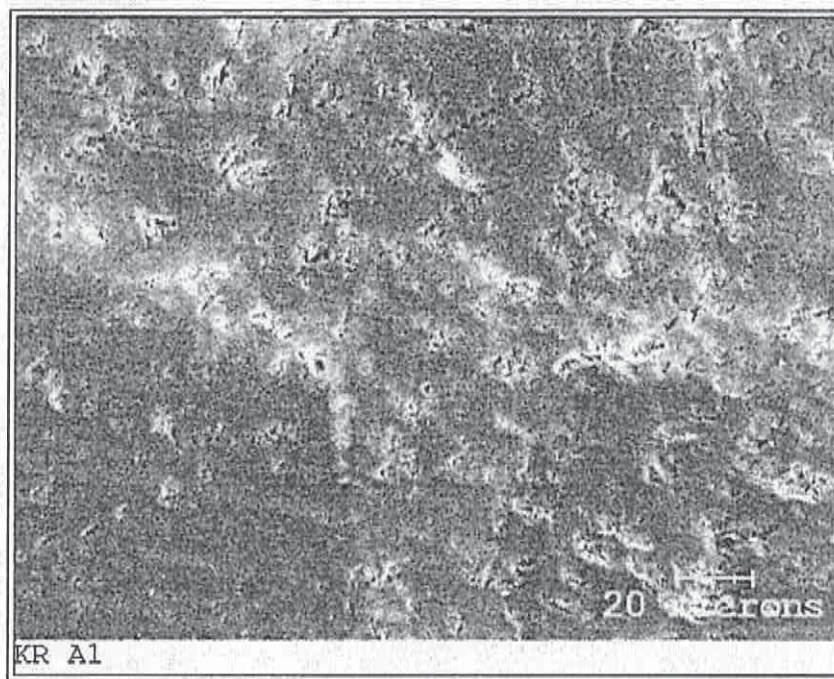
BSE- and SE-images of marble K, both unused and after 1 year on the test wall, are shown in Figs. 49-52. Grain boundaries can only partly and even then very vaguely be distinguished. No changes could be seen in the structure of the marble after 1 year on the test wall.

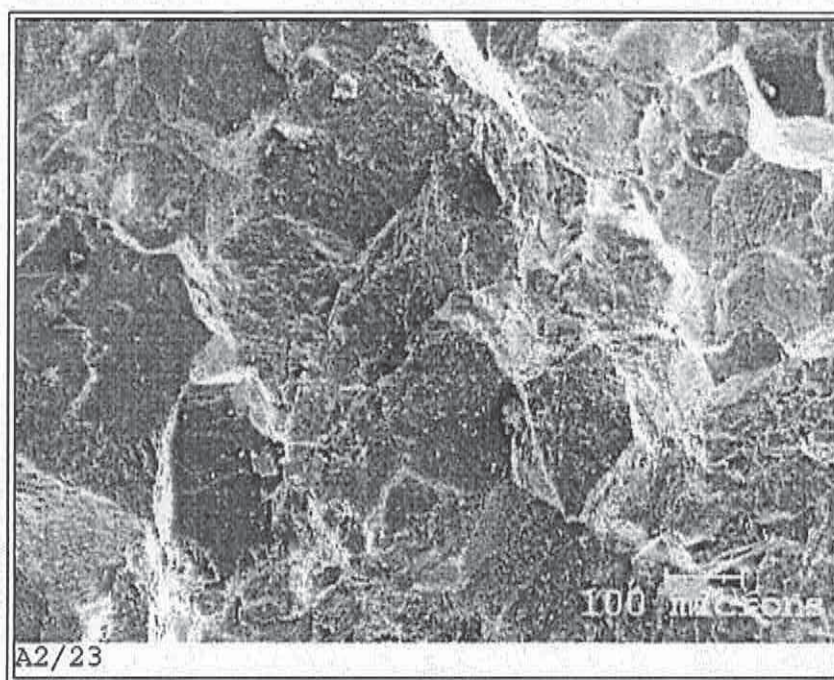
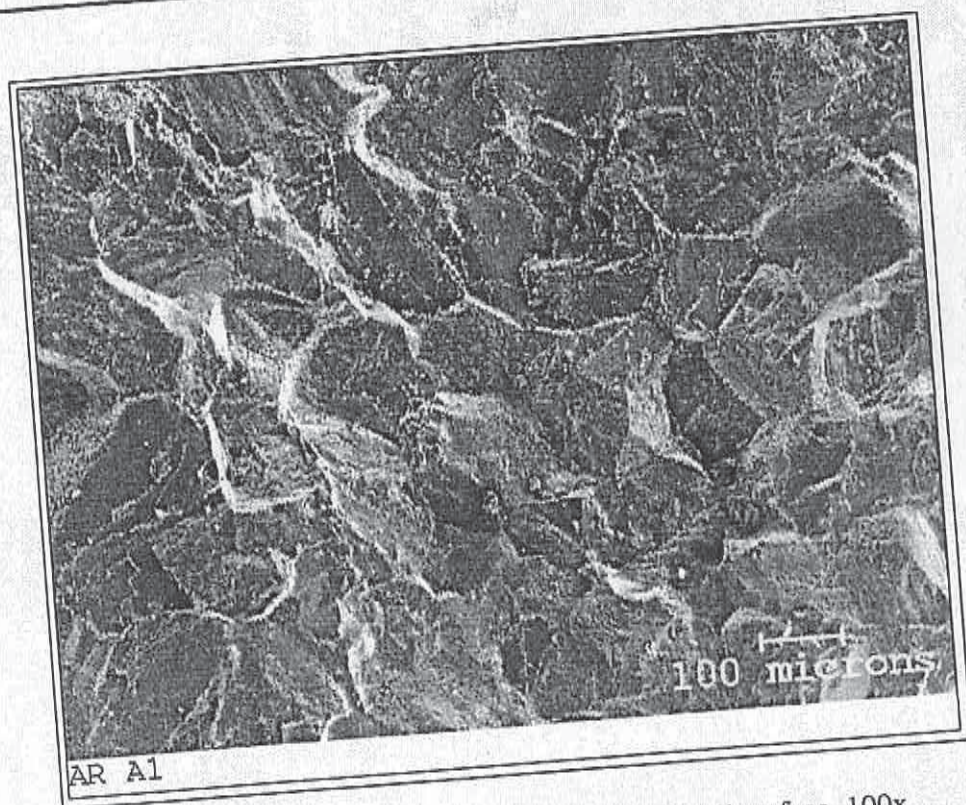
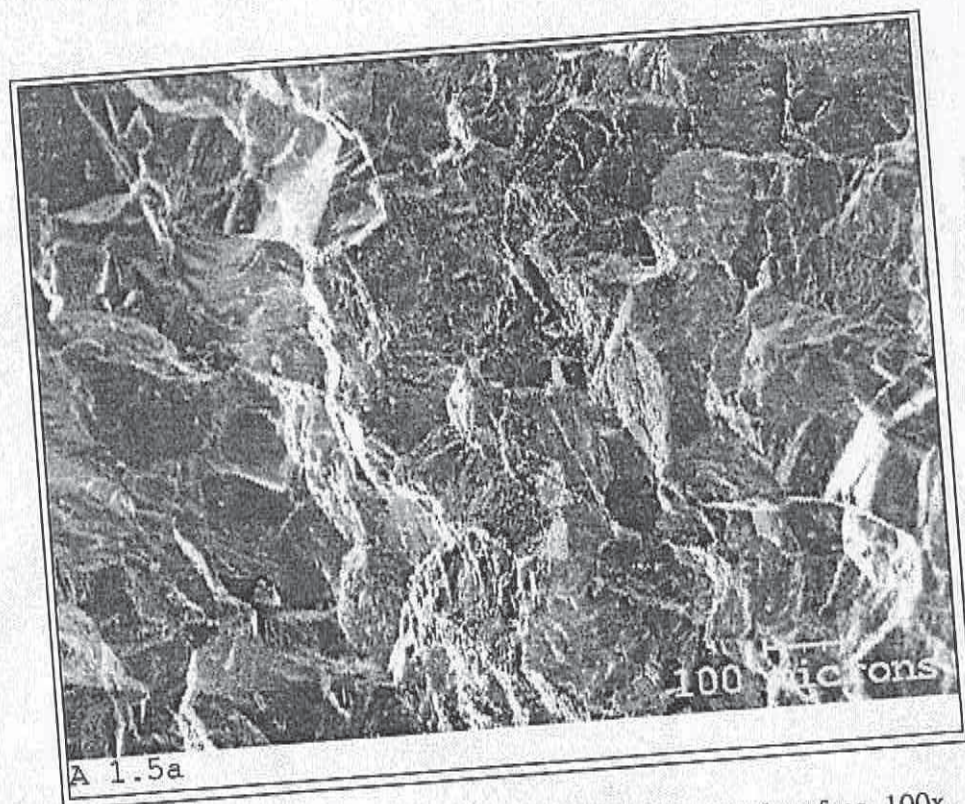
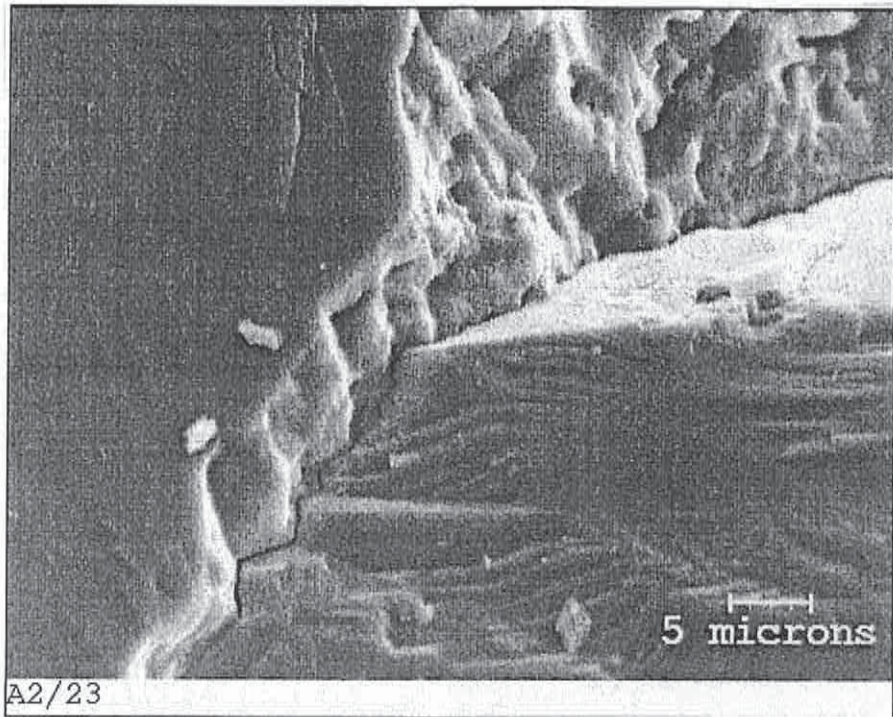
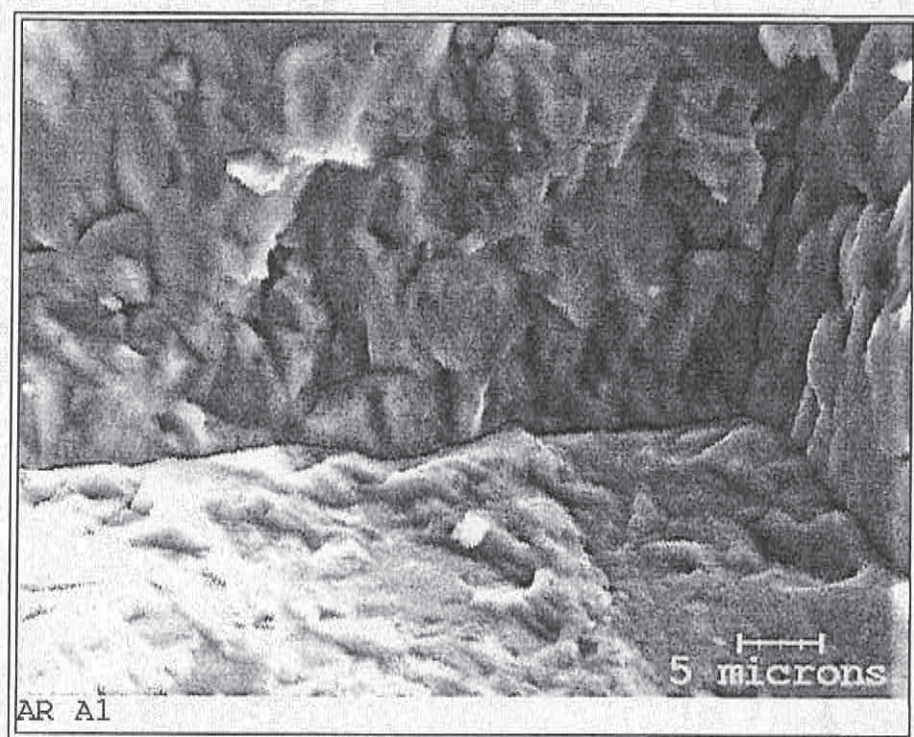
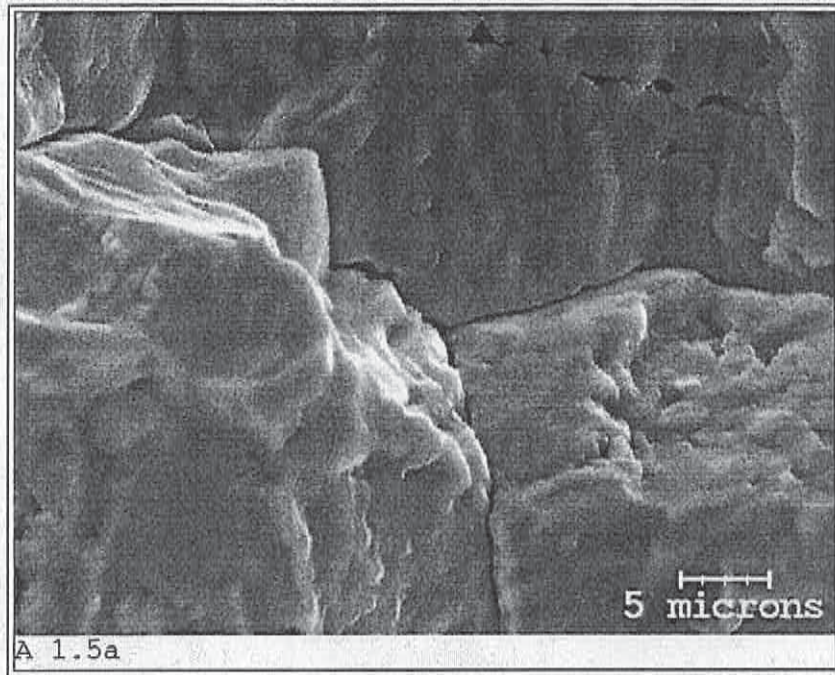
SEM-pictures of fractured surfaces of marble A, both unused and after 1 and 1.5 years on the test wall, are shown in Figs. 53-58. The individual grains can at least partly be distinguished from each other. Narrow cracks can also be noticed between some of the grains. More and wider cracks were detected when the marble had been exposed to the environmental stresses on the test wall. The maximum crack width after 1.5 years on the test wall is around 0.6-0.7  $\mu\text{m}$ .

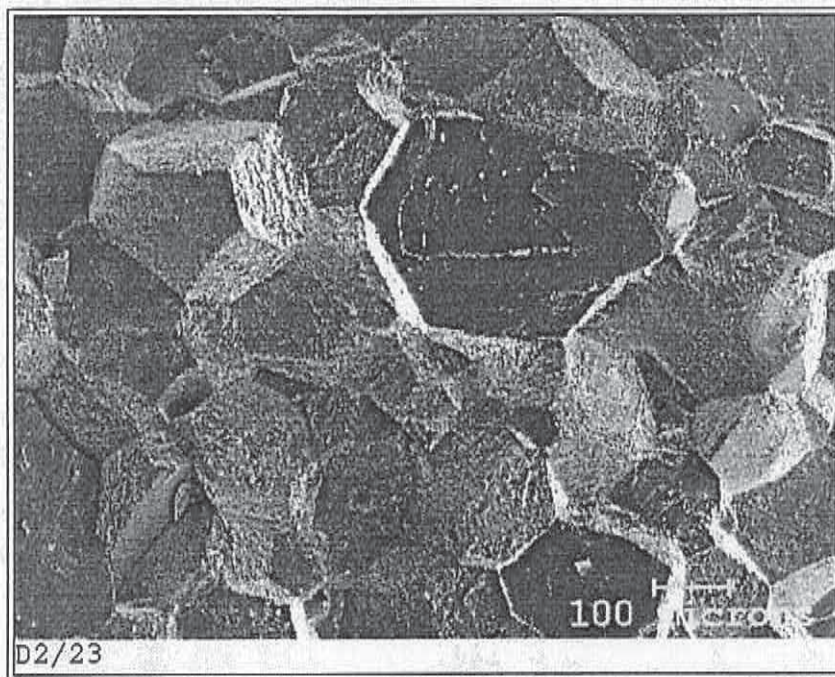
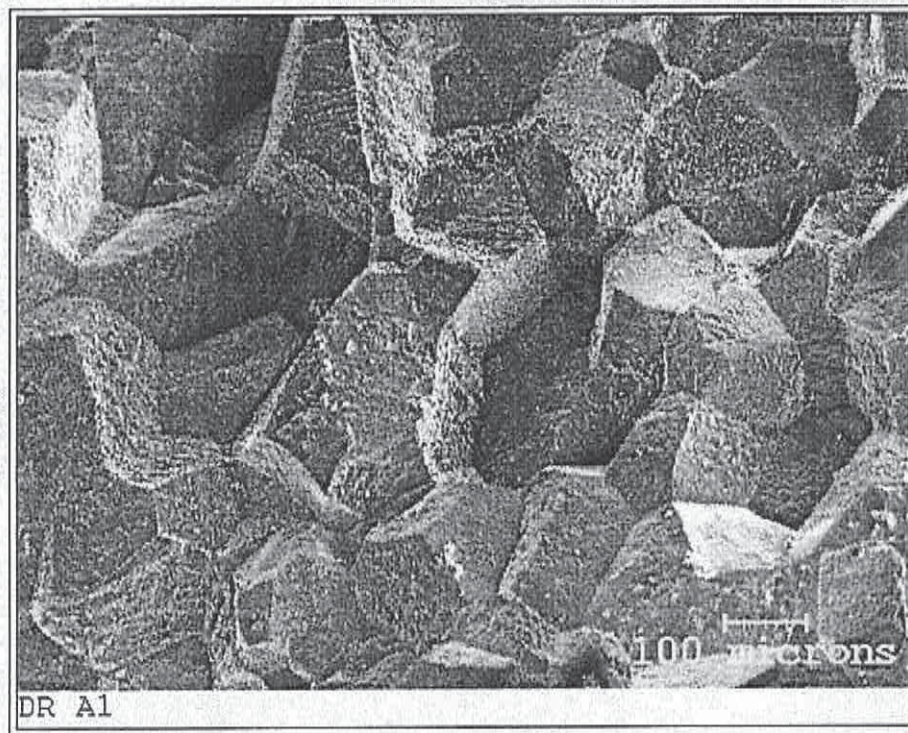
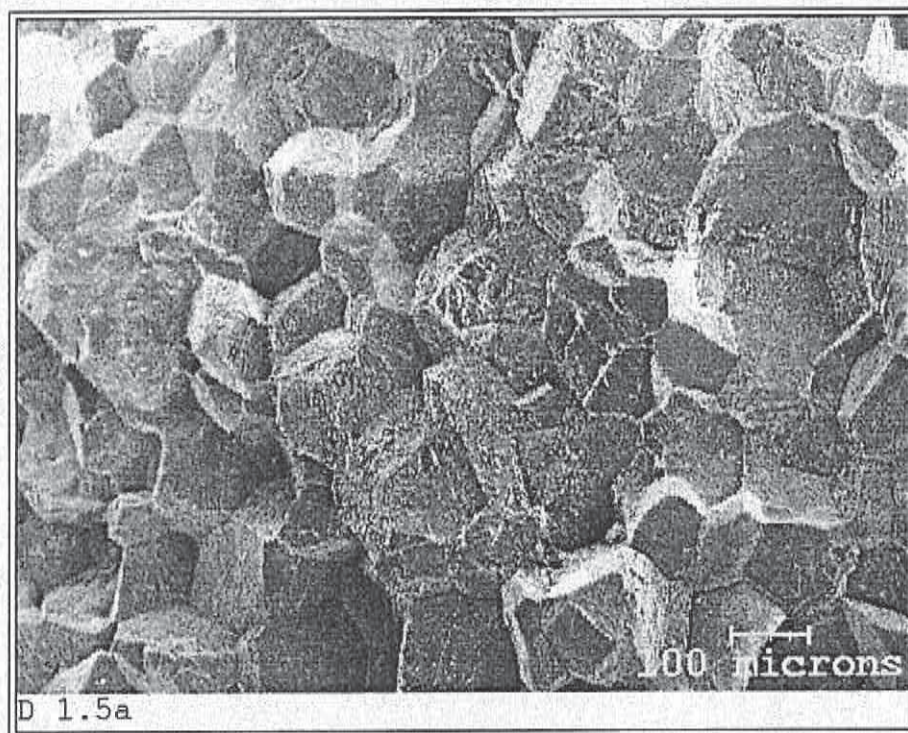
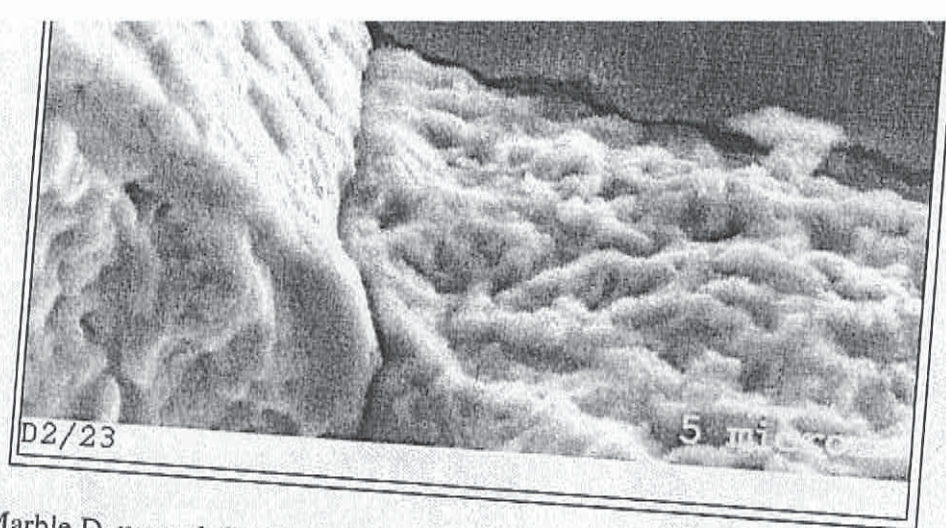
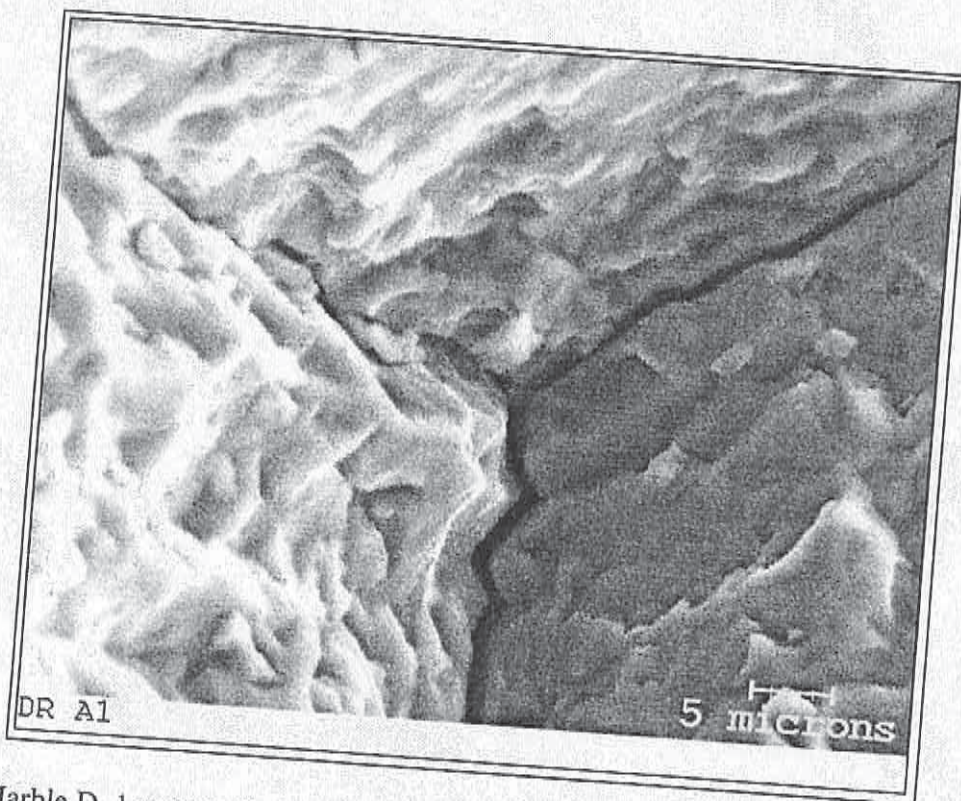
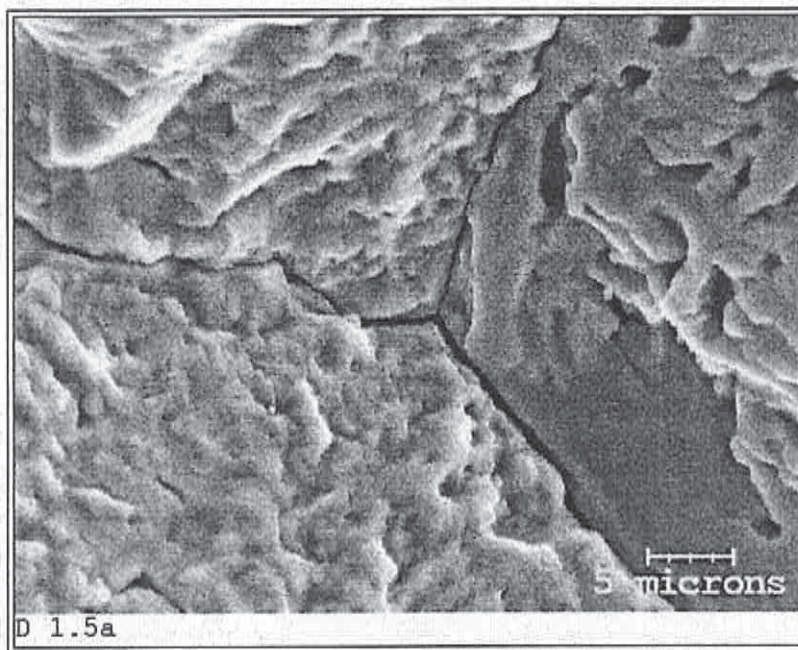
SEM-pictures of fractured surfaces of marble D, both unused and after 1 and 1.5 years on the test wall, are shown in Figs. 59-64. The individual grains can easily be distinguished from each other. Clear cracks can also be noticed between all the grains. These cracks were wider when the marble had been exposed to the environmental stresses on the test wall. The maximum crack width after 1.5 years on the test wall is around 1  $\mu\text{m}$ .
