# VTT BUILDING AND TRANSPORT

### Developing long term durability of marble facades

#### Subproject "Test wall"

Espoo, April 20, 2001

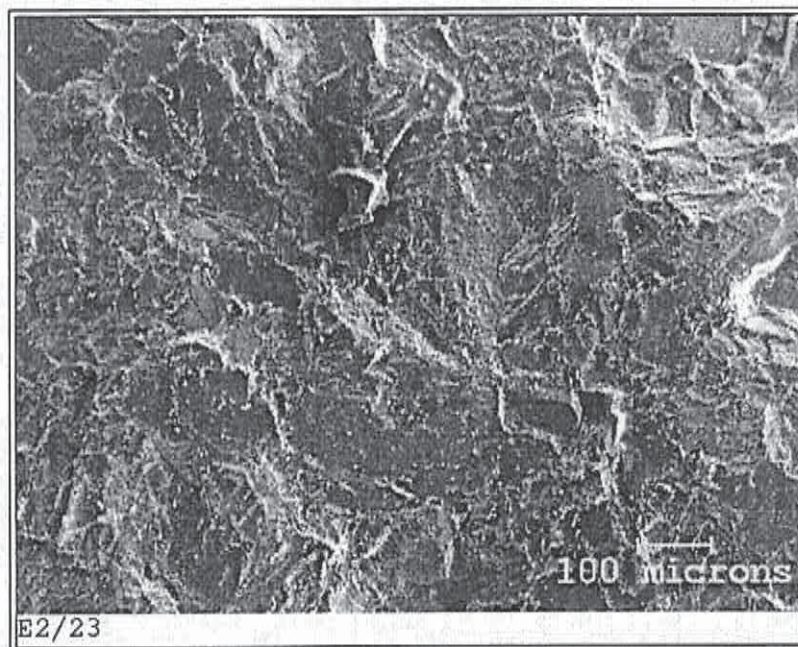
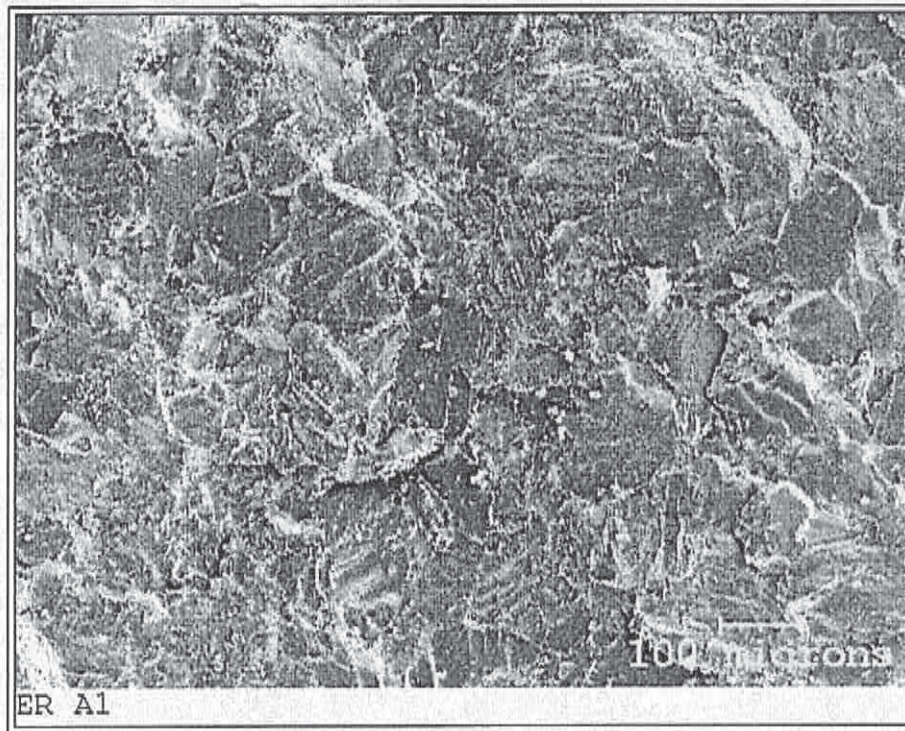
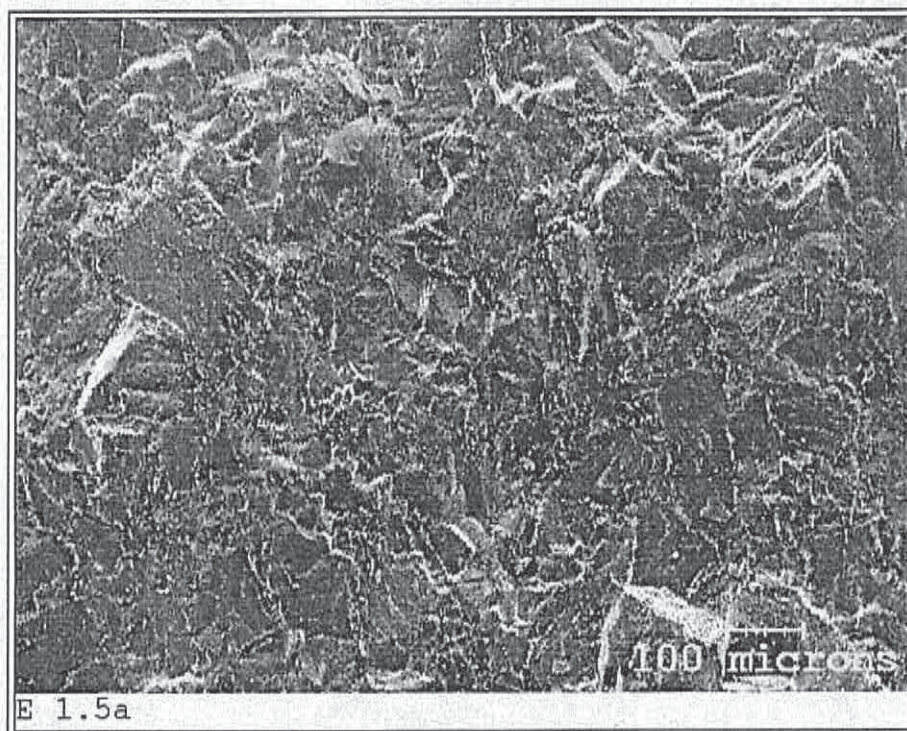
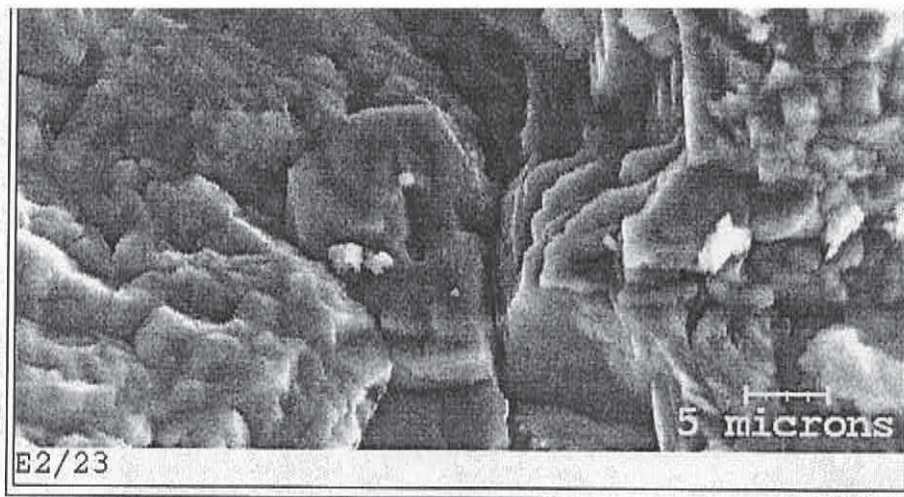
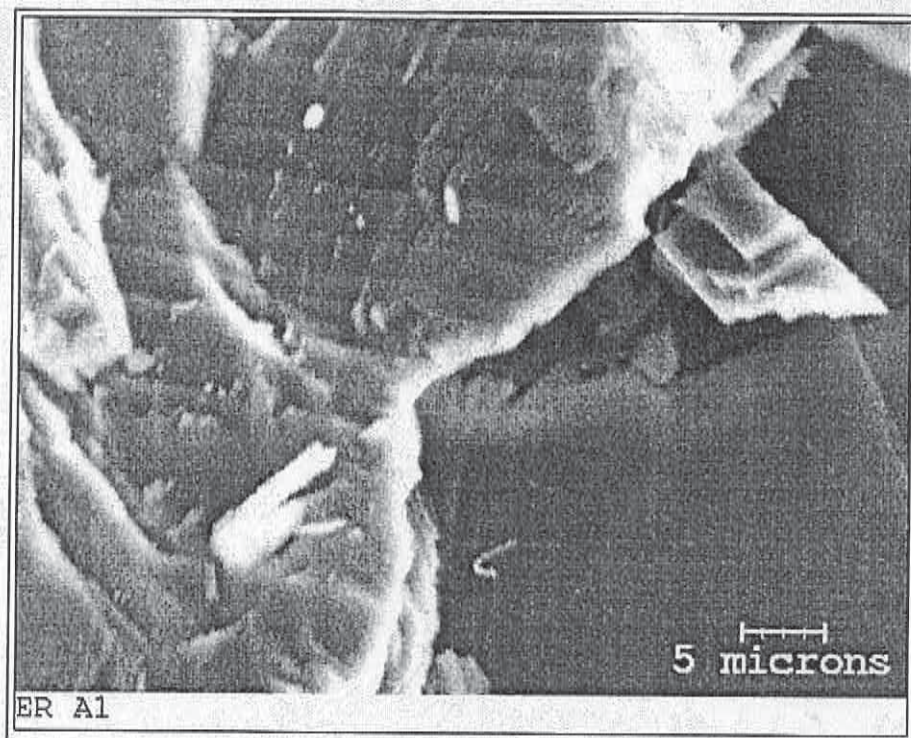
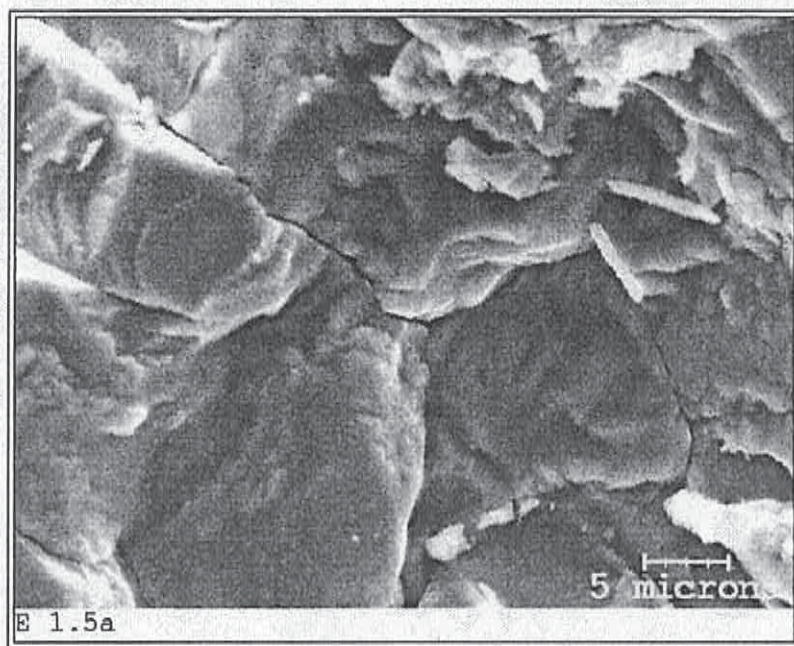
SEM-pictures of fractured surfaces of marble E, both unused and after 1 and 1.5 years on the test wall, are shown in Figs. 65-70. The grain boundaries can be seen only in some places. Thus, it is impossible to distinguish the grains from each other. Some very narrow cracks can be noticed between some of the grains. Some more and a little wider cracks were detected when the marble had been exposed to the environmental stresses on the test wall. The maximum crack width after 1.5 years on the test wall is around  $0.3\ \mu\text{m}$ .

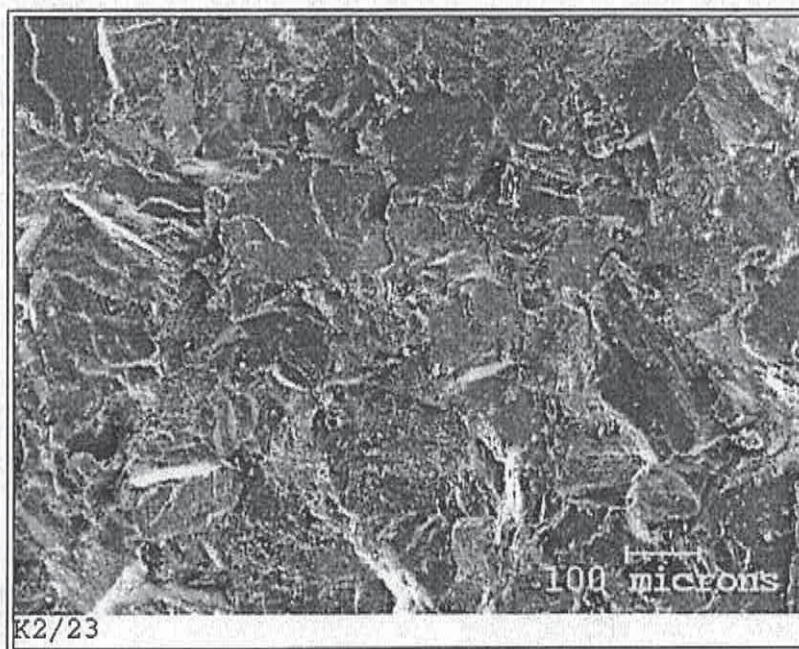
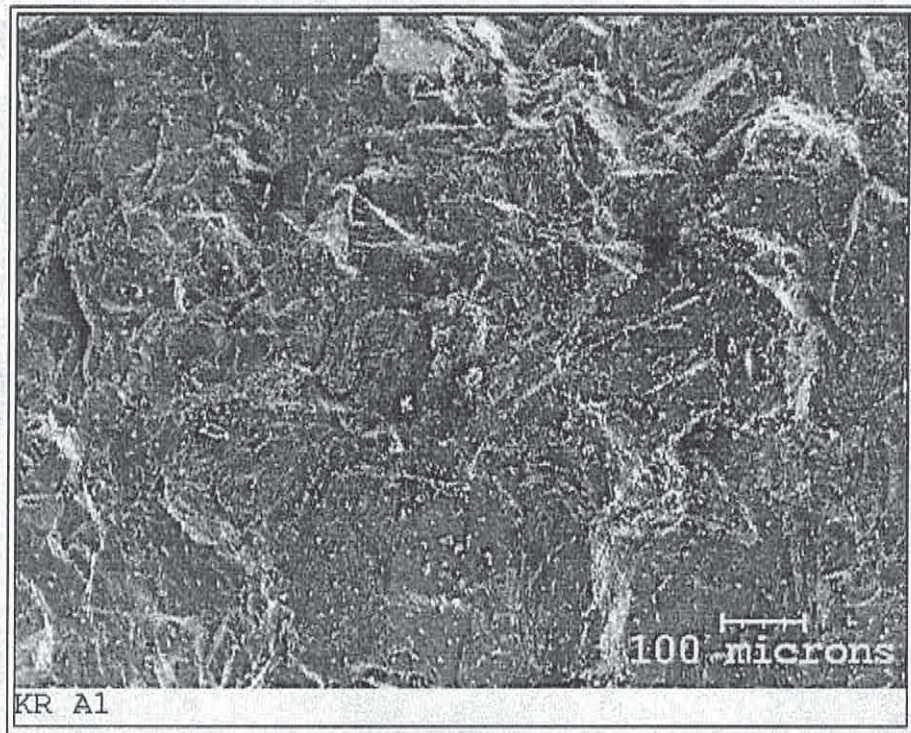
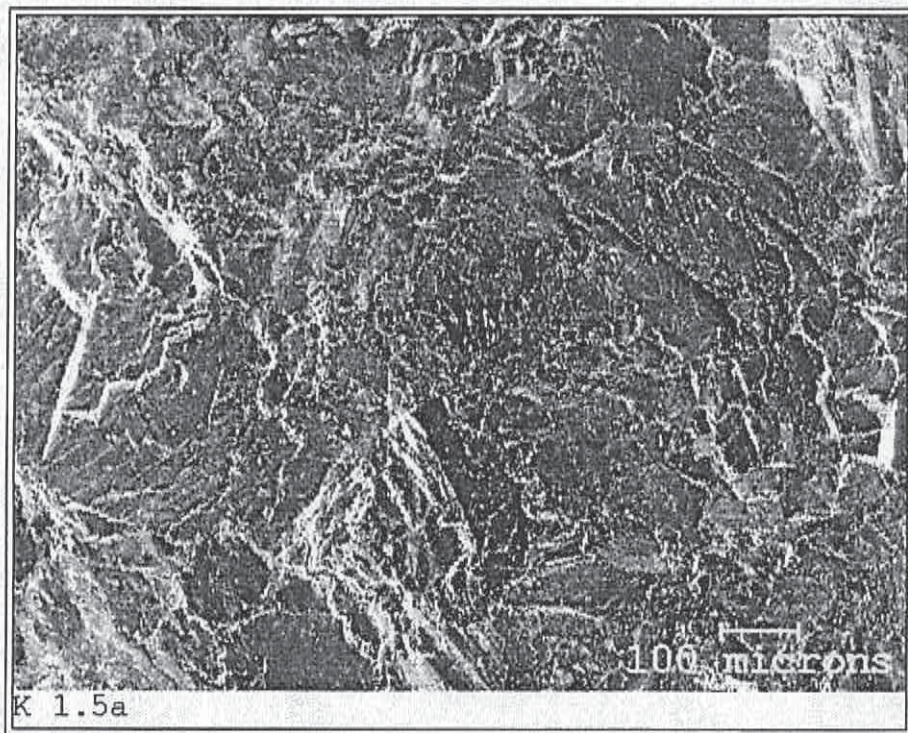
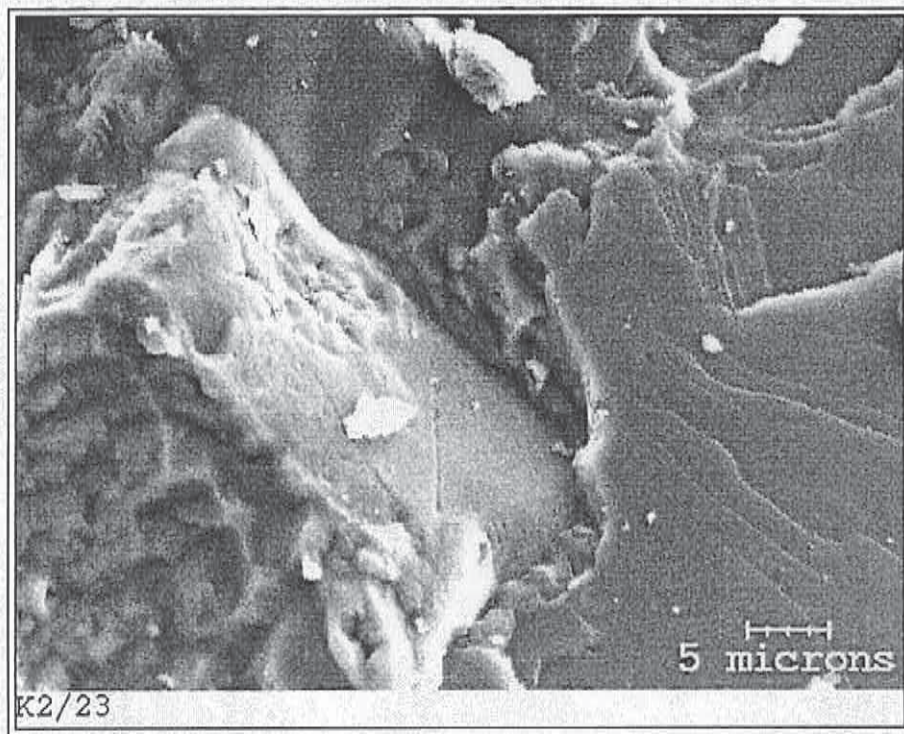
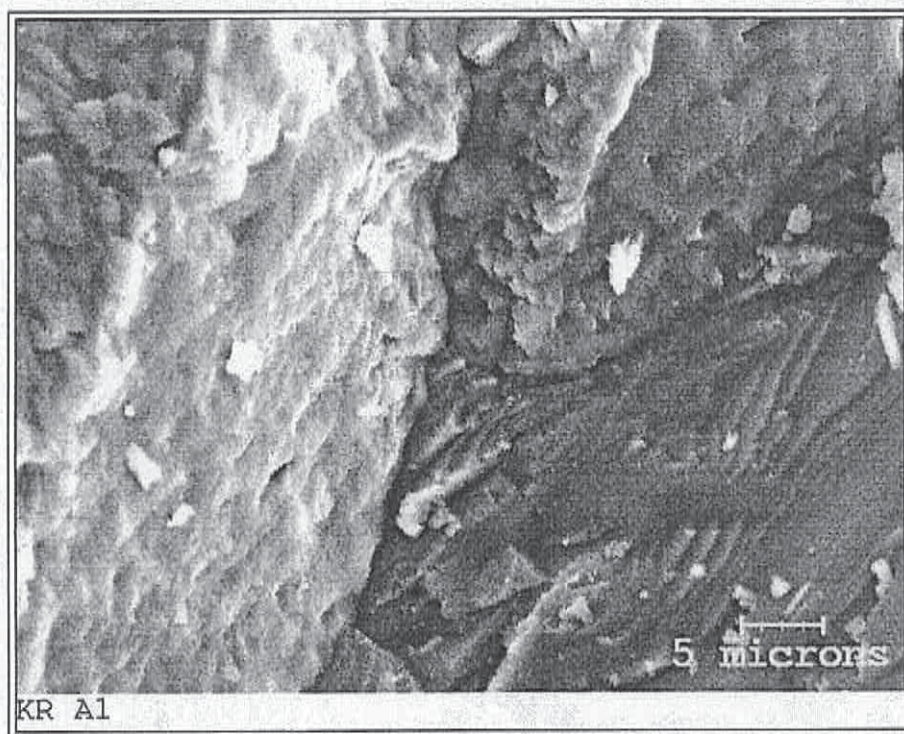
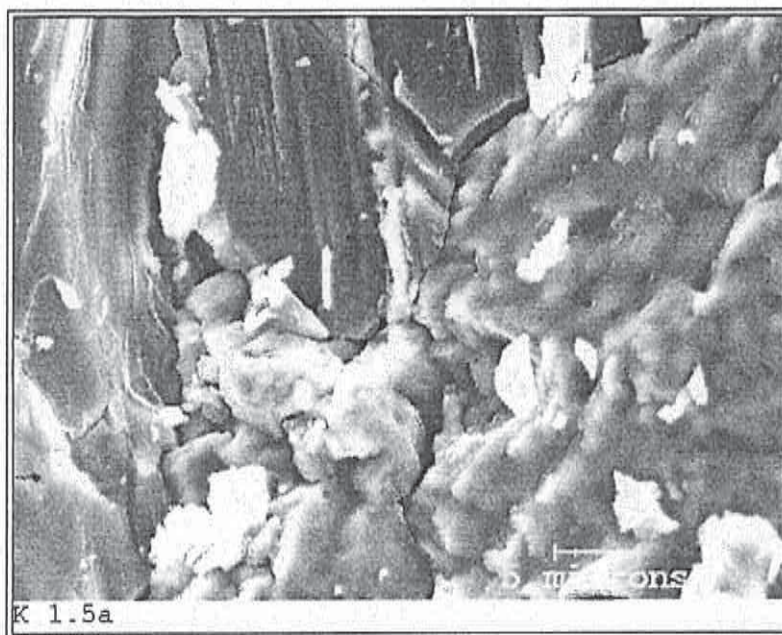
SEM-pictures of fractured surfaces of marble K, both unused and after 1 and 1.5 years on the test wall, are shown in Figs. 71-76. The grain boundaries can be seen only in some places. Thus, it is impossible to distinguish the grains from each other. Some very narrow cracks can be noticed between some of the grains. Some more and a little wider cracks were detected when the marble had been exposed to the environmental stresses on the test wall. The maximum crack width after 1.5 years on the test wall is around  $0.3\text{ }\mu\text{m}$ .

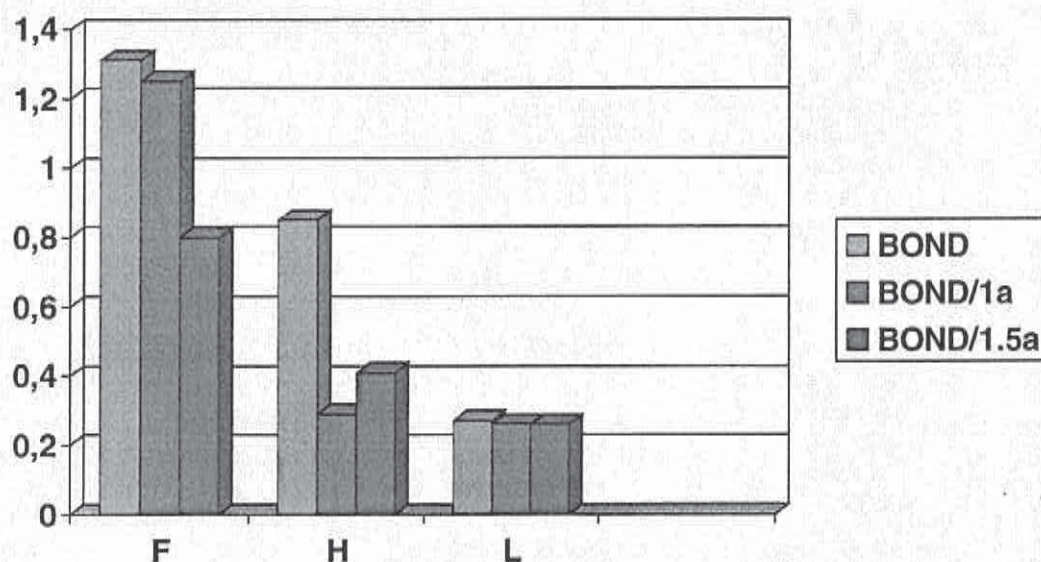
Figure 77. Bond strength of marble in marble clad elements (MPa).

In the element type F the breaking point was usually the interface between marble and concrete. Only in a couple of cases the loosening took place, at least partly, deeper inside concrete.

In the element type L the breaking point was always the interface between marble and the rest of the structure. Thus, the loosening of marble took place from the top of the glue layer.

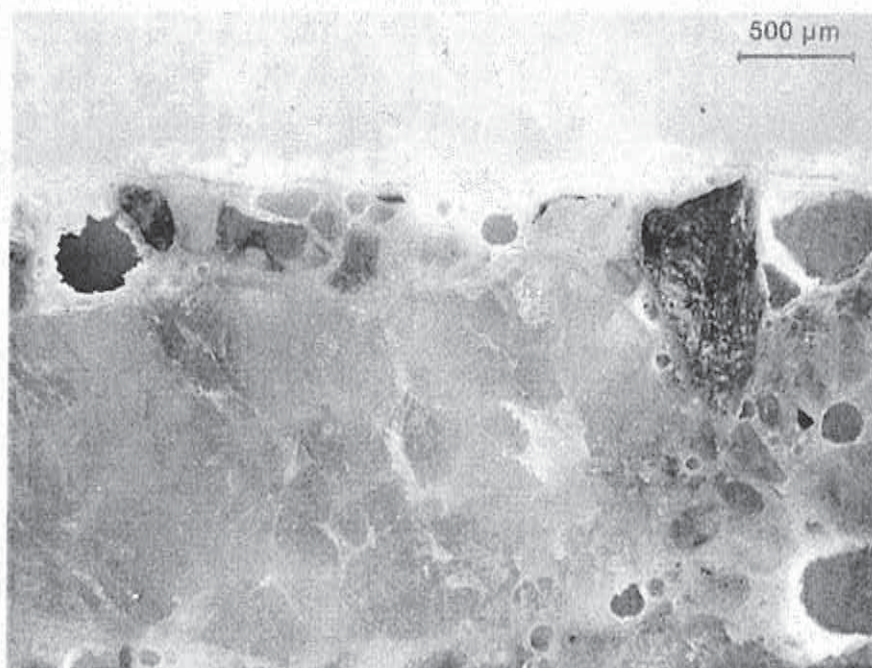
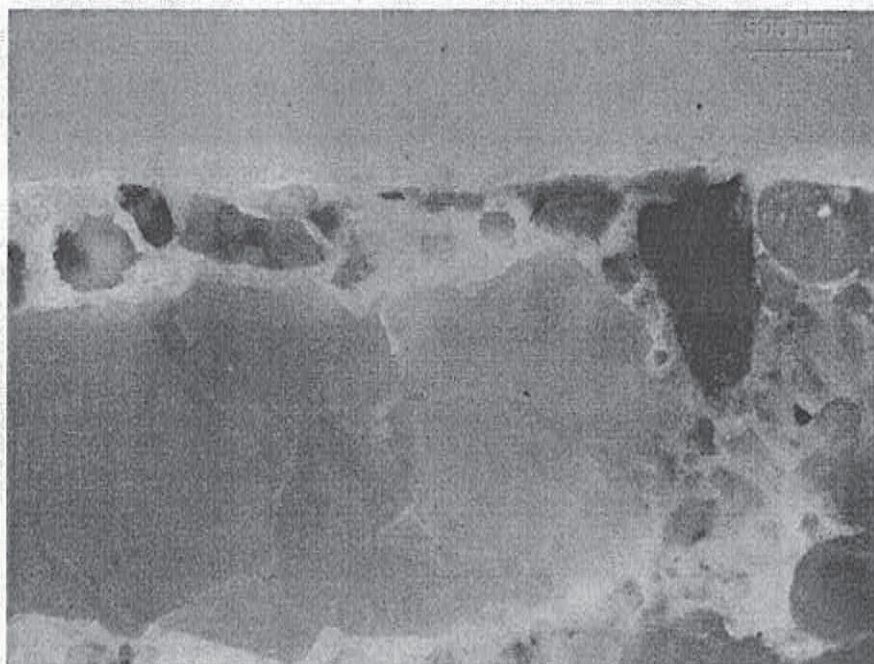
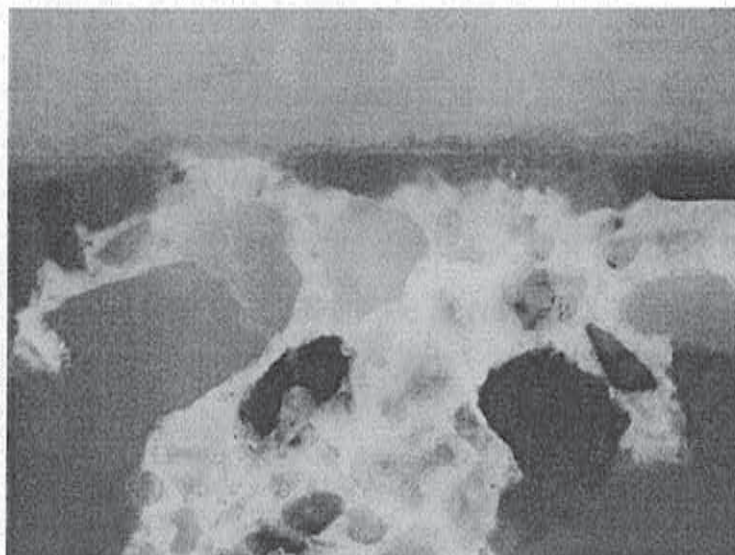
- contact between marble and concrete tight and cohesive
- a thin layer of third material, probably primer, between marble and concrete
- material (primer) layer rather continuous, though pores are common; thickness of the layer generally 20-30  $\mu\text{m}$ , in places even 60  $\mu\text{m}$
- in the unused element only a few very tiny cracks along the marble/concrete contact zone
- in the element stressed for 1.5 years on the test wall some slight and narrow cracking at the marble/concrete contact zone

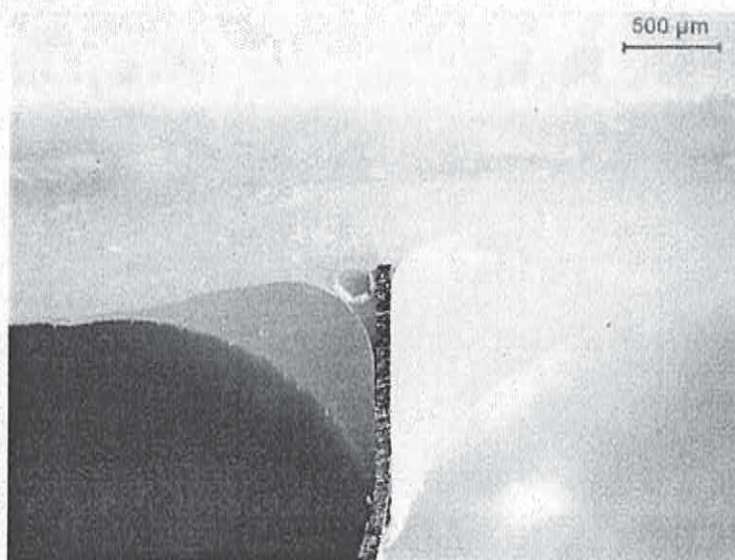
- a layer of glue between marble and metal structure, thickness of the layer approximately 1 mm
- structure of the unused element partly cracked along the contact zone marble/glue
- in the unused element the upper half of the glue layer tinted yellowish
- in the element stressed for 1.5 years on the test wall the upper half of the glue layer tinted brownish
- in the element stressed for 1.5 years on the test wall open crack on about 60% of the contact zone marble/glue

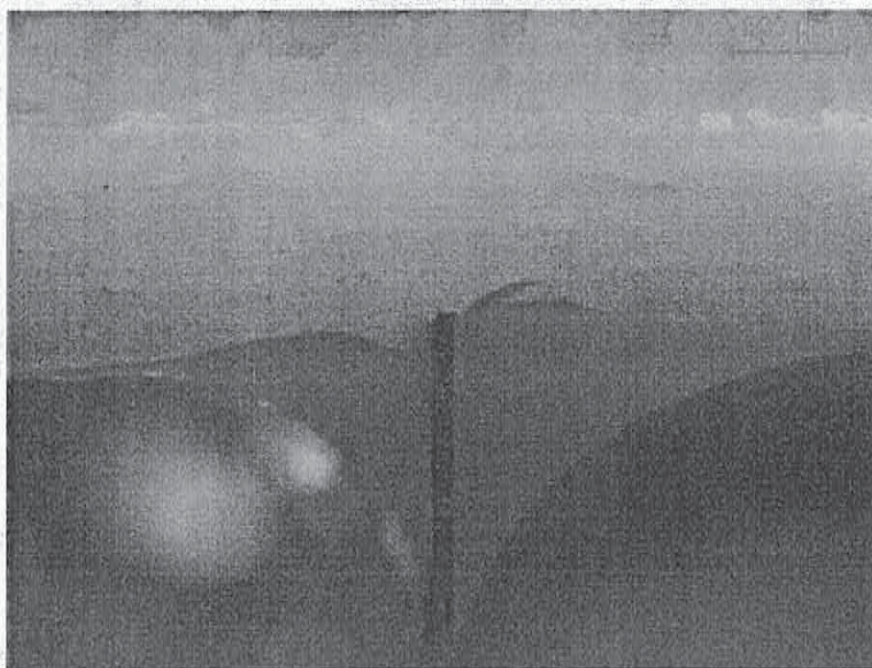
**Figure 83.** Microstructure of marble clad element H. Unused. Objective 2.5x, fluorescent light.

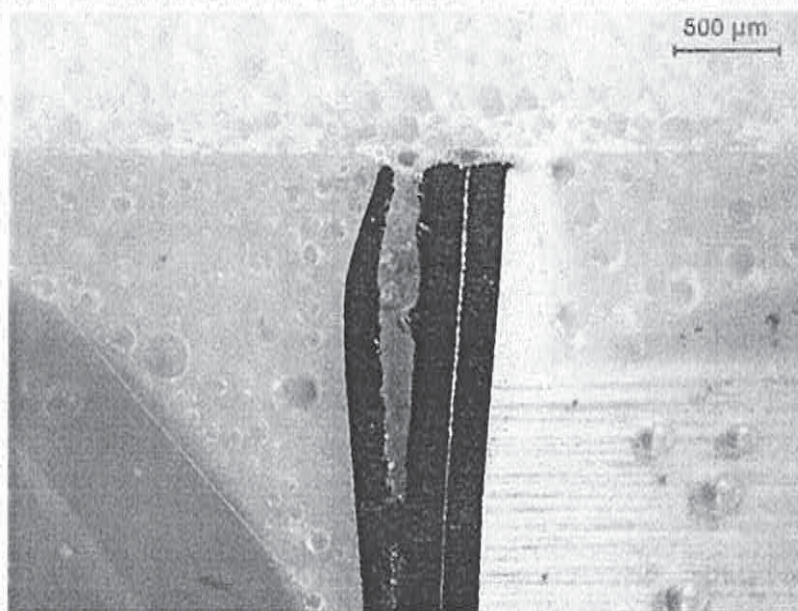
- a layer of glue between marble and metal structure, thickness of the layer approximately 0.5 mm
- the glue contains a lot of porosity
- in the unused element the glue layer partly detached from marble
- in the element stressed for 1.5 years on the test wall the glue layer rather tightly attached to marble, only minor cracking in some parts of the contact zone

**Figure 86.** Microstructure of marble clad element L. Unused. Objective 2.5x, oblique illumination.

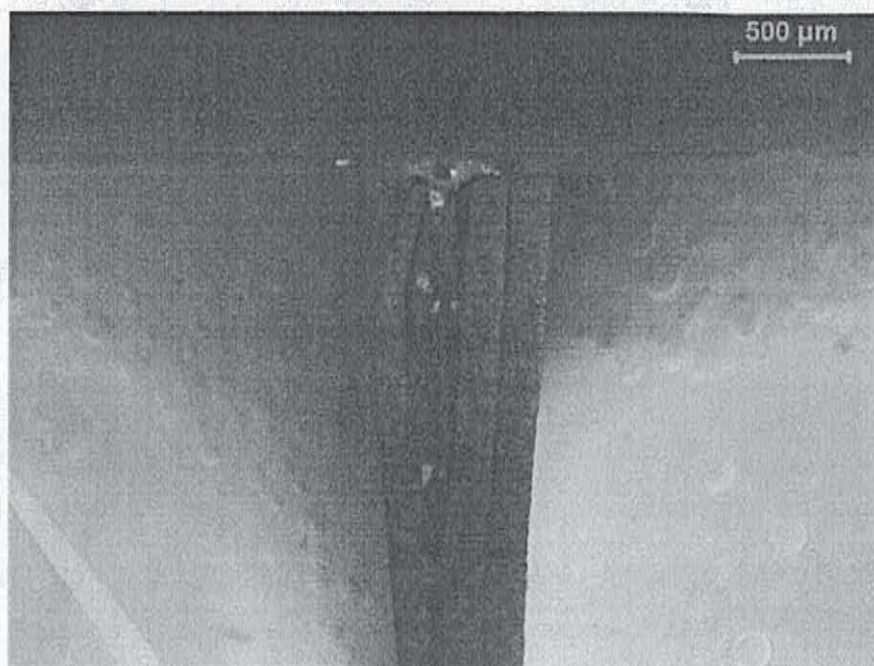
**Figure 87.** Microstructure of marble clad element L. Unused. Objective 2.5x, fluorescent light.

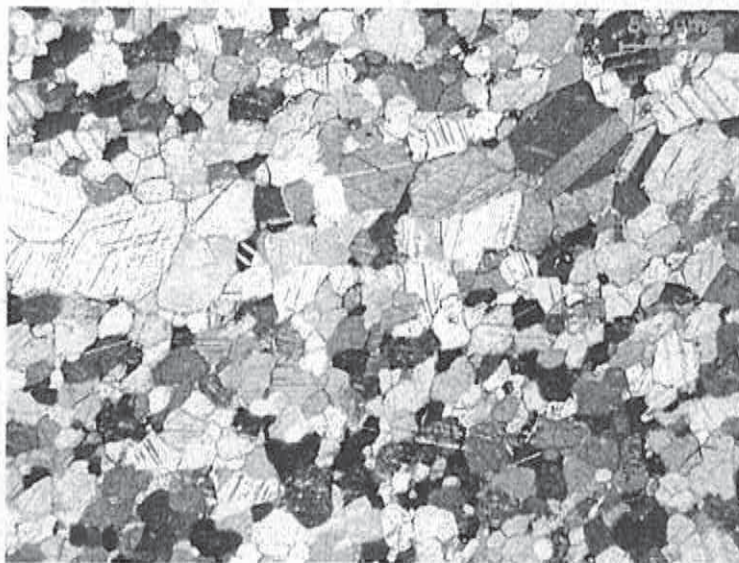
- fine-grained ground mass, slightly oriented, average grain size 0.1-0.2 mm
- in places more coarse-grained veinlets with a thickness of about 1 mm, veinlets show the same orientation as the ground mass
- grain boundaries clear, often straight, grains easily distinguished
- nearly pure carbonate rock, only a little quartz and opaque minerals, possibly feldspar

Figure 113. Microstructure of marble from case 1. Cross-polarized light.

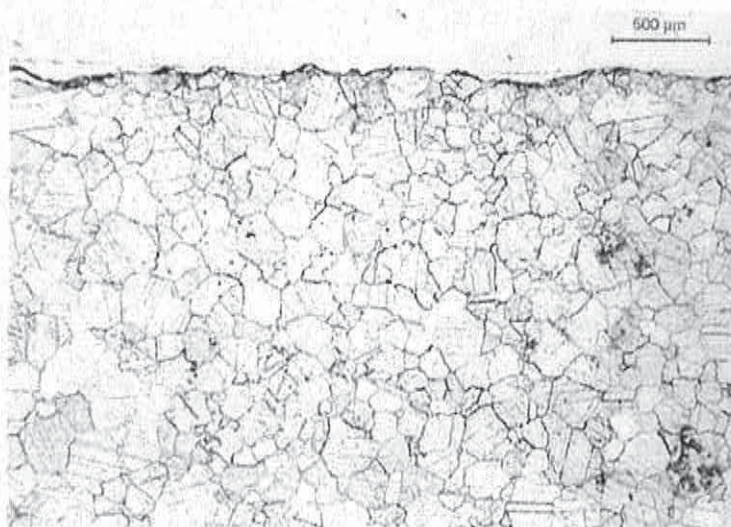
- ground mass fine-grained, even-grained, not oriented
- grain boundaries easily distinguished
- a few very fine-grained cryptocrystalline lenses, max. length about 10  $\mu\text{m}$ , inside the ground mass
- no heavy cracking
- outer surface dirty and uneven

**Figure 114.** Microstructure of older marble from case 2. Plane-polarized light.

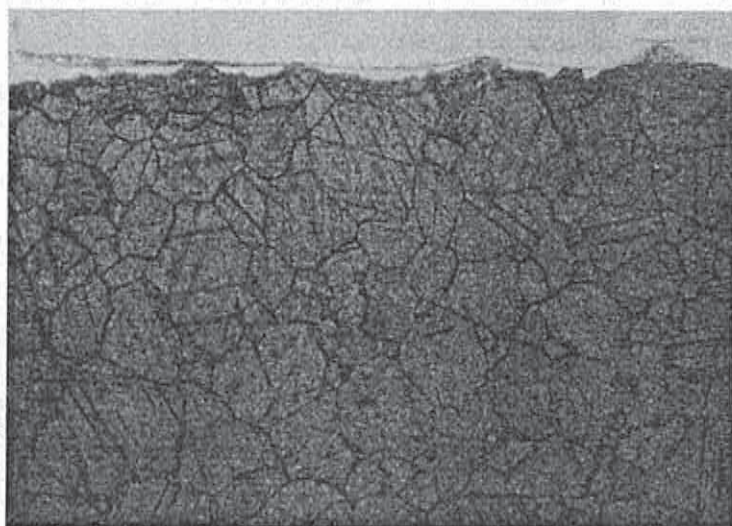
**Figure 115.** Microstructure of older marble from case 2. Fluorescent light.

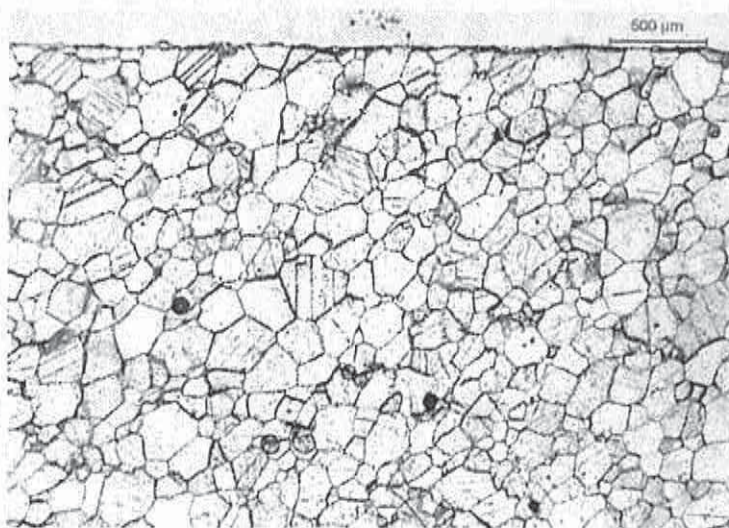
- ground mass fine-grained, fairly even-grained, not oriented
- grain boundaries easily distinguished
- a few very fine-grained cryptocrystalline lenses, max. length about 2-3 mm, inside the ground mass
- cracks between the grains extending to a depth of about 2-3 mm from the outer surface and to a depth of about 1-2 mm from the inner surface, some cracks cut the surface
- outer surface dirty

**Figure 116.** Microstructure of younger marble from case 2. Plane-polarized light.

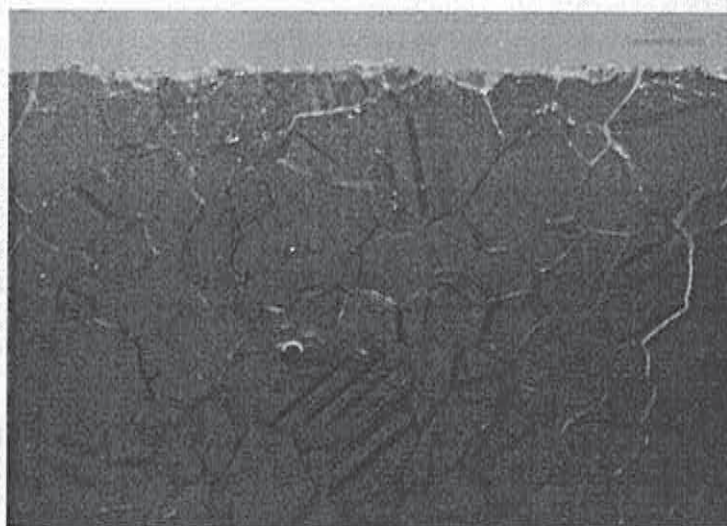
**Figure 117.** Microstructure of younger marble from case 2. Fluorescent light.

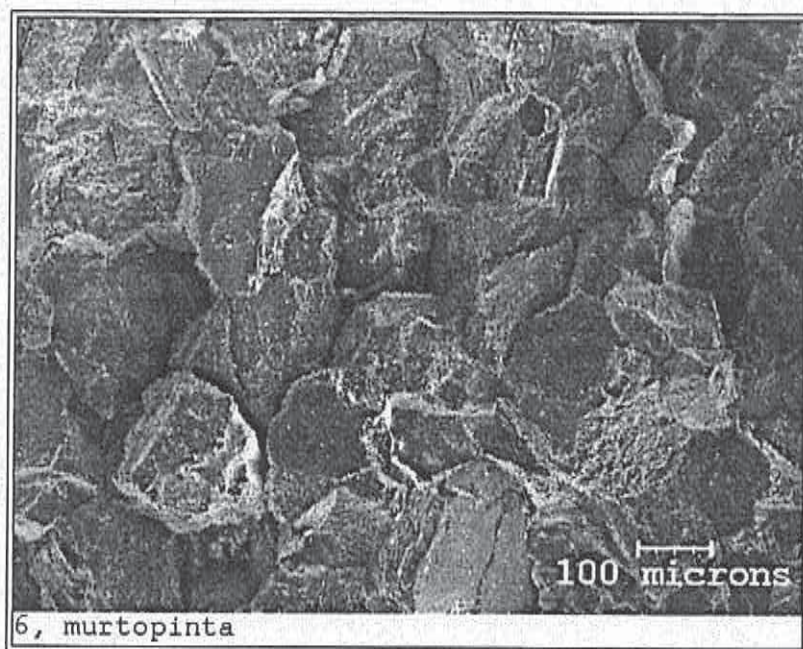
SEM-pictures of fractured surfaces of marble from the case 2 are shown in Figs. 122 and 123. In marble of the older part the individual grains can at least for the most part be distinguished from each other. In marble of the younger part the grains are almost detached from each other. Wide cracks can be noticed between all the grains. The average grain size of older marble is about 200  $\mu\text{m}$ , that of younger marble around 200-300  $\mu\text{m}$ .

**Figure 122.** Marble from case 2, older part. SE-image of fractured surface, 100x.
