# **12<sup>th</sup> International Congress on the Deterioration and Conservation of Stone**

# CONSERVATION OF ARCHITECTURAL MARBLE AT THE NEW YORK PUBLIC LIBRARY

Timothy Allanbrook<sup>1</sup> and Andrew Wilson<sup>2</sup>

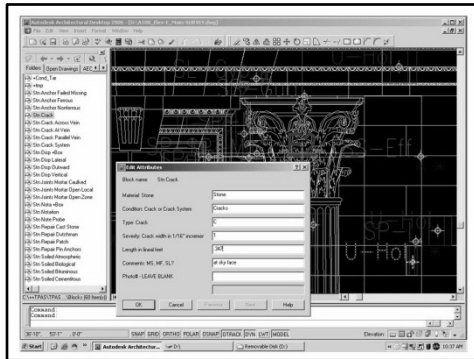
**Figure 4.** Screen capture from tablet software used to record existing conditions

An extremely detailed series of condition descriptions were developed to assure adequate flexibility in characterizing field observations. The conditions were categorized into broad types and sub-types. Finally, the quantity and severity of distress conditions observed, and comments relevant to the particular condition, were recorded through the course of the survey (Figure 4).

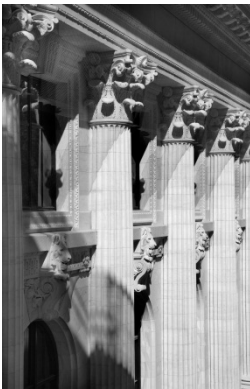
**Figure 10.** Detail of completed front facade

The restoration of this acclaimed building was executed with the highest quality and minimal compromise. The work sought a judicious balance of cleanliness with preservation of valuable historic fabric and patina. Thousands of instances of deterioration were recorded during the initial survey. These 'as-found' conditions were subjected to laboratory evaluation and field-testing of alternative conservation methodologies to establish the most appropriate and least invasive treatments. Then, during the three-year construction period, members of the preservation team made repair and treatment decisions on a stone by stone basis ranging from crack fills to more than 2,000 carved dutchman patches (Figure 10). This was truly a career topping project for all parties involved.

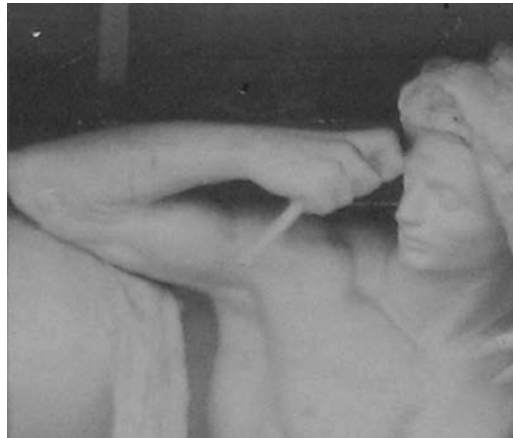
**Figure 6 (above):** Barnard Pediment Group Art in historic photo detail

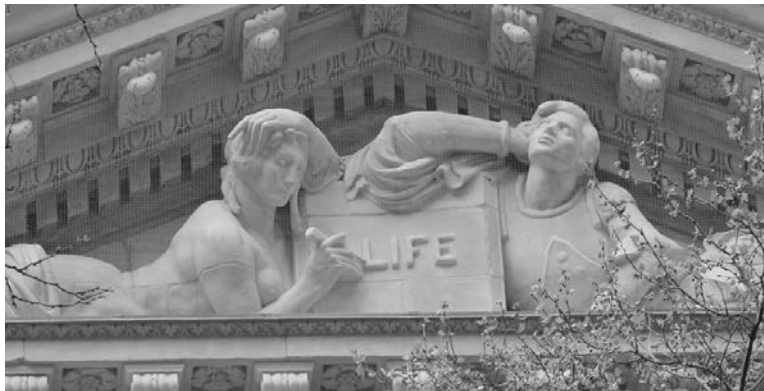
**Figure 11;** Barnard pediment group *Life* after treatment

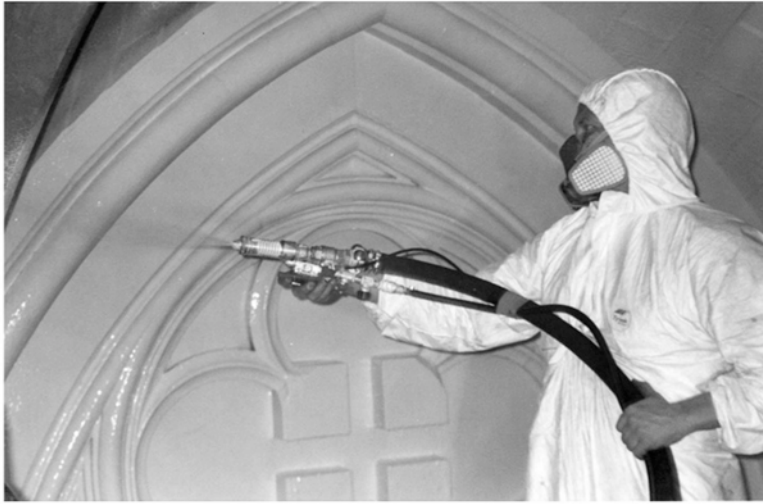
**Figure 2.** Spray application of Arte Mundit in progress. Photograph by the author.

A spray application was found to be optimal at Saint John as well as at several subsequent projects (figure 2). Spraying facilitates the application of the product, particularly when the stone is deeply carved or has deep crevices, and has critical impact on cure time, the removal process, and the degree of cleaning largely because of the thickness and uniformity of application that can be achieved by spraying. Brush or roller application did not achieve comparable results at Saint John. Use of a roller resulted in too thin an application, especially on uneven and high relief substrates, because the stiffness of the roller did not allow the product to settle uniformly. Conversely, application of too thick a coating (more likely when using a trowel or brush) was found to be problematic because of its impact on cure.

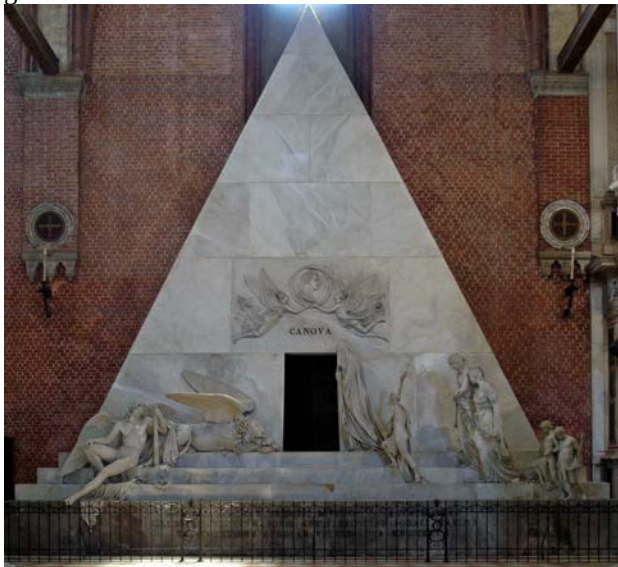
Fig. 1. The cenotaph to Antonio Canova

In recent decades, the funerary monument dedicated to Antonio Canova in the Basilica dei Frari has suffered serious decay phenomena. The sharp increase in deterioration processes observed in different areas has caused the loss of large areas of marble detail from the surface of the statues. As there is an urgent need to stop the increasing rate of marble decay the authorities responsible for protection of the cultural and monumental heritage decided to start a comprehensive survey to identify the causes of alteration. Macroscopic observation of the marble surface showed different forms of alteration as well as the massive presence of salt efflorescence. A number of different types of alteration were observed macroscopically and in order to assess the deterioration mechanisms samples were taken from the decayed areas. ESEM observations together with EDS analyses have enabled us to explain the stages, each corresponding to different features, through which exfoliation and lamination of surface scales is taking place.

A survey of the moisture content of the masonry structure under the steps of the monument has established that moisture from the ground is being transmitted by direct contact of the brick core with the marble. As a consequence capillary migration of water transports salt solution onto the marble surface, where it forms droplets.

In order to stop the rapidly increasing rate of decay, observed over the last ten years, there is an urgent need for action to prevent any further capillary rising damp by inserting a damp proof course and at the same time to detach the statues from the base in order to remove the salts embedded in the marble.

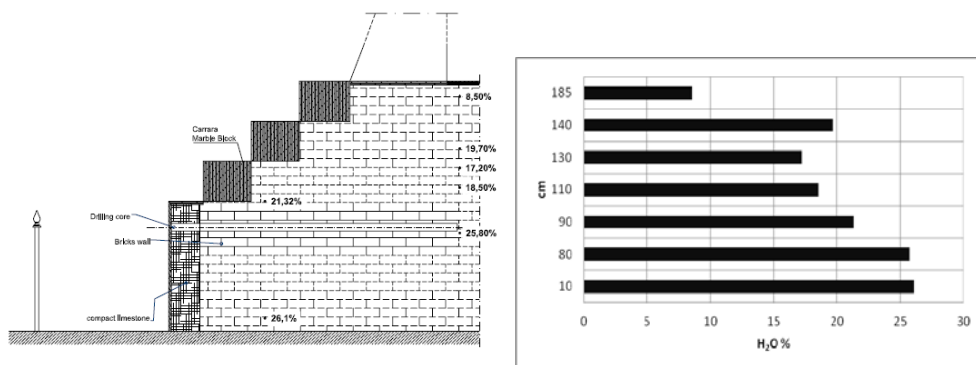
The supporting structure was investigated by the use of georadar and by drilling cores into the base to a depth of 2 metres. Georadar measurements established that the three steps are formed of marble blocks (35 cm thick) and the supporting structure consists of brick masonry. Georadar measurements also emphasized high water content in the supporting brick structure.

The moisture content profile from ground level up to the base of the pyramid was measured by drilling cores at different heights and depths. The water content is close to 25% up to a height of 80 cm and it slowly decreases to 18-20% up to 140 cm. At the base of the door (190 cm. from ground level), the water content decreases to 8.5% (Fig. 5). The data obtained indicated that the brick supporting structure is completely saturated with water and as there is no discontinuity between the brick structure and the marble blocks or statues the capillary rising damp phenomenon is causing the migration of salts from the brick structure towards the external surfaces of the marble blocks and statues.

Fig. 5 a,b. Bricks supporting structure and moisture content at different heights.

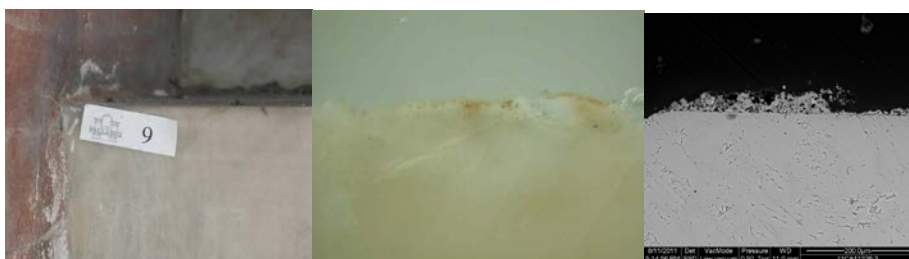
In order to explain the different types of alteration observed, the crystal structure of a sample of sound material was analyzed by thin and cross section. Sound marble shows a compact structure and no inter-crystalline detachment. Also visible on the external surface is a wax deposit due to maintenance treatment (Fig. 6c)

Fig. 6. a) sample 9 from a sound area, b) cross-section at OM, c) cross section at ESEM. In cross section no micro-cracks are visible indicating that marble is in good condition, not weathered.

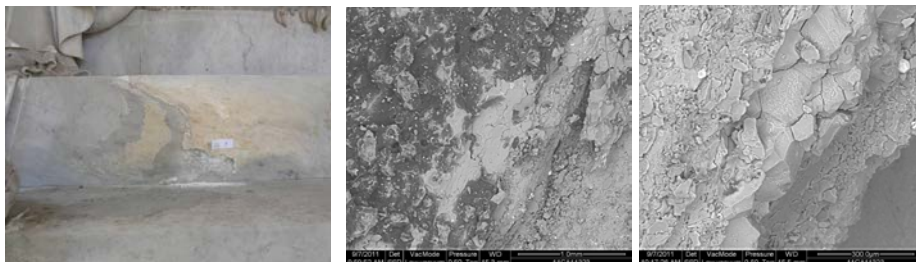
In order to validate the biological colonization mechanism proposed by previous researchers a sample presenting the exfoliation phenomenon was taken from the same location. Visual macroscopic examination of the thin marble scale enabled six levels of progressive exfoliation to be identified (fig. 9). SEM observation shows the presence of sodium chloride crystals between different scales; these are responsible for the detachment. Microanalysis also emphasizes the presence of potassium chloride and gypsum.

Fig. 9. a) sample location. b) three layers from outside. c) three more layers inwards

By analyzing the single layers we have observed that the different levels alternately feature calcite crystals with marked micro-fissures and small sulphur- and chloride-rich crystals without a regular shape, thus indicating a secondary gypsum formation (Fassina, 1978, 1994, 1995)) together with primary sodium chloride crystals.

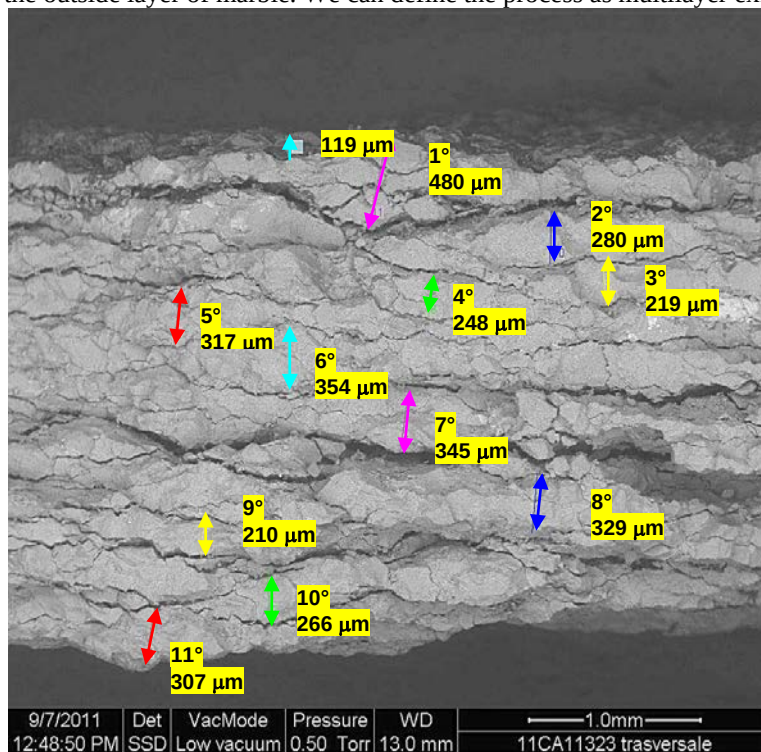
The ESEM observations and the microanalysis by EDS suggest that the mechanism of crystal decohesion and the consequent sugaring of calcite structure may have a different pathway which is manifesting as an exfoliation pattern that is generally common for sedimentary stone and follows the sedimentation layers, which are almost (more or less) parallel. Crystal decohesion, which was previously the first step in alteration, progresses forming a discontinuity line more or less parallel to the outside surface, a process that explains the layer exfoliation which is proceeding inwards from the outside layer of marble. We can define the process as multilayer exfoliation.

Fig. 11. The black layer (119 μm thick) on the outside surface is the wax treatment, the first layer is 480 μm thick and all the subsequent layers are about 300 μm. The total thickness is 3 mm.

These veins are responsible of preferential migration, both vertically and horizontally of lagoon water by capillarity. The source of salt solution is the brick supporting structure which is completely saturated with lagoon water. SEM observation showed a salt accumulation in these layers in a similar way of a sedimentary stone and the final result is an exfoliation process which is taking place at first on the external surface layer and successively is recessing in the internal layers as it clearly visible in fig. 11. The damage features actually observed showed an irregular front of the maximum height of the rising damp due to the orientation of these veins (horizontally or vertically oriented with respect to outside external surface) of the marble blocks of the step.

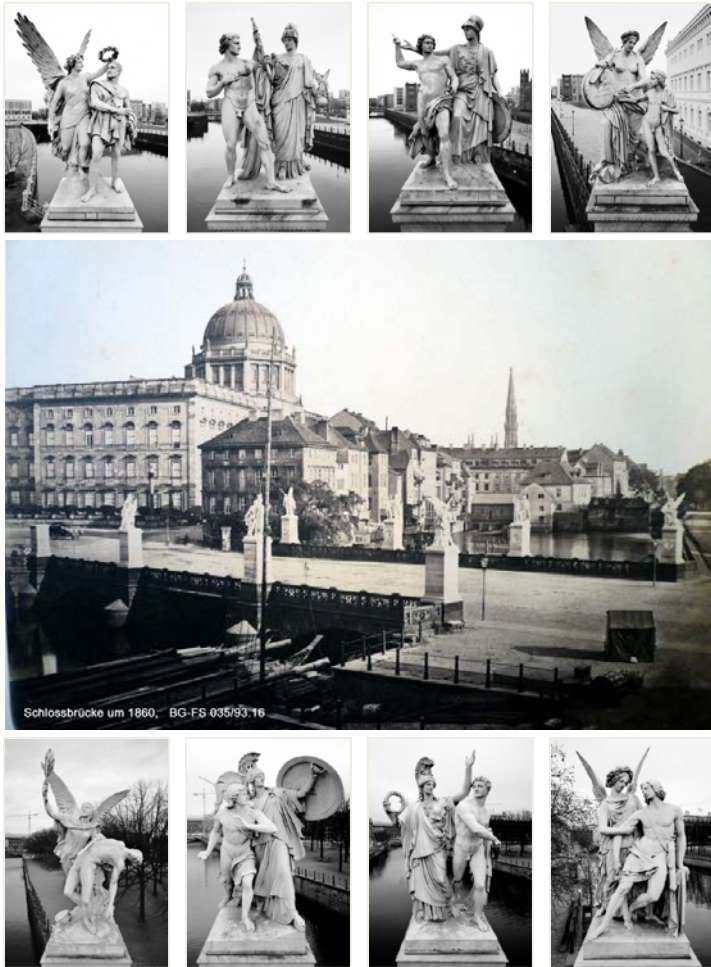
**Figure 1:** Centre:  
Historical photo of  
the “Schlossbrücke”  
before 1857. One  
sculpture (to the left)  
has not yet been  
assembled in this  
view.  
Small pictures:  
Current state of the  
sculptures. The  
photos are arranged  
in the same order as  
the sculptures in the  
historical photo.

As a result of their eventful history and their long exposition time the sculptures show considerable signs of damage. Significant mechanical damage was caused by the incorrect transport and storage during World War II. These damages have been repaired and missing parts have been replaced. In general, the back-weathering of the original material is moderate. The surface locally shows a pronounced roughness and in some areas a sugar-like crumbling. In these parts, the marble fabric is strongly deteriorated. Even if the sculptures were carefully cleaned in 2009, the surfaces have shown a pronounced biological colonization. In areas of increased roughness the biofilm penetrates deep into the microcracks and accelerates the deterioration.

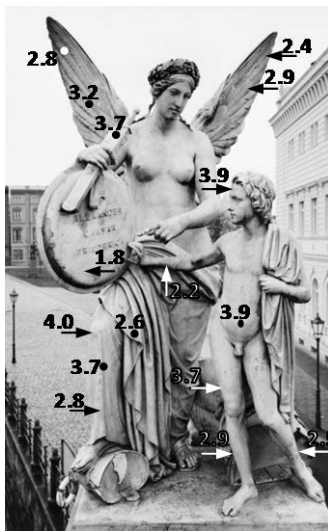
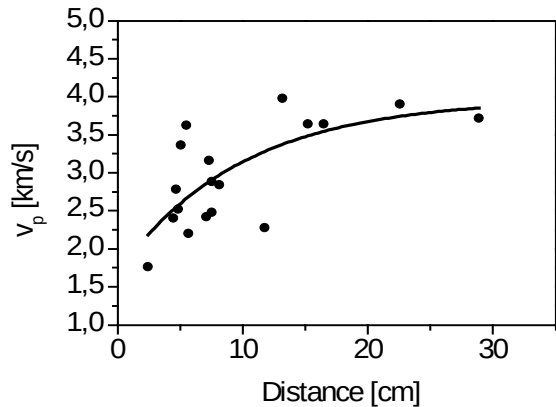
The structural integration of the sculptures was assessed by measurements of the ultrasonic velocities. Figure 3 shows the results for the sculpture on the south-west side. According to a damage classification for Carrara marble presented by (Köhler 1991, Siegesmund & Snethlage, 2011), the condition of the sculptures can be described in the following way: massive parts with diameters above 15 cm show ultrasonic velocities between 3 and 4 km/s. The condition of these parts can be classified as „increasingly porous“. The ultrasonic velocities of more filigree elements with a thickness below 15 cm such as the wings of Nike or the arms and legs typically range between 2 and 3 km/s. After the classification by Köhler these parts can be designated as “sugar-like disintegrated”. Therefore, the sculpture can be classified as distinctly deteriorated, but the stability is not in acute danger. The distribution of the ultrasonic velocities in general points to the conclusion that the deterioration is more distinctive near the surface (Fig. 3). The results are representative for all sculptures of the Schlossbrücke, except one sculpture, which is in a critical condition.

**Figure 3:** Results of the ultrasonic measurements on the sculpture on the south-west side of the bridge. The ultrasonic velocities are given in km/s. The comparison of the velocities and measurement distances clearly show that the deterioration is more pronounced on filigree parts.

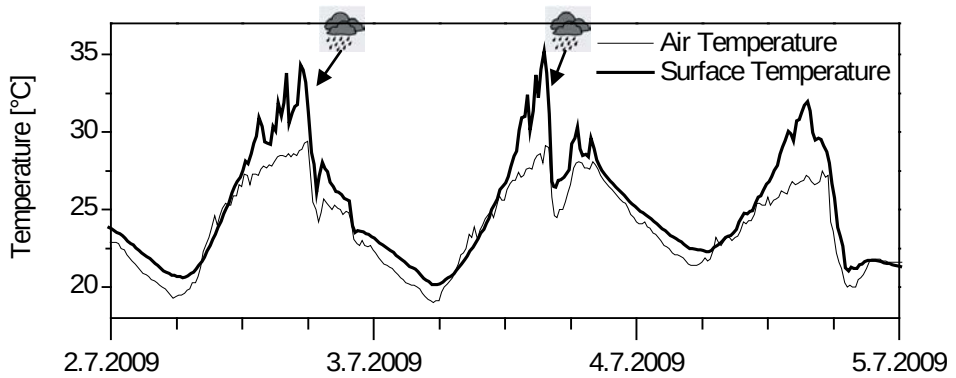
Figure 6 illustrates an additional phenomenon that accelerates marble degradation. On the 3rd of July 2009, the air temperature on this sunny day increased from about 20°C in the morning to about 30°C in the afternoon. At the same time, the surface temperature on the west side increased from 20 to 35°C. In the afternoon, the temperature on the west side suddenly decreased to 27°C within 1 h. The reason is a sudden rain shower. After the rain, the temperature again reached up to 30°C and the surfaces dried. Events like this may be relatively rare but they are significant for marble deterioration. On the afternoon of the 4th of July 2009 it started raining again, but due to the temporarily overcast condition, the temperature drop was less abrupt.

**Figure 6:** Air and surface temperature measured on the sculpture at the south-west side of the bridge at the beginning of July 2009. Sudden temperature drops are due to driving rain.

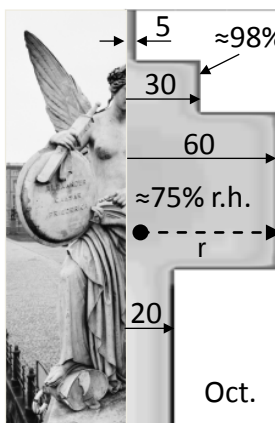
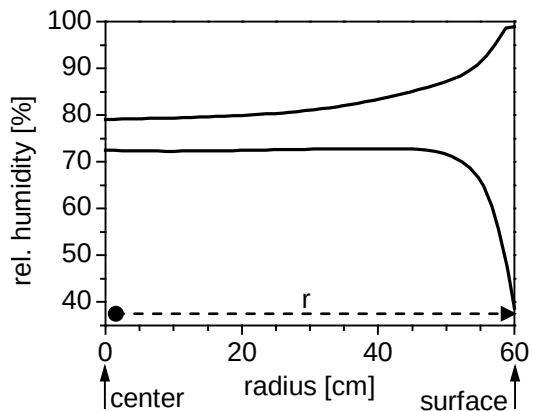
**Figure 7:** Calculated moisture distribution for October in a numerical model of a sculpture (left) and moisture fluctuation (minimum and maximum) from October to April along the cross section ( $r$ ) of the torso.

In the first step, the temperature and moisture distribution within a freely exposed sculpture were calculated (Fig. 7) based on the climate data from Potsdam. The results of the simulation clearly show that the moisture fluctuation inside massive sculptural parts are relatively low, whereas the moisture within around 5 cm below the surface ranges between 40 and nearly 100 % relative humidity. In regards to the deterioration mechanism mentioned above, this is in a good agreement with the present condition of the sculptures.
