# **MARA -PROJECT**

## **DEVELOPING LONG-TERM DURABILITY OF MARBLE FACADES**

# **FINAL REPORT**

30.4.2001

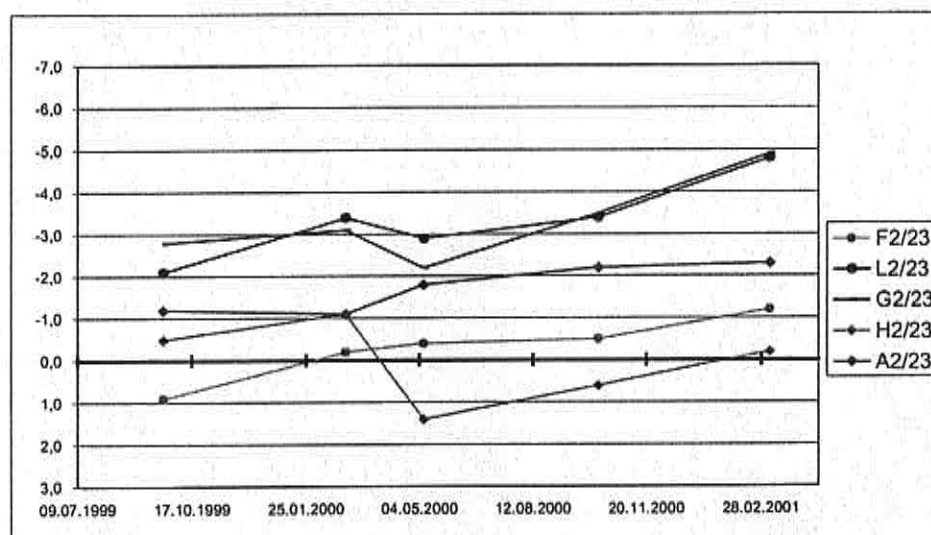
**Figure 29.** Measured bowings on wall 23. Structural products.

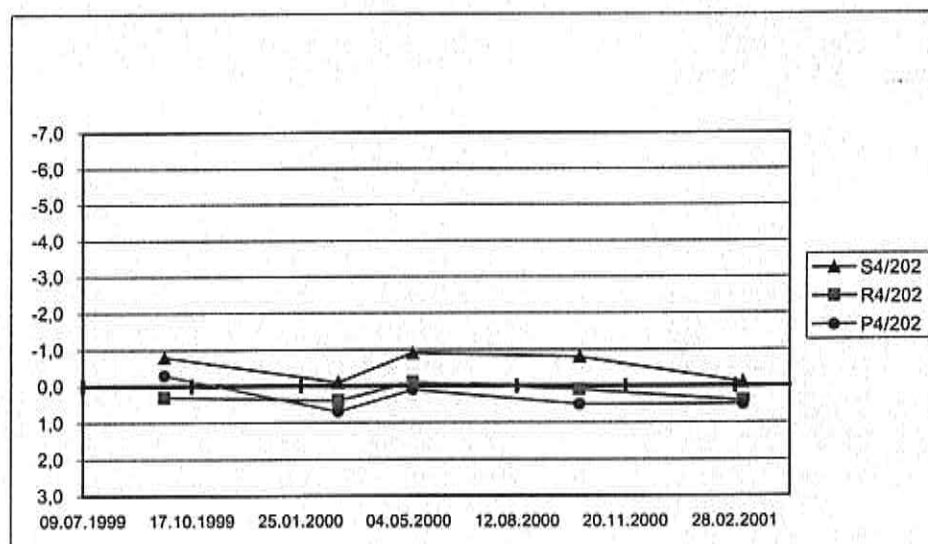
Also three different granites were included in the field tests. Measured bowings are presented in figure 30. Bowing as a word is very much of exaggeration in this context, practically no changes in the straightness of these products can be seen.

**Figure 30.** Measured bowings on wall 202. Granites.

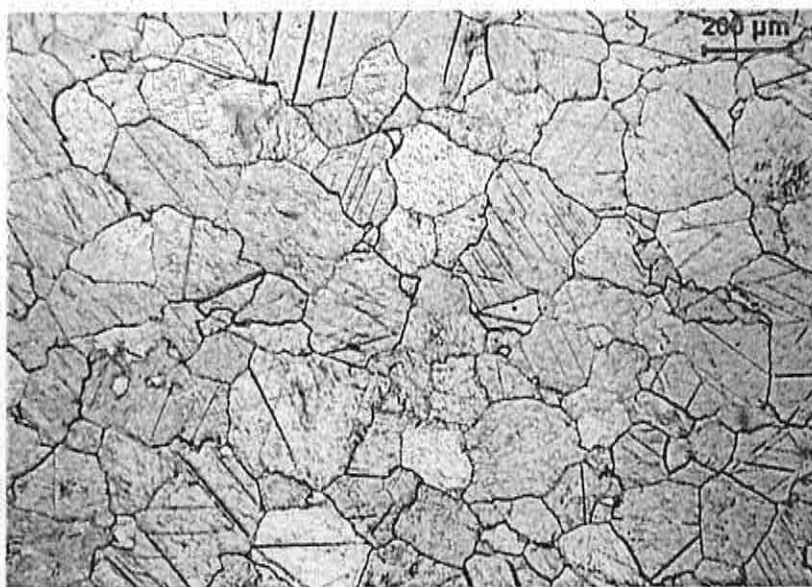
- groundmass fine-grained, fairly even grained, not oriented, massive
- average grain size 200-300  $\mu m$
- slightly porphyroblastic, some larger porphyroblasts (max  $\varnothing$  6 mm) in the groundmass
- nearly pure carbonate rock, contains only very little opaque minerals
- alteration of the grains insignificant
- no changes observable after 1 year on the test wall

**Figure 33.** Microstructure of marble A. Unused. Plane-polarized light.

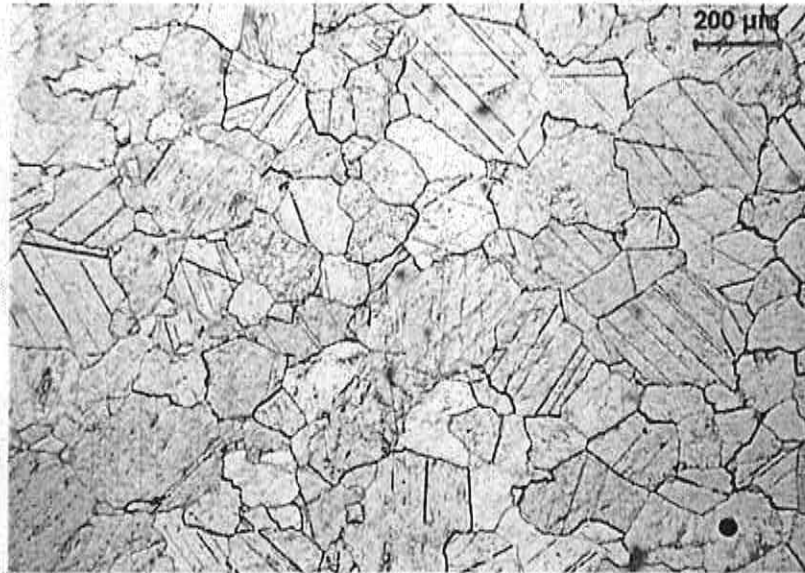
**Figure 34.** Microstructure of marble A. 1 year on the test wall. Plane-polarized light.

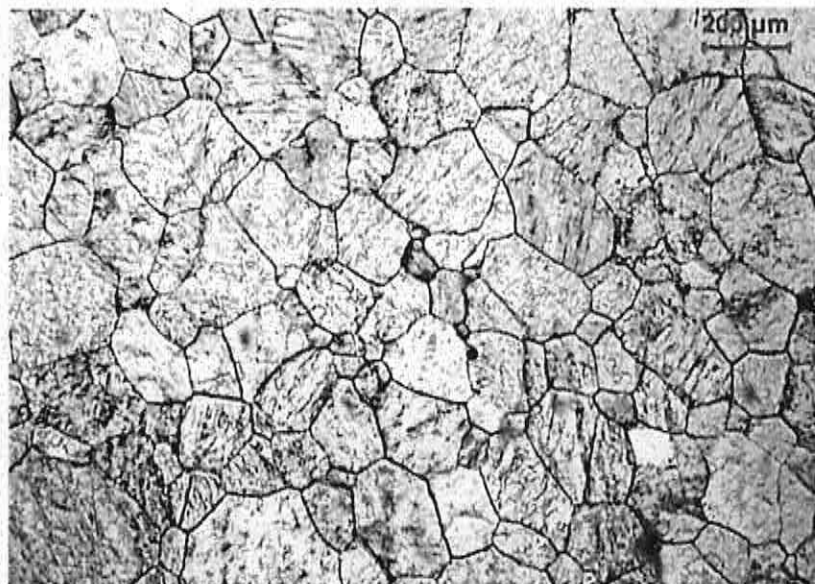
- fine-grained, fairly even grained, nor oriented, massive
- average grain size 200-300 μm
- nearly pure carbonate rock, contains very little mica type minerals
- some alteration of the grains
- no changes observable after 1 year on the test wall

**Figure 35.** Microstructure of marble D. Unused. Plane-polarized light.

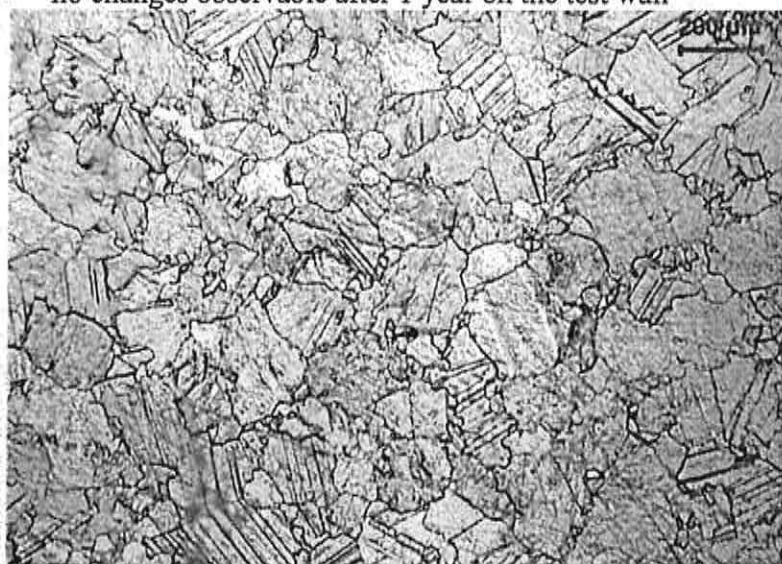
- fine-grained, not oriented
- grain size varies from microcrystalline up to 0.8 mm
- very fine-grained (cryptocrystalline) lenses among the groundmass, the lenses pass gradually into groundmass
- nearly pure carbonate, contains some opaque and mica type minerals
- some alteration of the grains
- no changes observable after 1 year on the test wall

**Figure 37.** Microstructure of marble E. Unused. Plane-polarized light.

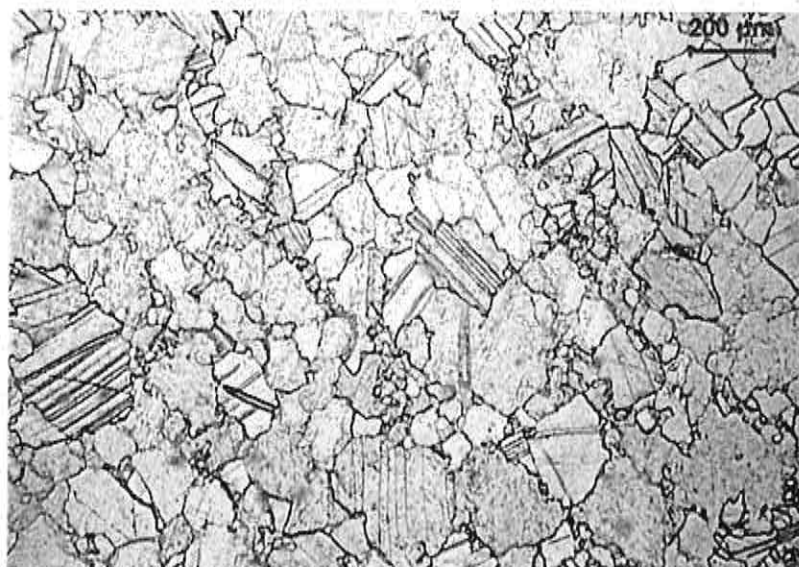
**Figure 38.** Microstructure of marble E. 1 year on the test wall. Plane-polarized light.

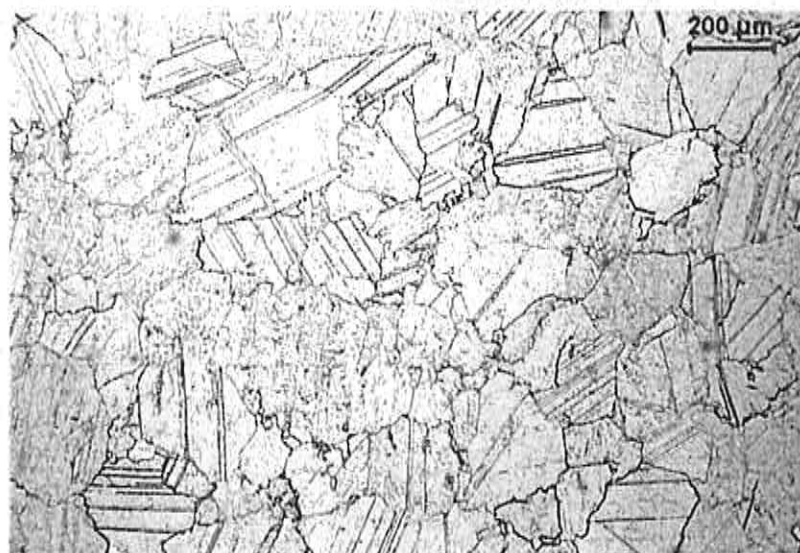
- fine-grained, not oriented
- average grain size about 200 μm
- very fine-grained (cryptocrystalline) lenses and veins among the groundmass, lense boundaries are distinguished from the groundmass
- nearly pure carbonate rock, contains some opaque minerals
- little alteration of the grains
- no changes observable after 1 year on the test wall

**Figure 40.** Microstructure of marble K. 1 year on the test wall. Plane-polarized light.

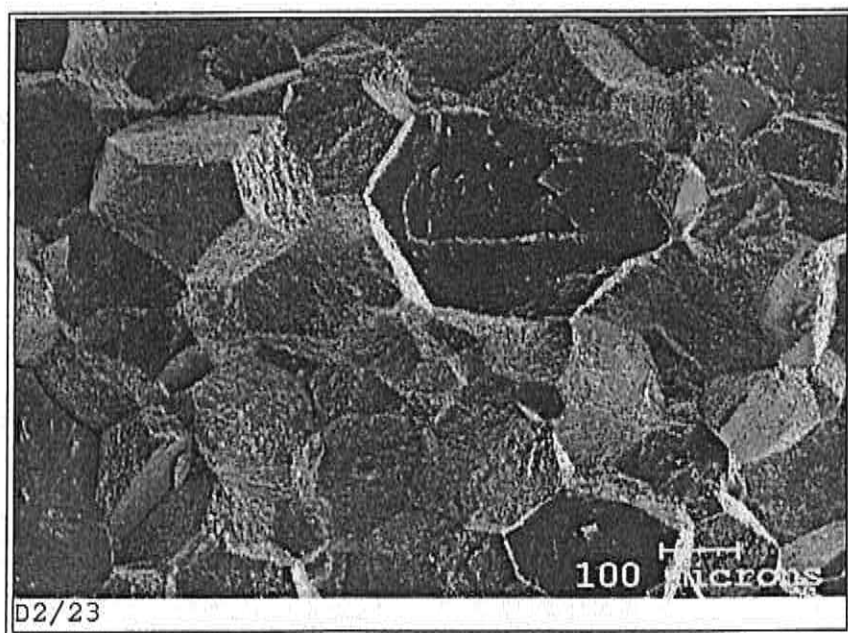
SEM-pictures of fractured surfaces of marble D, both unused and after 1 and 1.5 years on the test wall, are shown in Figs. 41-43. The individual grains can easily be distinguished from each other. Clear cracks can also be noticed between all the grains. These cracks become wider when the marble is exposed to the environmental strains on the test wall. The maximum crack width after 1.5 years on the test wall is around 1  $\mu\text{m}$ . Respective pictures of marbles A, E and K can be found in Appendix 1.

**Figure 41.** Marble D, unused. SE-image of fractured surface, 100x.

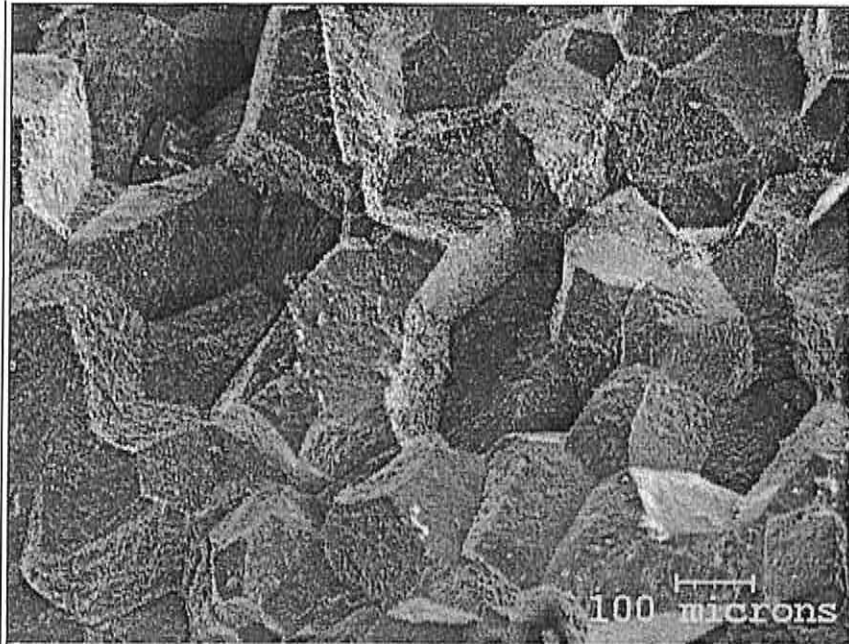
Figure 42. Marble D, 1 year on field test. SE-image of fractured surface. 500x.

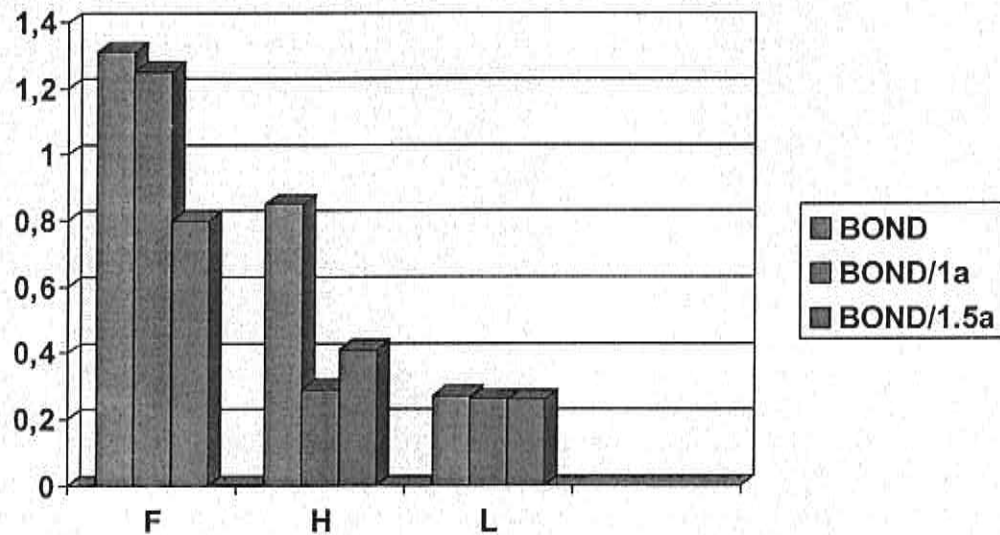
**Figure 44.** Bond strength of marble in marble clad elements (MPa).

In the element type F the breaking point was usually the interface between marble and concrete. Only in a couple of cases the loosening took place, at least partly, deeper inside concrete.

In the element type L the breaking point was always the interface between marble and the rest of the structure. Thus, the loosening of marble took place from the top of the glue layer.

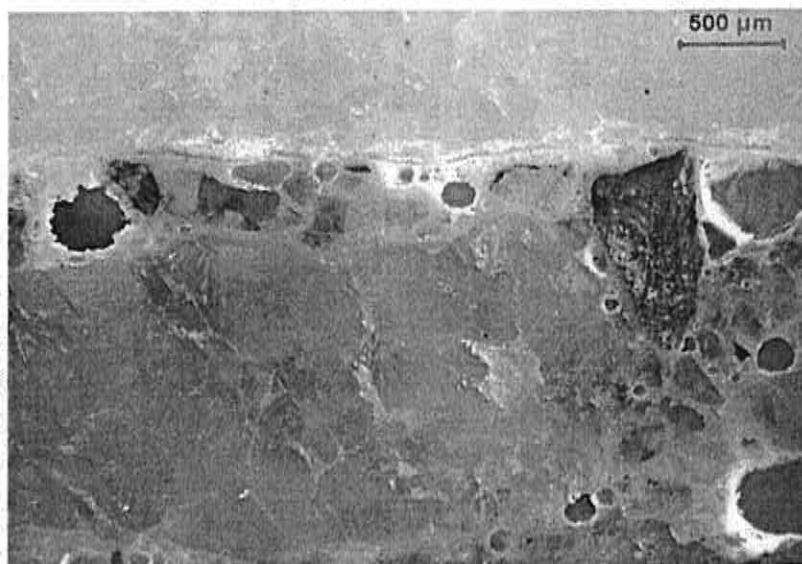
- contact between marble and concrete tight and cohesive
- a narrow layer of third material, probably primer, between marble and concrete
- material (primer) layer rather continuous, though pores are common; thickness of the layer generally 20-30µm, in places even 60 µm
- in the unused element only a few very tiny cracks along the marble/concrete contact zone
- in the element strained for 1.5 years on the test wall some slight and narrow cracking at the marble/concrete contact zone

**Figure 45.** Microstructure of marble clad element F. Unused. Objective 2.5x, oblique illumination.

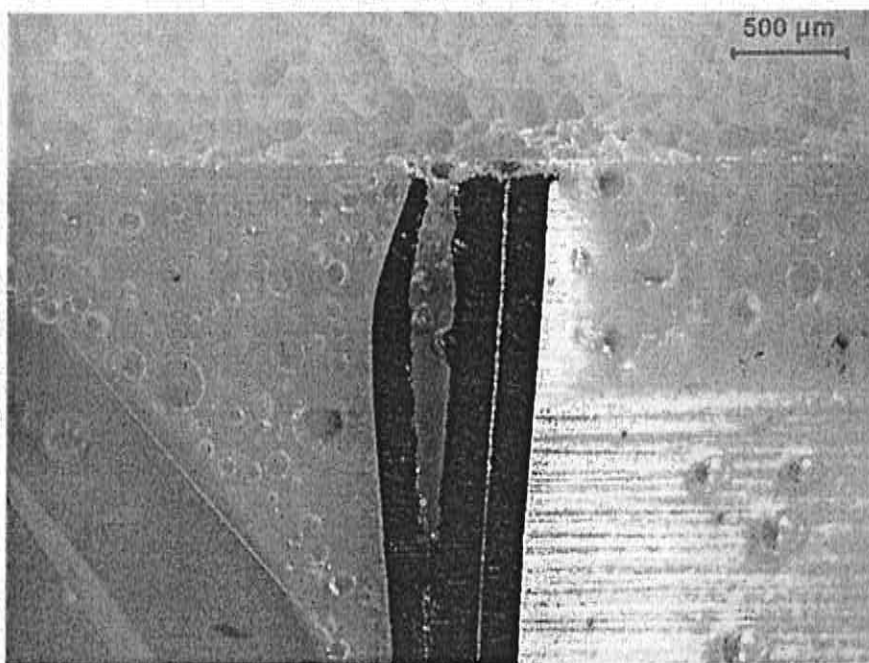
- a layer of glue between marble and metal structure, thickness of the layer approximately 0.5 mm
- the glue contains a lot of porosity
- in the unused element the glue layer partly detached from marble
- in the element strained for 1.5 years on the test wall the glue layer rather tightly attached to marble, only minor cracking in some parts of the contact zone

**Figure 46.** Microstructure of marble clad element L. Unused. Objective 2.5x, oblique illumination.
