# VTT BUILDING AND TRANSPORT

### Developing long term durability of marble facades

#### Subproject "Test wall"

Espoo, April 20, 2001

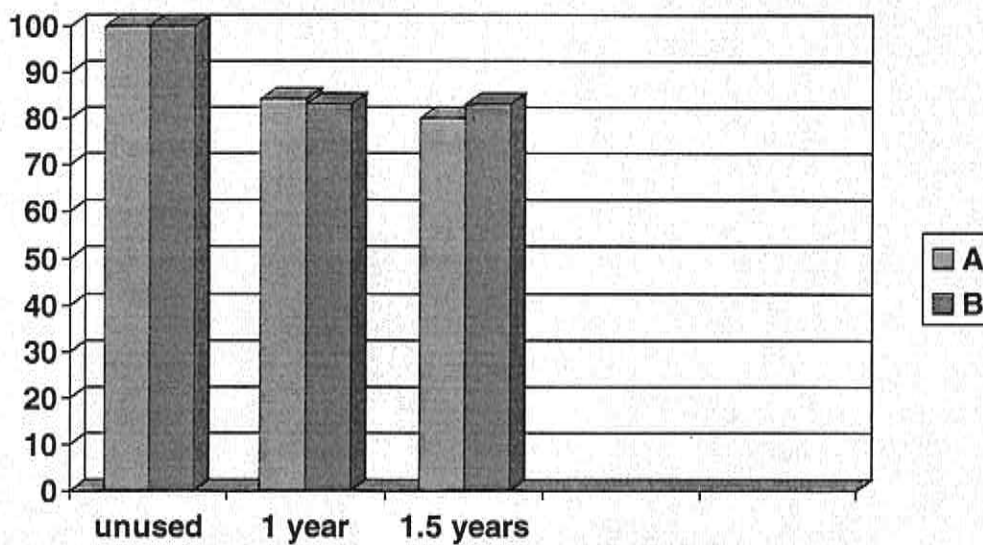
The loss of marble strength on the test wall is illustrated also in Figs. 3-6. In each case the flexural strength of unused marble has been given the value of 100.

**Figure 3.** Flexural strength of marble A. A relative scale.

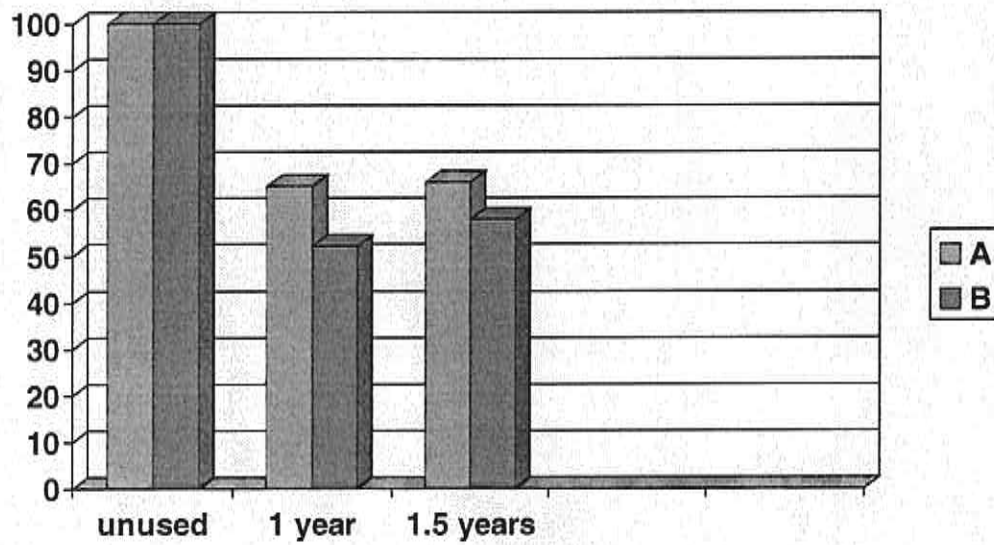
Figure 4. Flexural strength of marble D. A relative scale.

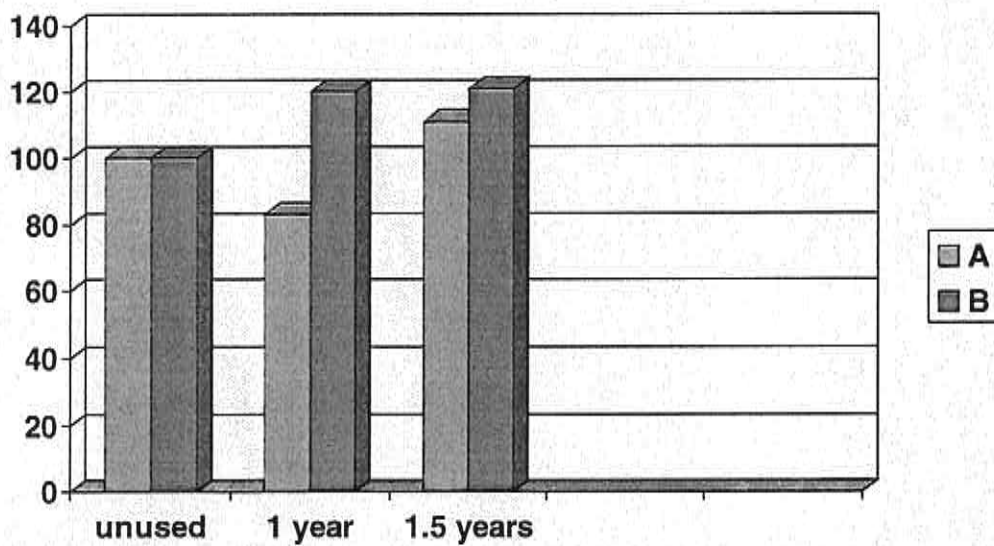
Figure 5. Flexural strength of marble E. A relative scale.

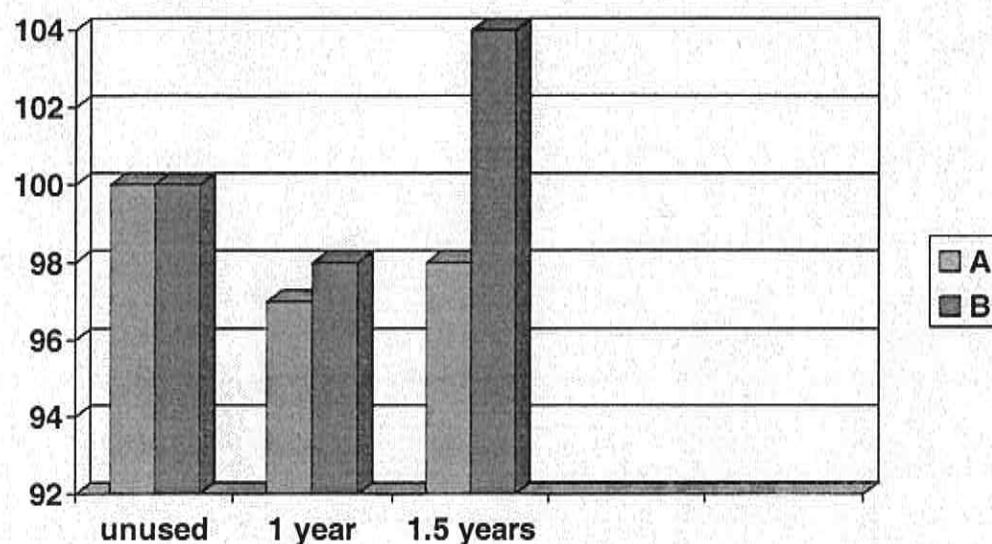
Figure 6. Flexural strength of marble K. A relative scale.

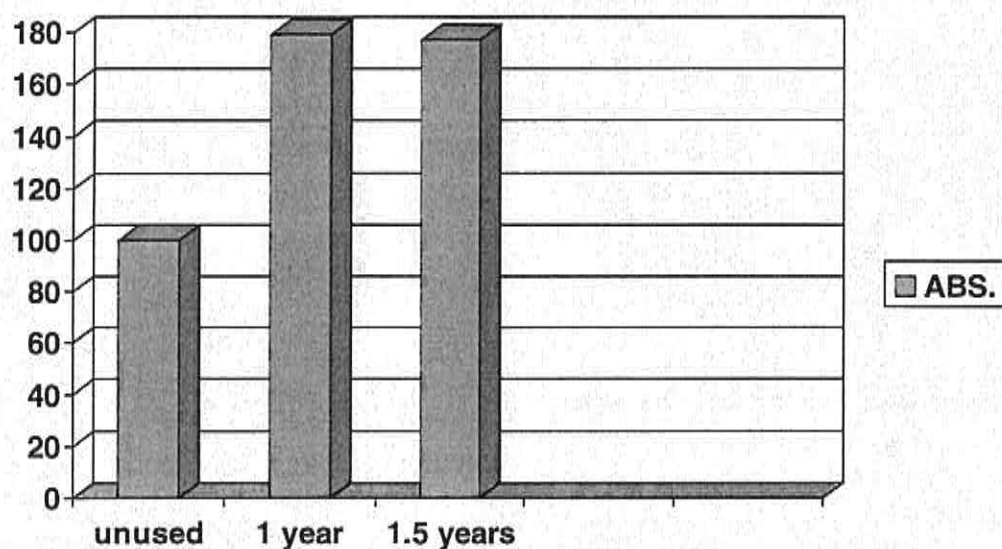
The increase of water absorption and porosity on the test wall is illustrated also in Figs. 9-12. In each case the water absorption (porosity) of unused marble has been given the value of 100.

Figure 9. Water absorption (porosity) of marble A. A relative scale.

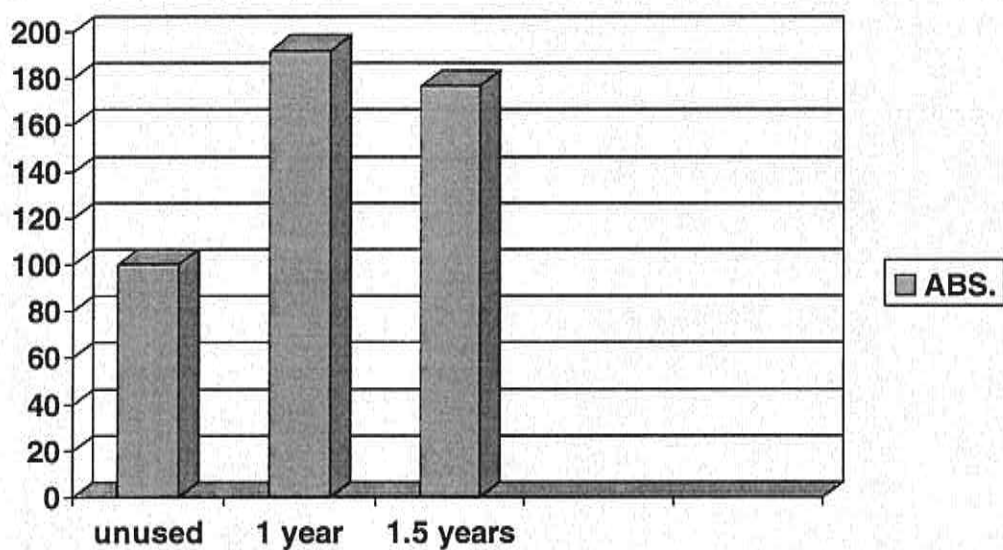
Figure 10. Water absorption (porosity) of marble D. A relative scale.

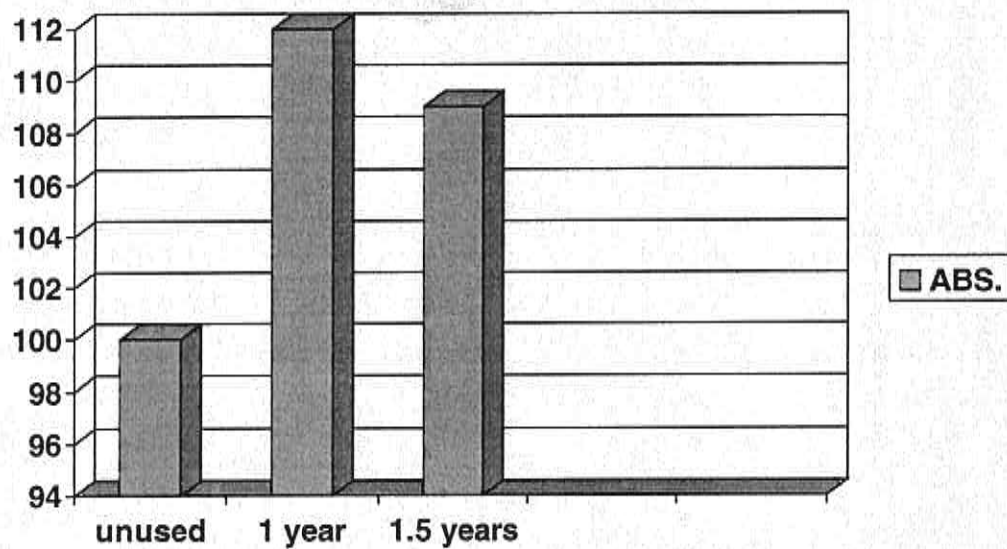
Figure 11. Water absorption (porosity) of marble E. A relative scale.

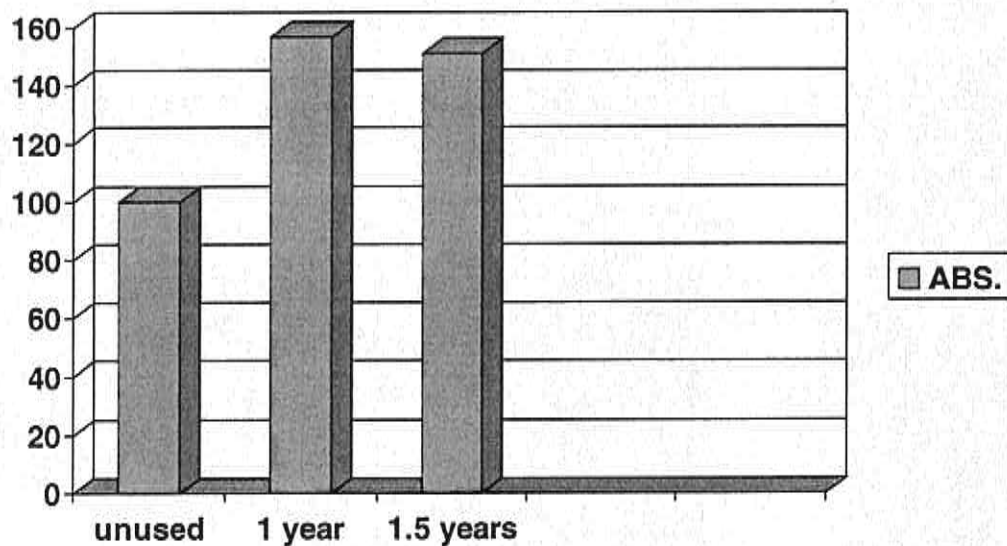
Figure 12. Water absorption (porosity) of marble K. A relative scale.

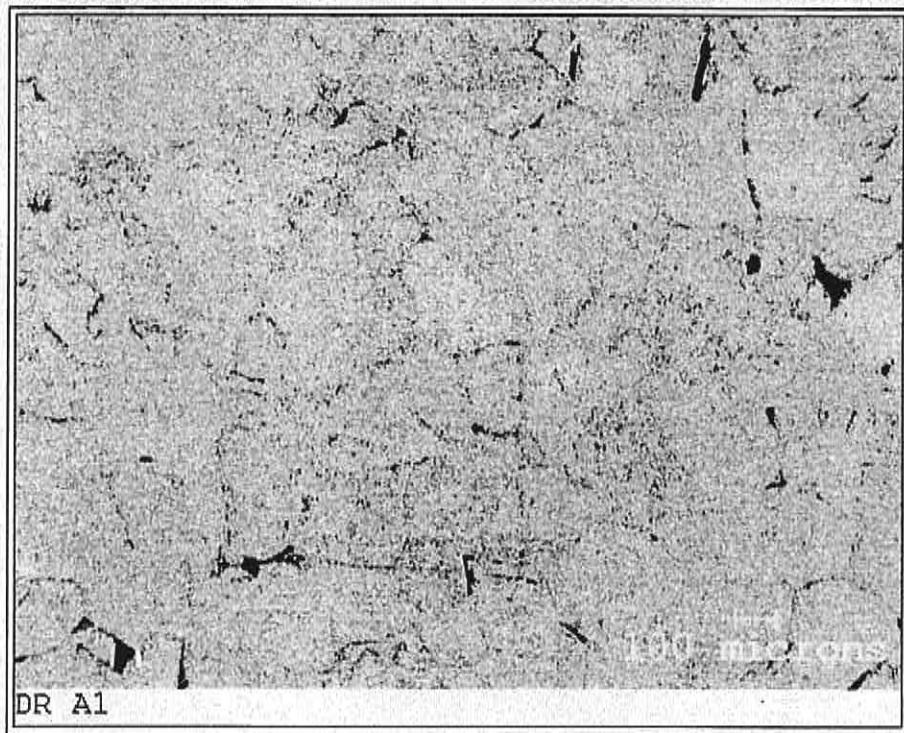
BSE- and SE-images of marble D, both unused and after 1 year on the test wall, are shown in Figs. 41-44. Grain boundaries can clearly be distinguished. Stresses caused by 1 year on the test wall seemed to affect the structure of the marble in such a way that the grain boundaries could be distinguished even more easily.

**Figure 42.** Marble D, 1 year on the test wall. BSE-image, 50x.

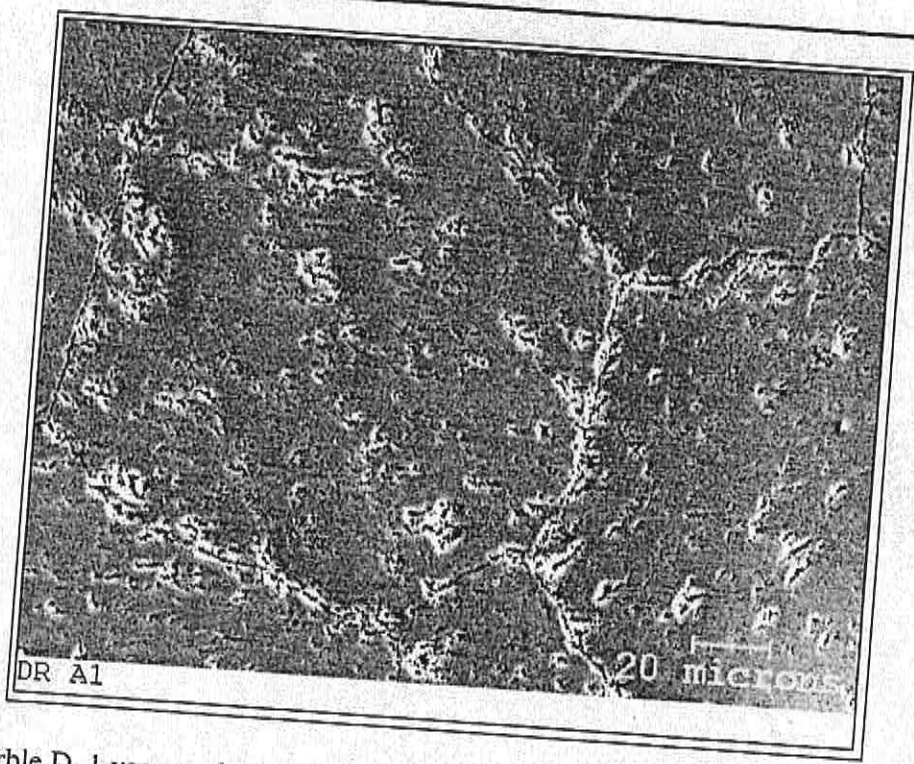
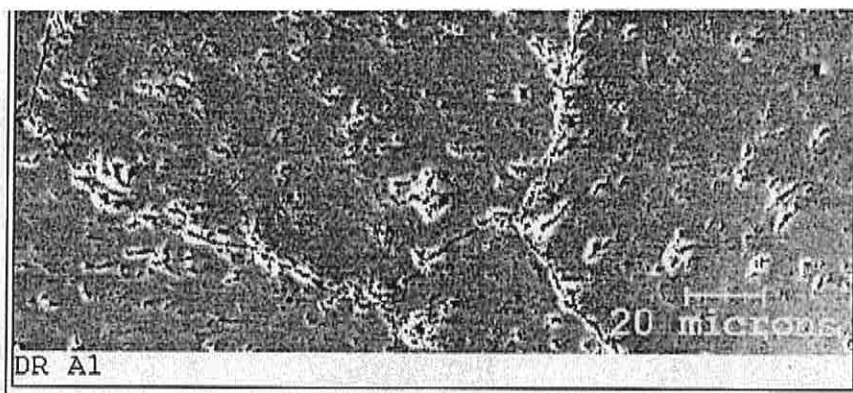
**Figure 44.** Marble D, 1 year on the test wall. SE-image, 500x.

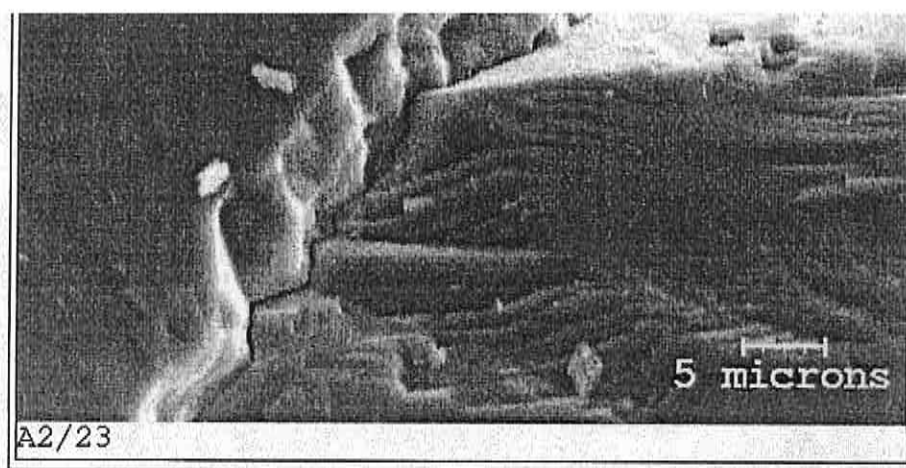
SEM-pictures of fractured surfaces of marble A, both unused and after 1 and 1.5 years on the test wall, are shown in Figs. 53-58. The individual grains can at least partly be distinguished from each other. Narrow cracks can also be noticed between some of the grains. More and wider cracks were detected when the marble had been exposed to the environmental stresses on the test wall. The maximum crack width after 1.5 years on the test wall is around 0.6-0.7  $\mu\text{m}$ .

**Figure 56.** Marble A, unused. SE-image of fractured surface, 2500x.

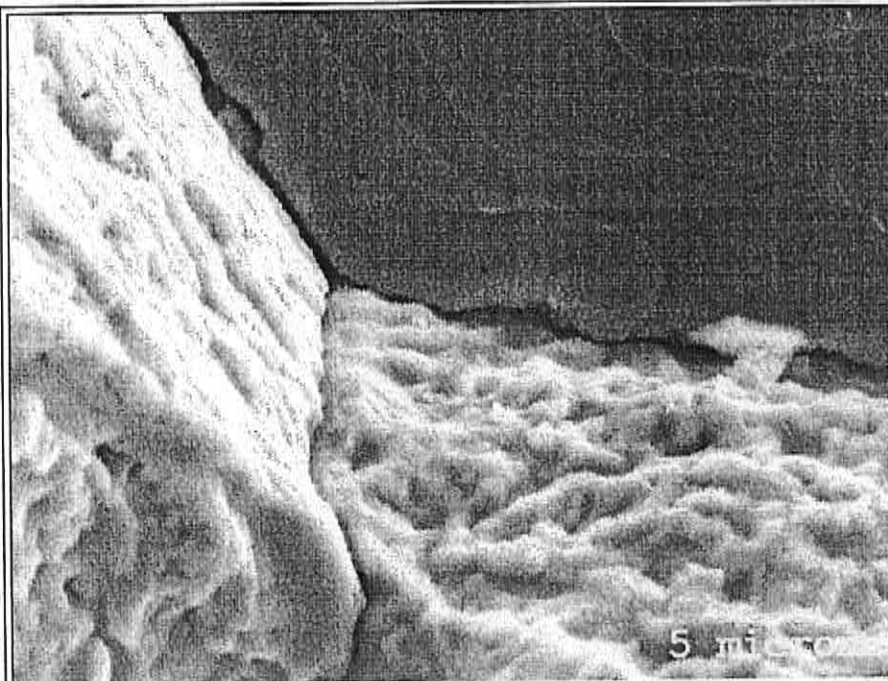
D2/23

SEM-pictures of fractured surfaces of marble D, both unused and after 1 and 1.5 years on the test wall, are shown in Figs. 59-64. The individual grains can easily be distinguished from each other. Clear cracks can also be noticed between all the grains. These cracks were wider when the marble had been exposed to the environmental stresses on the test wall. The maximum crack width after 1.5 years on the test wall is around 1  $\mu\text{m}$ .

**Figure 61.** Marble D, 1.5 years on the test wall. SE-image of fractured surface, 100x.

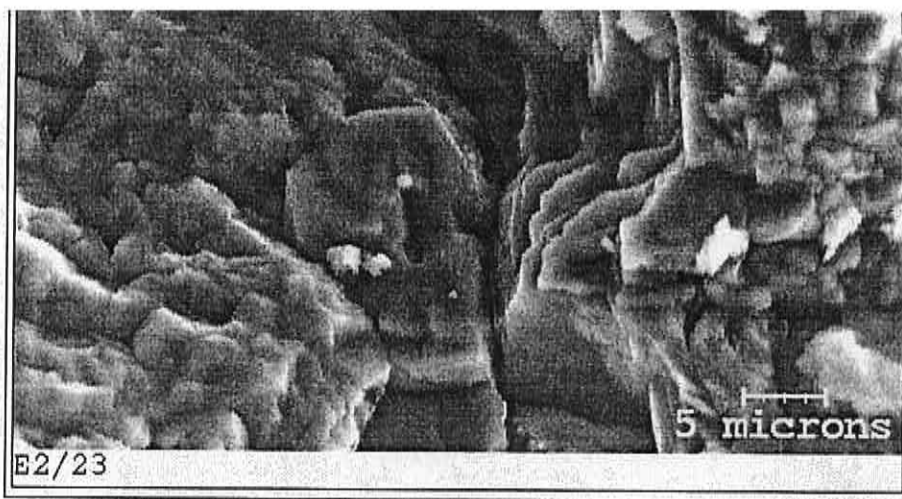
SEM-pictures of fractured surfaces of marble E, both unused and after 1 and 1.5 years on the test wall, are shown in Figs. 65-70. The grain boundaries can be seen only in some places. Thus, it is impossible to distinguish the grains from each other. Some very narrow cracks can be noticed between some of the grains. Some more and a little wider cracks were detected when the marble had been exposed to the environmental stresses on the test wall. The maximum crack width after 1.5 years on the test wall is around  $0.3\ \mu\text{m}$ .

**Figure 68.** Marble E, unused. SE-image of fractured surface, 2500x.

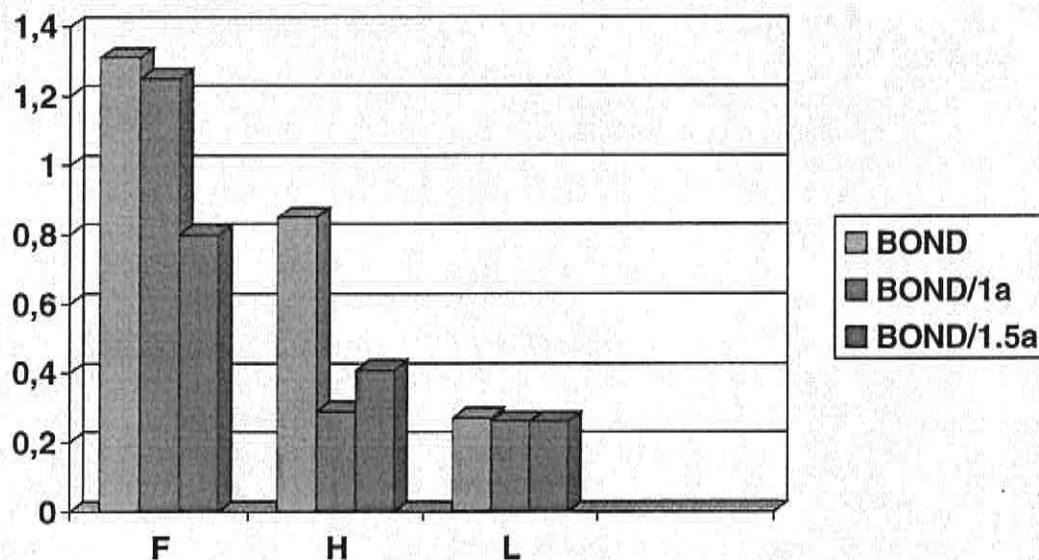
Figure 77. Bond strength of marble in marble clad elements (MPa).

In the element type F the breaking point was usually the interface between marble and concrete. Only in a couple of cases the loosening took place, at least partly, deeper inside concrete.

In the element type L the breaking point was always the interface between marble and the rest of the structure. Thus, the loosening of marble took place from the top of the glue layer.

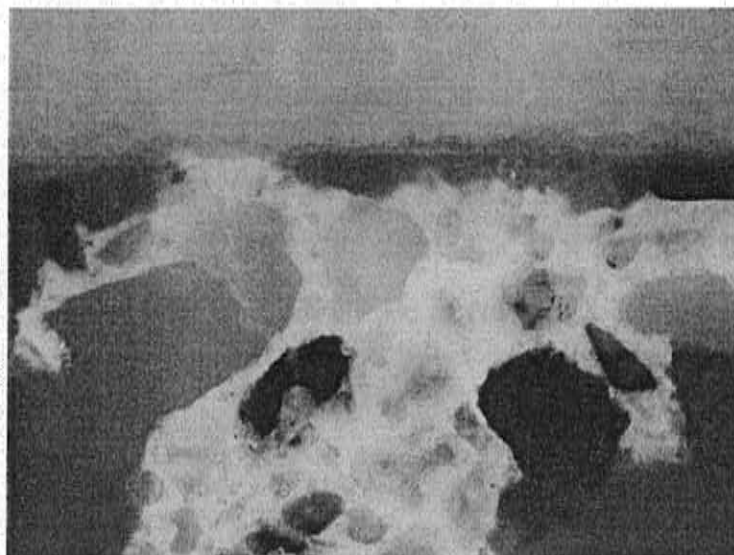
- contact between marble and concrete tight and cohesive
- a thin layer of third material, probably primer, between marble and concrete
- material (primer) layer rather continuous, though pores are common; thickness of the layer generally 20-30  $\mu\text{m}$ , in places even 60  $\mu\text{m}$
- in the unused element only a few very tiny cracks along the marble/concrete contact zone
- in the element stressed for 1.5 years on the test wall some slight and narrow cracking at the marble/concrete contact zone

**Figure 81.** Microstructure of marble clad element F. 1.5 years on the test wall. Objective 2.5x, fluorescent light.

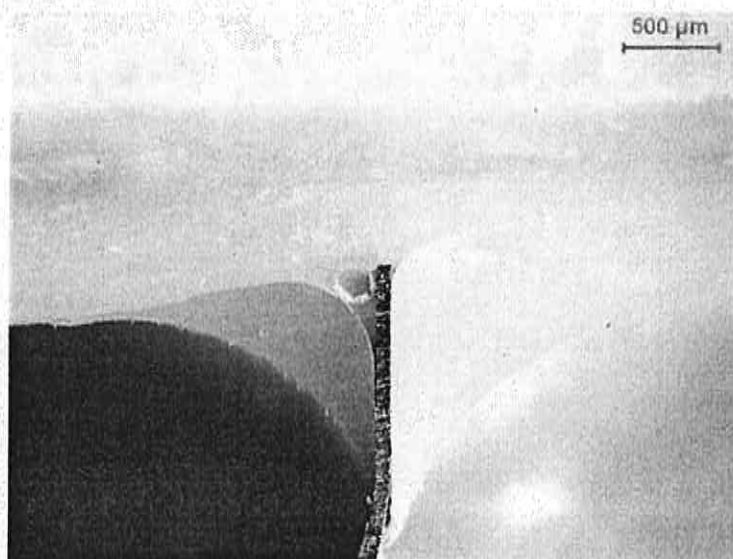
- a layer of glue between marble and metal structure, thickness of the layer approximately 1 mm
- structure of the unused element partly cracked along the contact zone marble/glue
- in the unused element the upper half of the glue layer tinted yellowish
- in the element stressed for 1.5 years on the test wall the upper half of the glue layer tinted brownish
- in the element stressed for 1.5 years on the test wall open crack on about 60% of the contact zone marble/glue

**Figure 82.** Microstructure of marble clad element H. Unused. Objective 2.5x, oblique illumination.

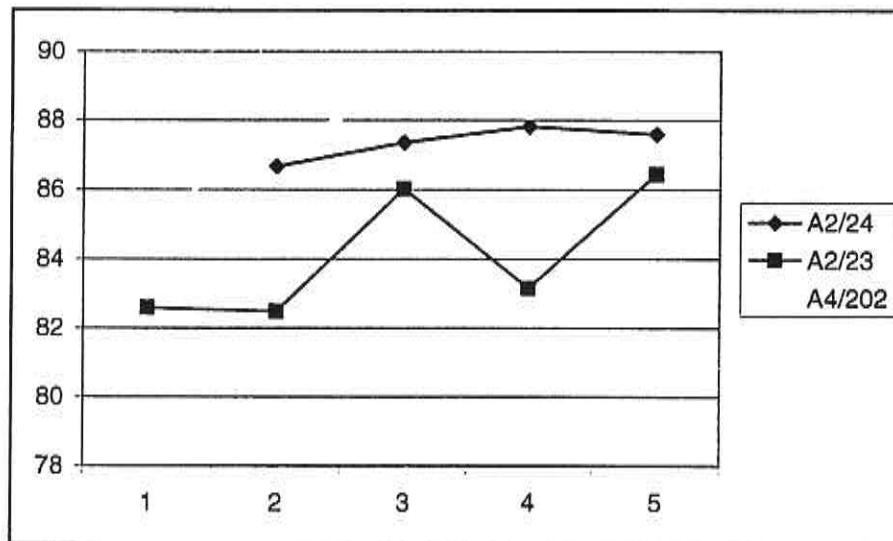
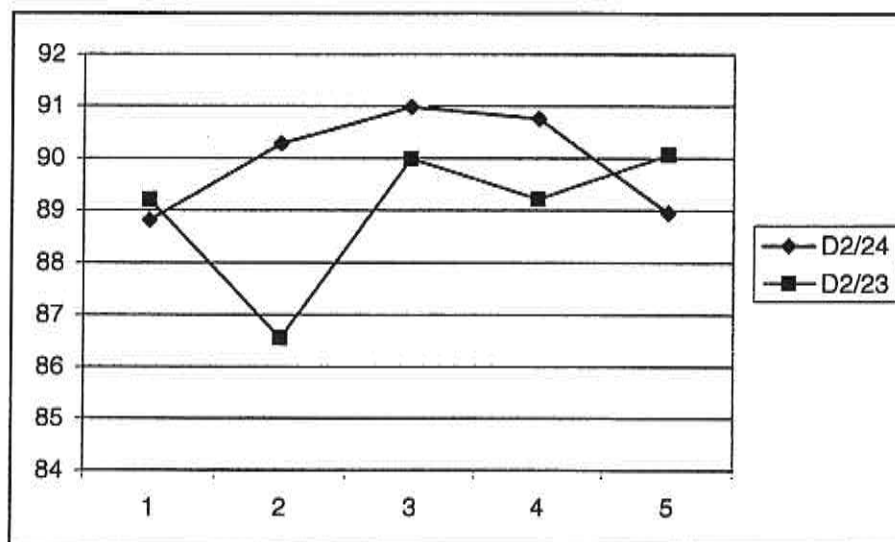
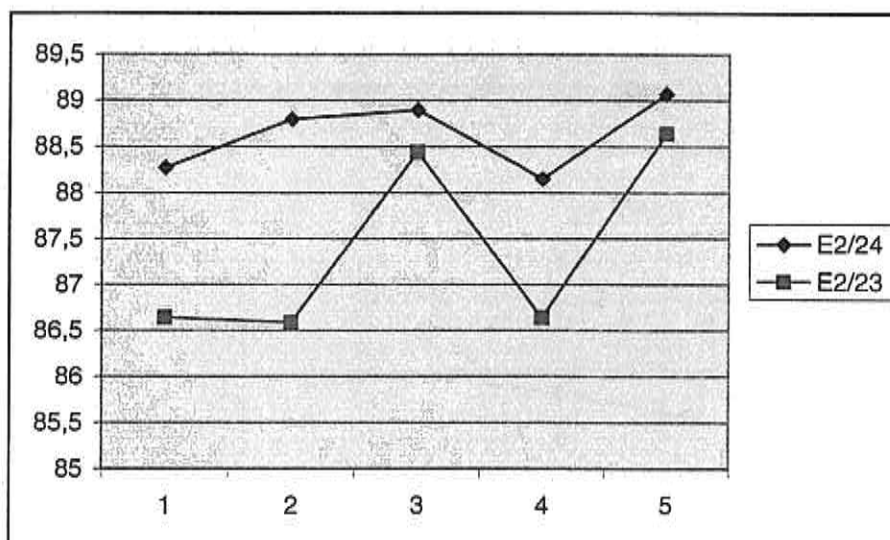
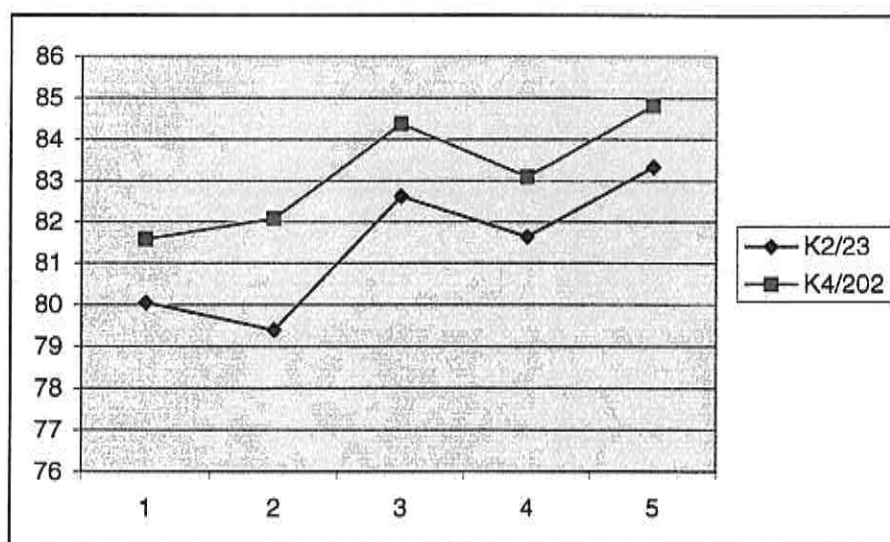
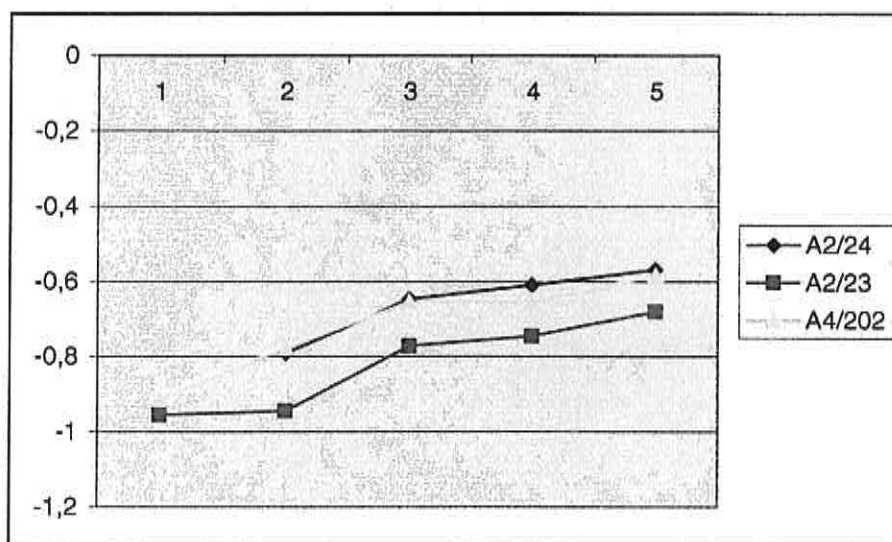
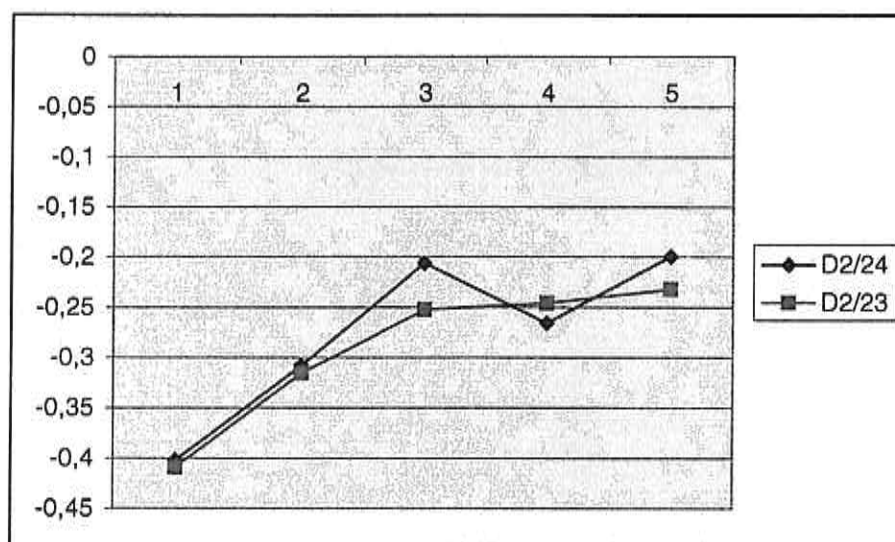
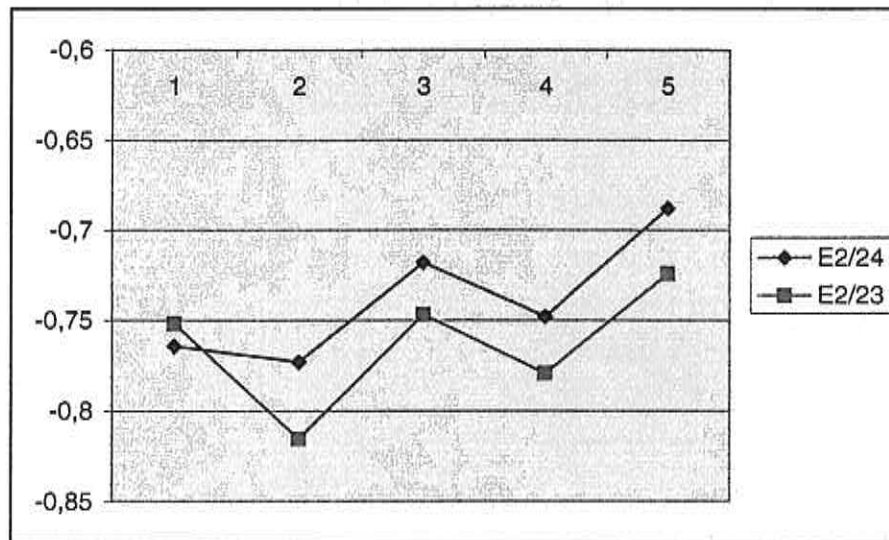
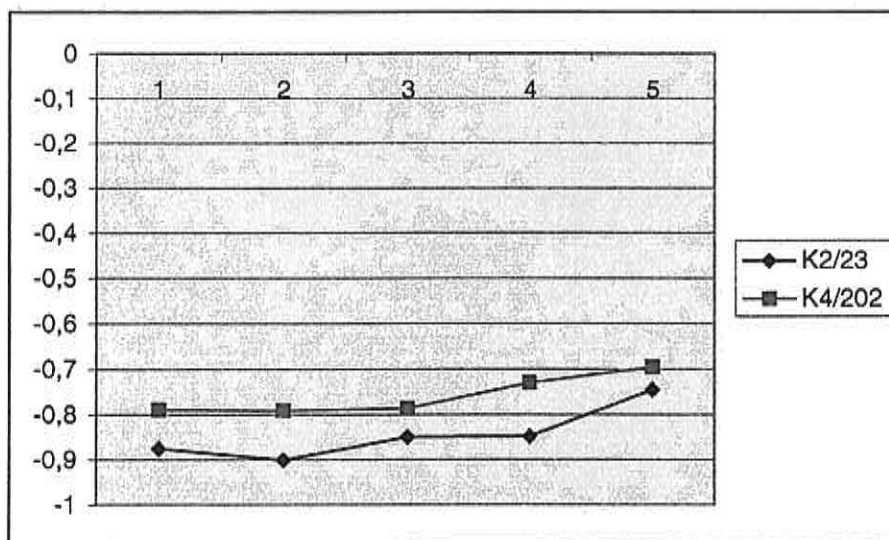
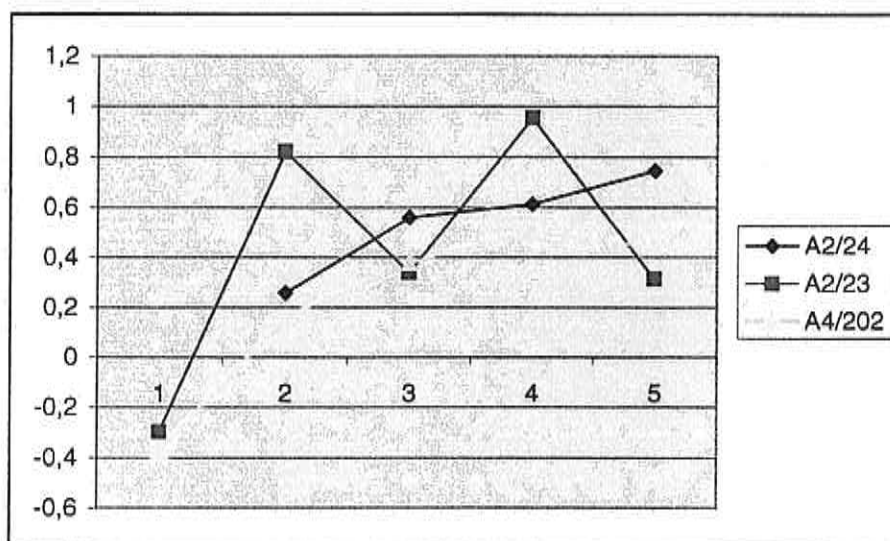
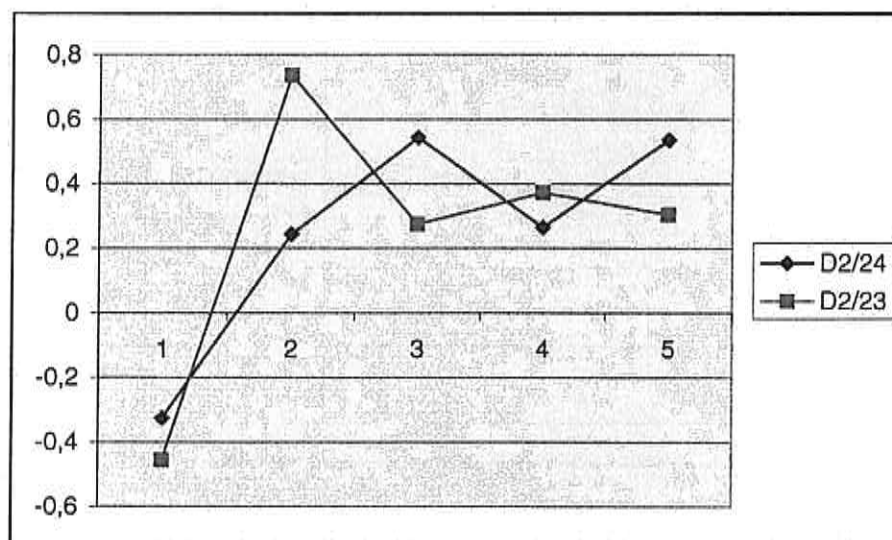
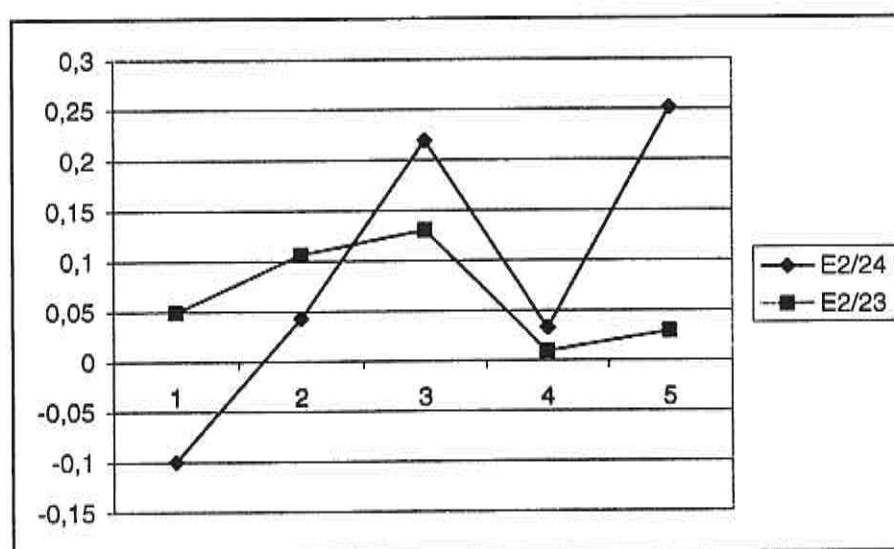
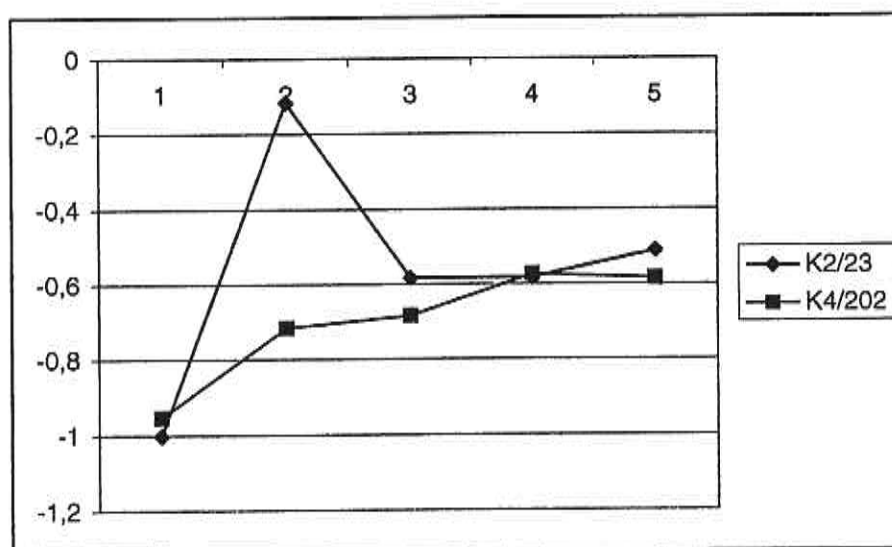
According to the colour measurements the whiteness of the marbles increased. This was evident especially during the first year. After that the changes seem to have been slow, if not negligible. Also, there has been a slight tendency for the co-ordinates a and b to move towards more positive values. This means that the marbles are getting more red and more yellow, which could refer to fouling of the marble surfaces. So far the changes have, however, been small. The results from the colour measurements are shown in Figs. 93-104. The detailed results are presented in Appendix 4.

The colour differences,  $\Delta E$ , of the marbles calculated from the values of the first (1) and the last (5) measurements are shown in Table 14. According to the results the colour change of marbles A and K, with the exception of slab A2/24, is evident. However, the colour change of marbles D and E is hardly noticeable so far.

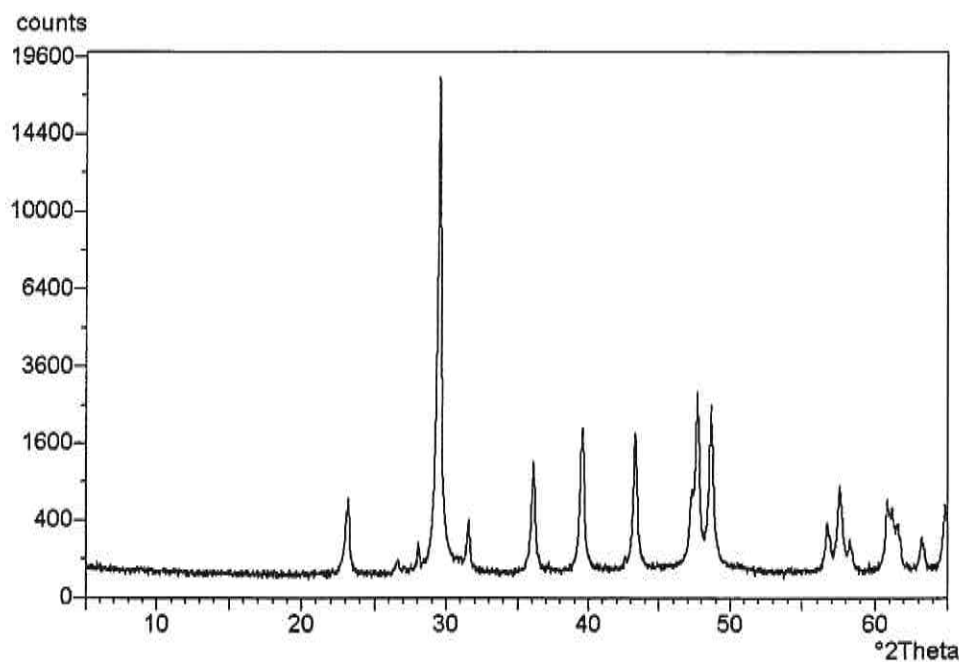
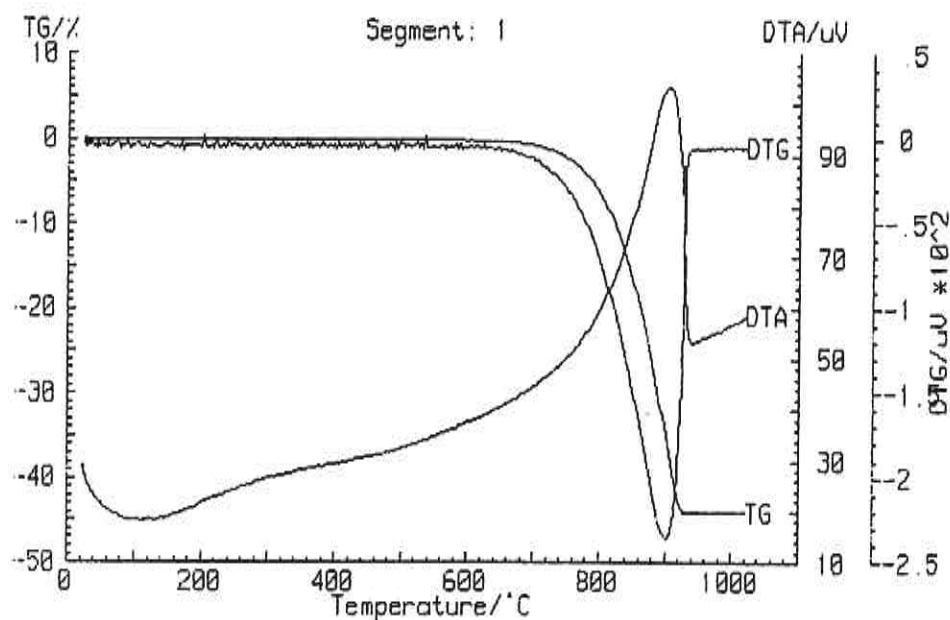
Marble from the building representing the case 1 was practically pure calcite, i.e. calcium carbonate. It contained only a few percents of quartz, feldspar and possibly mica as impurities. The weight loss of the marble in thermal analysis was 44.0 w-%. The X-ray diffraction diagram of the marble is shown in Fig.105 and its thermal curves in Fig. 106.

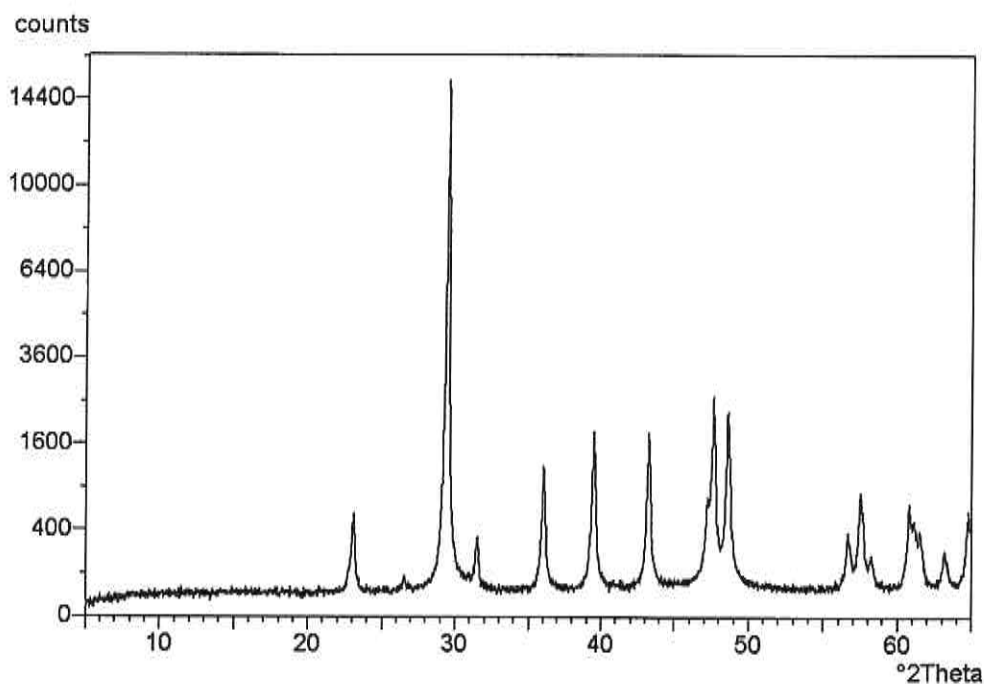
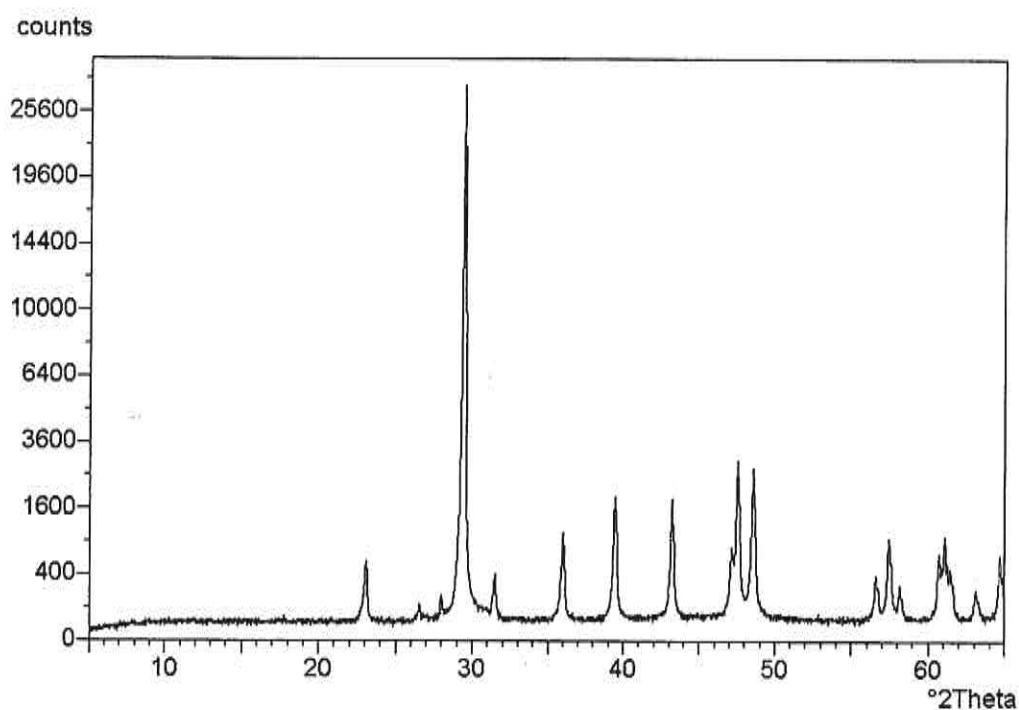
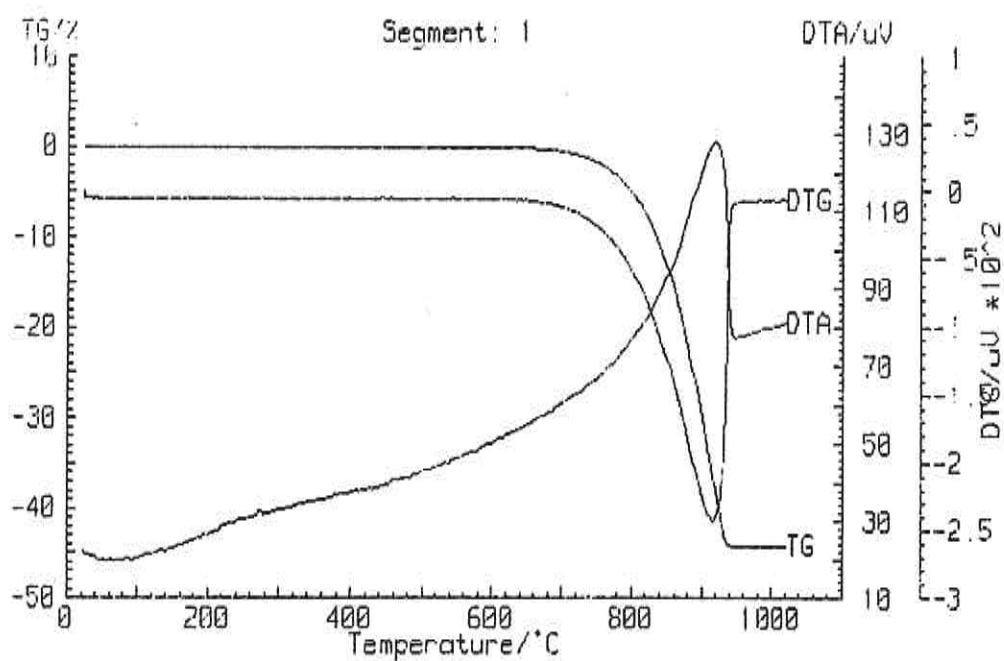
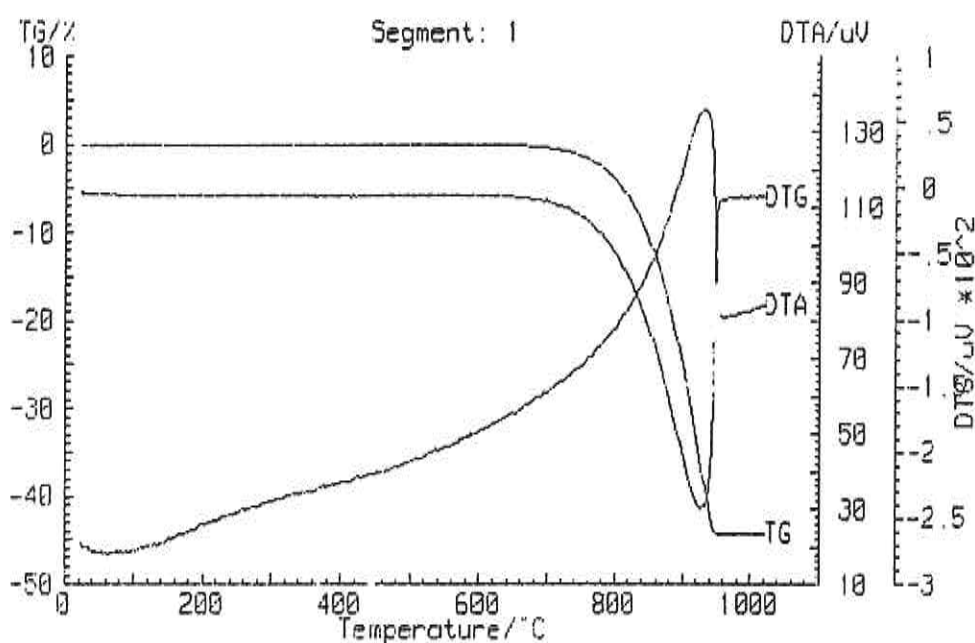
Marbles from the building representing the case 2 were practically pure calcite, i.e. calcium carbonate. Marble from the older part contained only a few percents of quartz, marble from the younger part a few percents of quartz and feldspar as impurities. The weight loss of older marble in thermal analysis was 44.3 w-% and that of younger 44.2 w-%. The X-ray diffraction diagrams of marbles are shown in Figs. 107 and 108 and their thermal curves in Figs. 109 and 110.

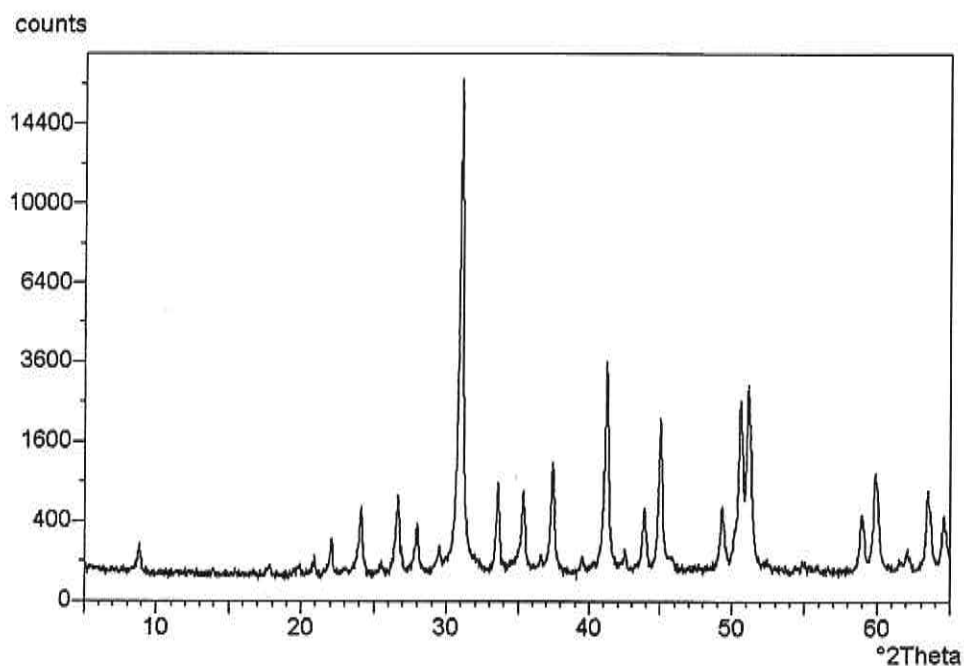
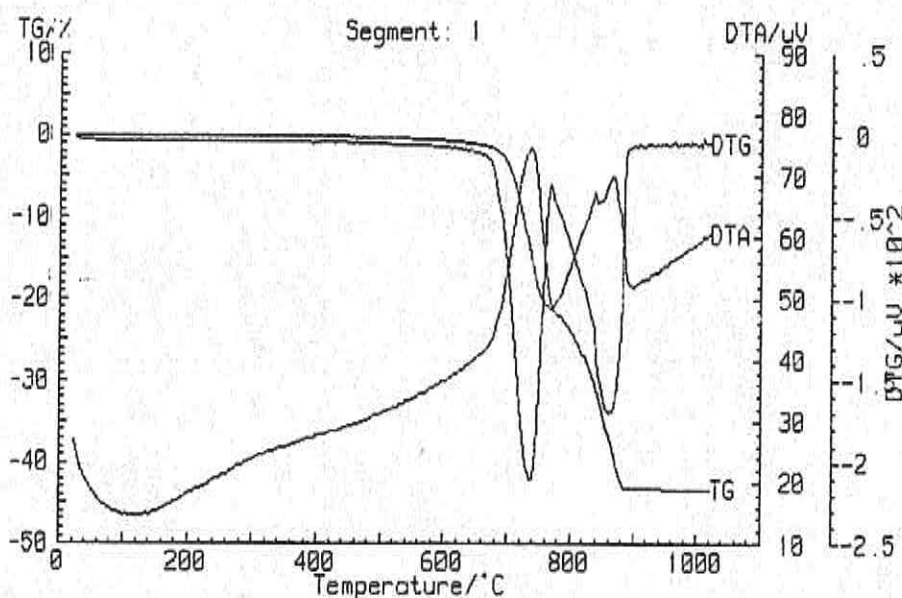
The main component of marble from the building representing the case 3 was dolomite, i.e. calcium magnesium carbonate. Thus, it was not question about marble. It contained also a notable amount of quartz and feldspar plus some mica and calcite as impurities. The weight loss of stone in thermal analysis was 43.3 w-%. The X-ray diffraction diagram of stone is shown in Fig.111 and its thermal curves in Fig. 112.

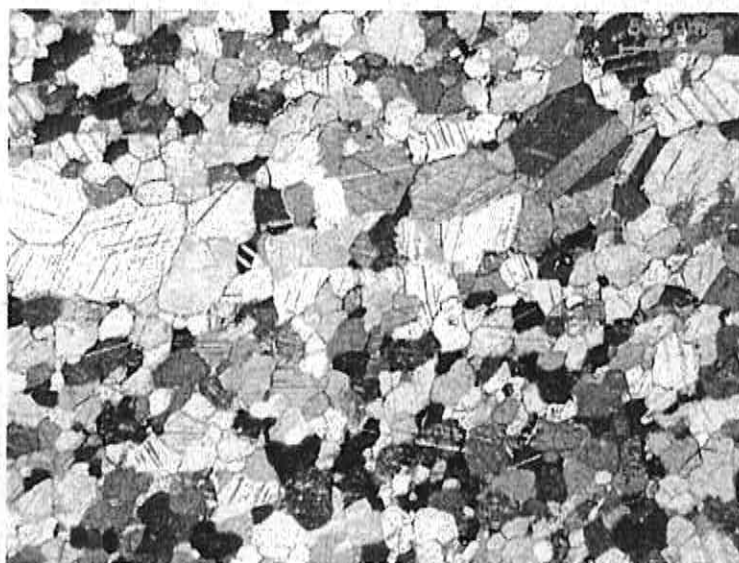
- fine-grained ground mass, slightly oriented, average grain size 0.1-0.2 mm
- in places more coarse-grained veinlets with a thickness of about 1 mm, veinlets show the same orientation as the ground mass
- grain boundaries clear, often straight, grains easily distinguished
- nearly pure carbonate rock, only a little quartz and opaque minerals, possibly feldspar

Figure 113. Microstructure of marble from case 1. Cross-polarized light.

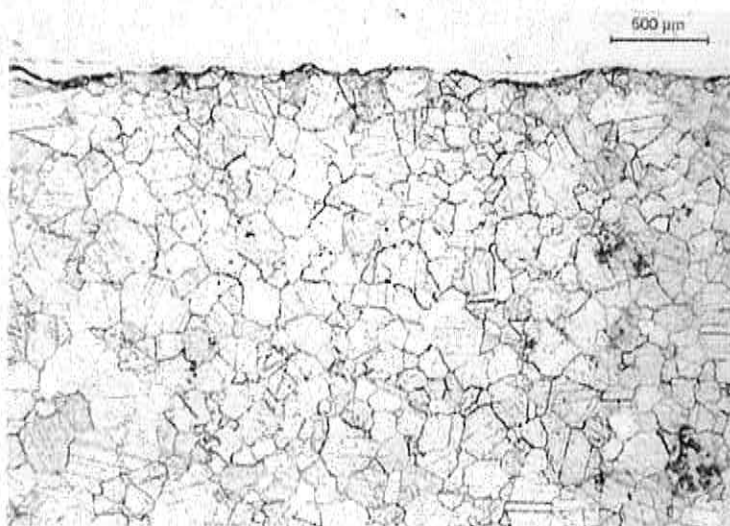
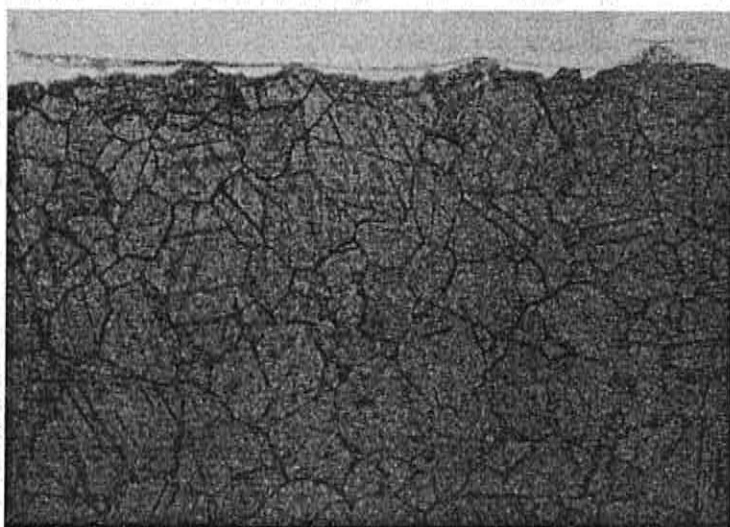
- ground mass fine-grained, even-grained, not oriented
- grain boundaries easily distinguished
- a few very fine-grained cryptocrystalline lenses, max. length about 10  $\mu\text{m}$ , inside the ground mass
- no heavy cracking
- outer surface dirty and uneven
