# VTT BUILDING AND TRANSPORT

### Developing long term durability of marble facades

#### Subproject "Test wall"

Espoo, April 20, 2001

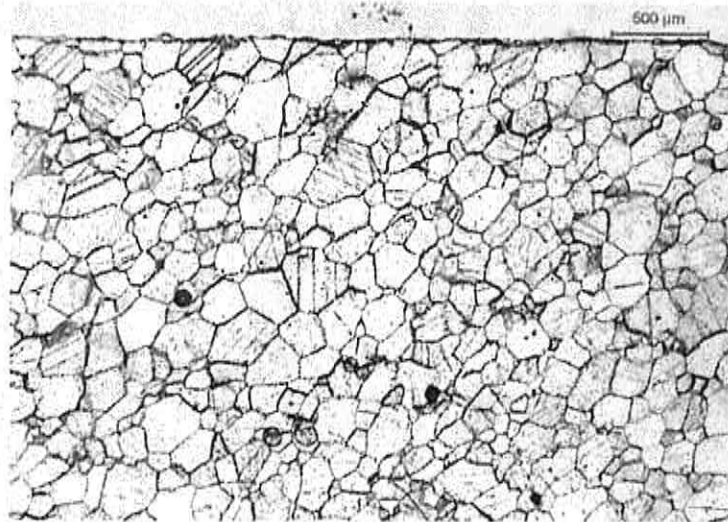
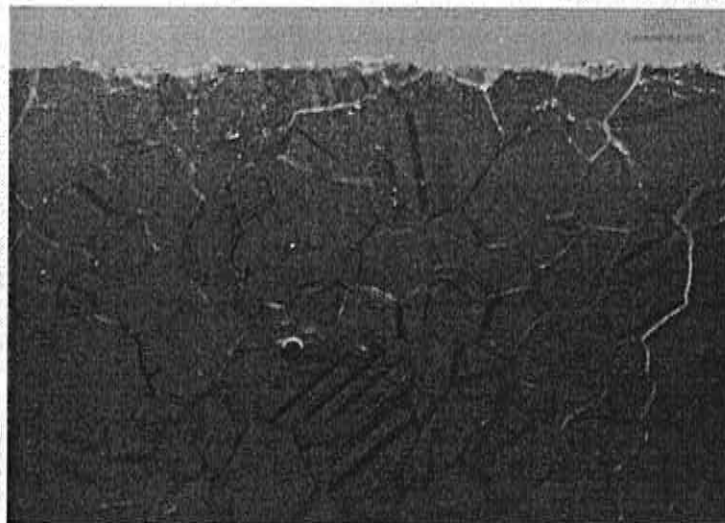
- ground mass fine-grained, fairly even-grained, not oriented
- grain boundaries easily distinguished
- a few very fine-grained cryptocrystalline lenses, max. length about 2-3 mm, inside the ground mass
- cracks between the grains extending to a depth of about 2-3 mm from the outer surface and to a depth of about 1-2 mm from the inner surface, some cracks cut the surface
- outer surface dirty

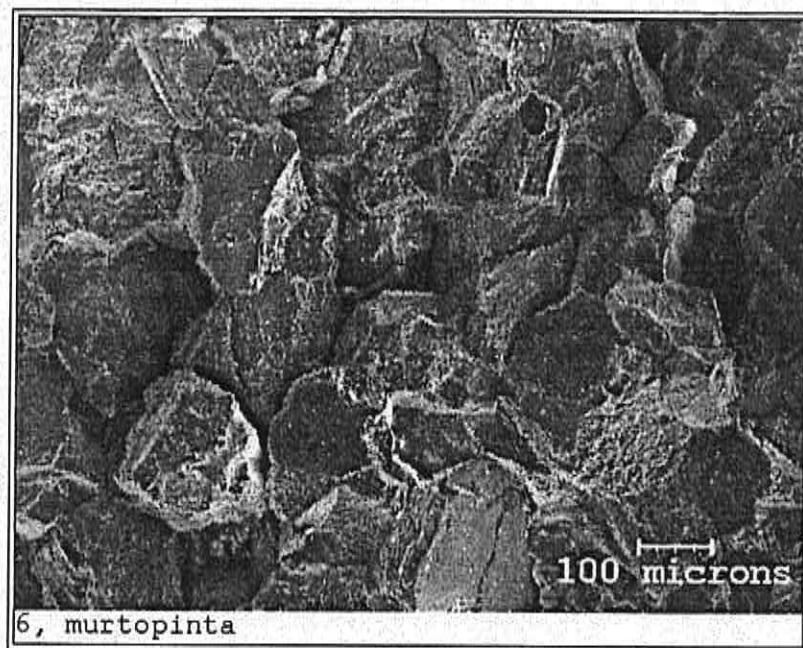
SEM-pictures of fractured surfaces of marble from the case 2 are shown in Figs. 122 and 123. In marble of the older part the individual grains can at least for the most part be distinguished from each other. In marble of the younger part the grains are almost detached from each other. Wide cracks can be noticed between all the grains. The average grain size of older marble is about 200  $\mu\text{m}$ , that of younger marble around 200-300  $\mu\text{m}$ .

**Figure 122.** Marble from case 2, older part. SE-image of fractured surface, 100x.

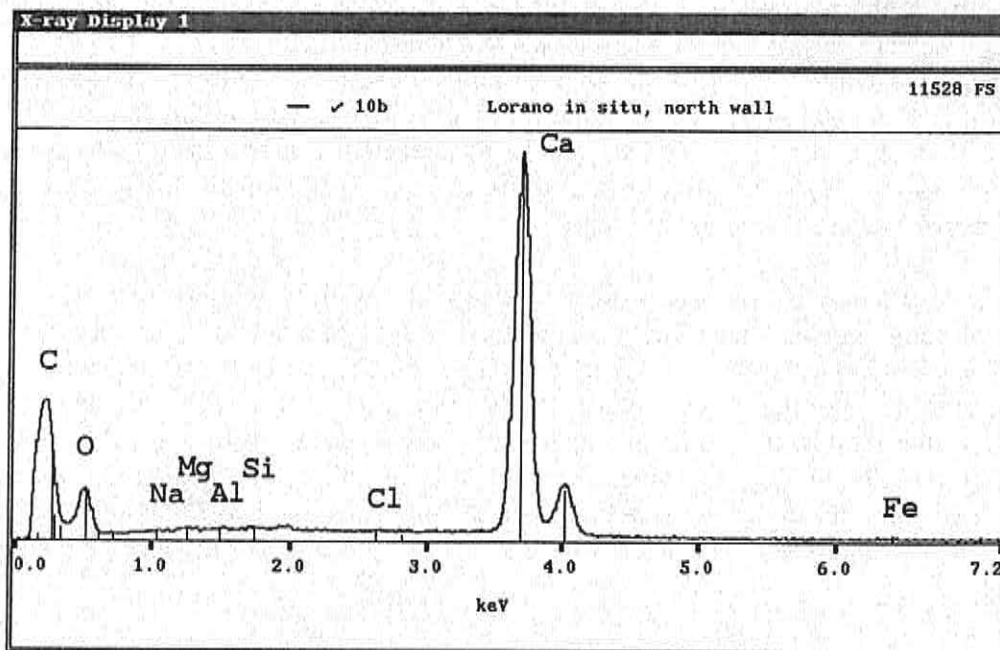
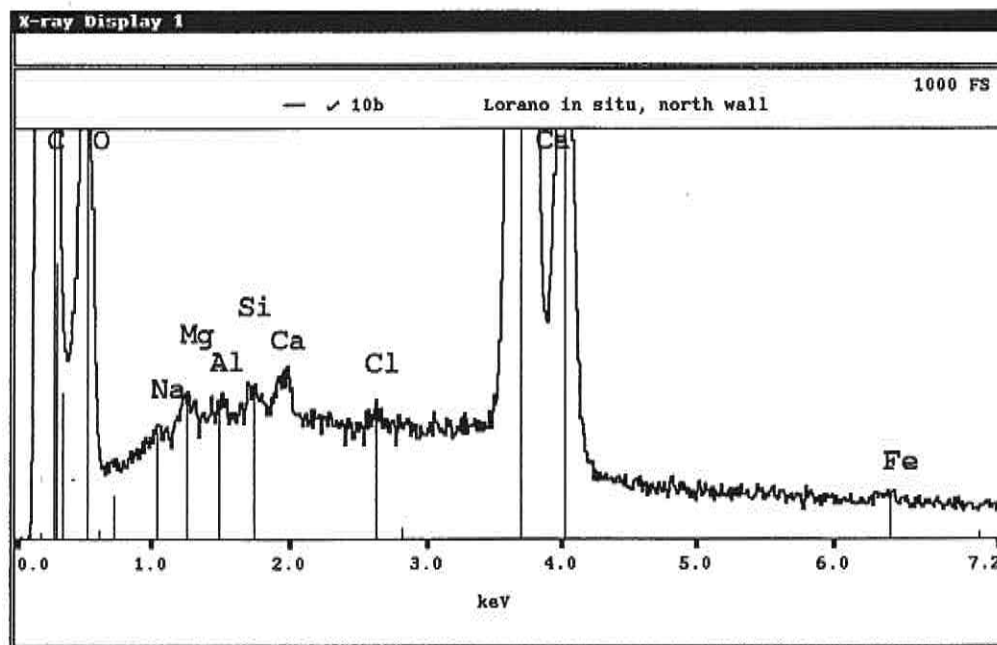
In connection with the SEM-study also the chemical composition of marble from the northern wall of Finlandia Hall was surveyed by using an energy dispersive PGT Imix spectrometer (EDS). The analysis was made from the fractured surface very close to the outer surface of the slab. The composition observed was practically that of the unused marble, only a little chlorine was detected. The EDS-spectra of marble are shown in Figs. 128 and 129.
